**Seshasayee Paper and Boards Limited
Erode**

**Thermography as a Tool to Improve
Reliability**

IN SPB

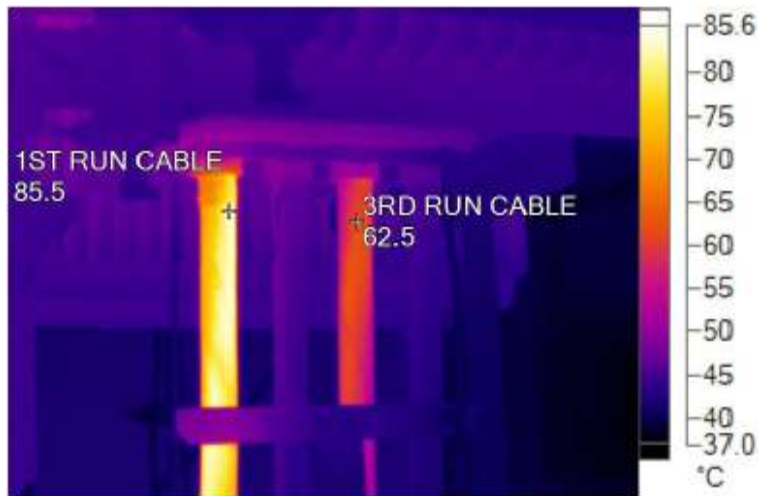
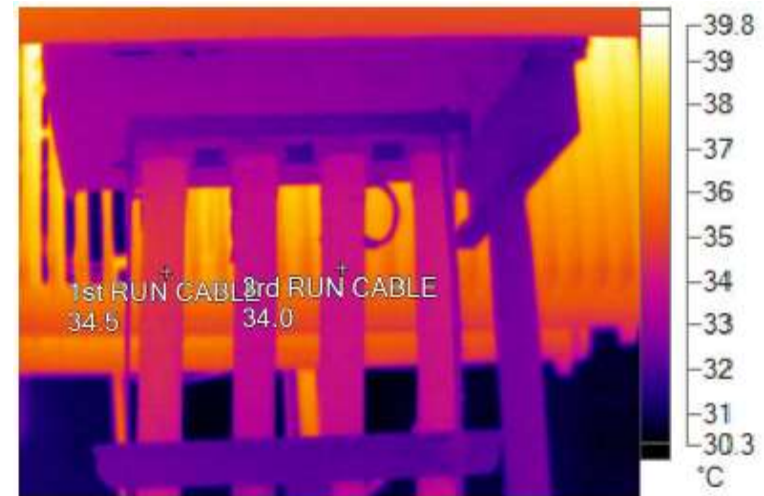
5MVA-III TRANSFORMER

- OBSERVED HIGH TEMP ON TRANSFORMER SECONDARY CABLE TERMINATION
- CABLE RELUGED AND TERMINATION TIGHTNESS CHECKED.
- WORK ATTENDED AND FOUND NORMAL

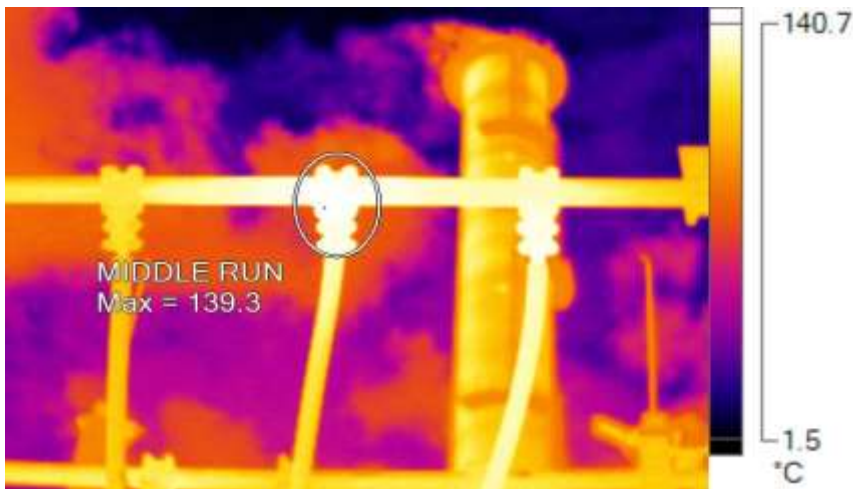
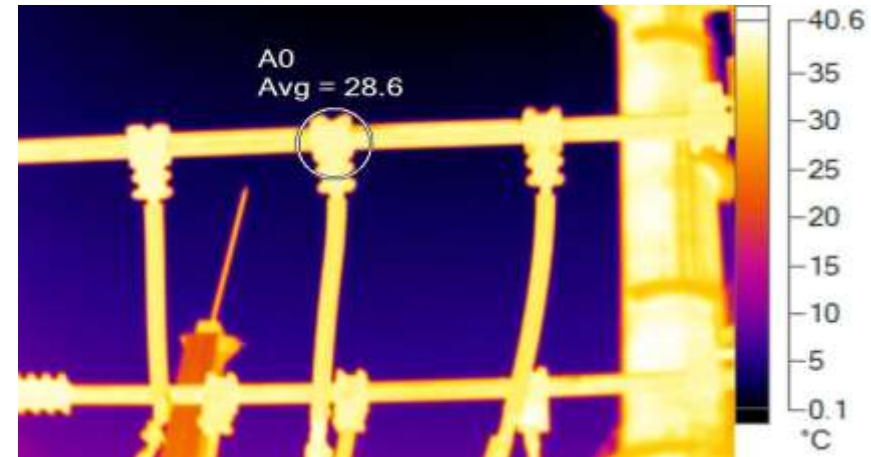
110KV YARD

- OBSERVED HIGH TEMP ON 22KV MIDDLE RUN CABLE GLAND
- CHECK AND FOUND CRACK IN GLAND
- AFTER GLAND CHANGED FOUND NORMAL

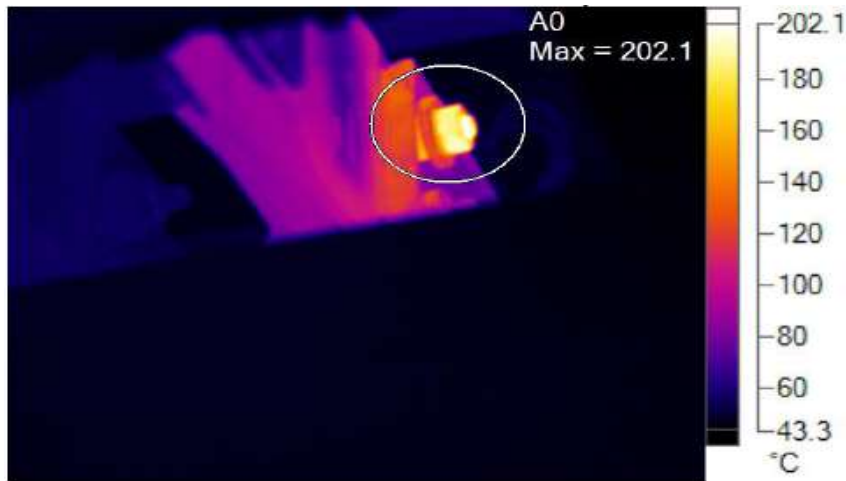
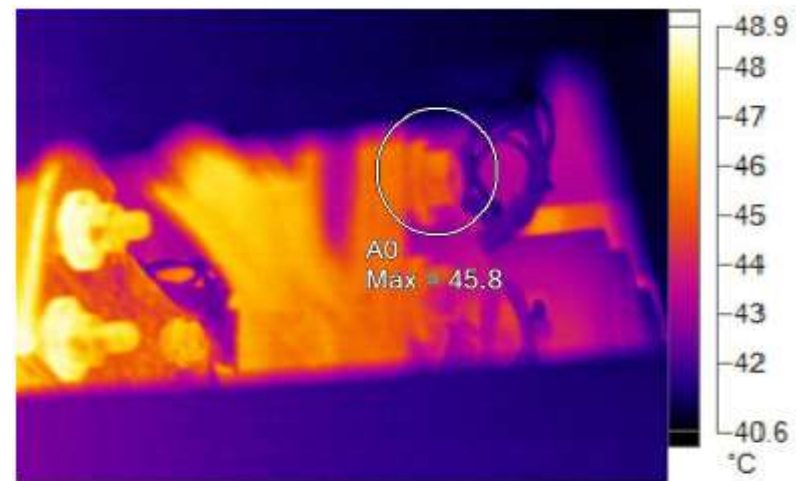
MF-III PANEL 502 BREAKER

- OBSERVED HIGH TEMP ON BREAKER INCOMING B-PHASE ISOLATING TERMINATION
- TERMINATION TIGHTNESS CHECKED
- AFTER WORK ATTENED AND FOUND NORMAL

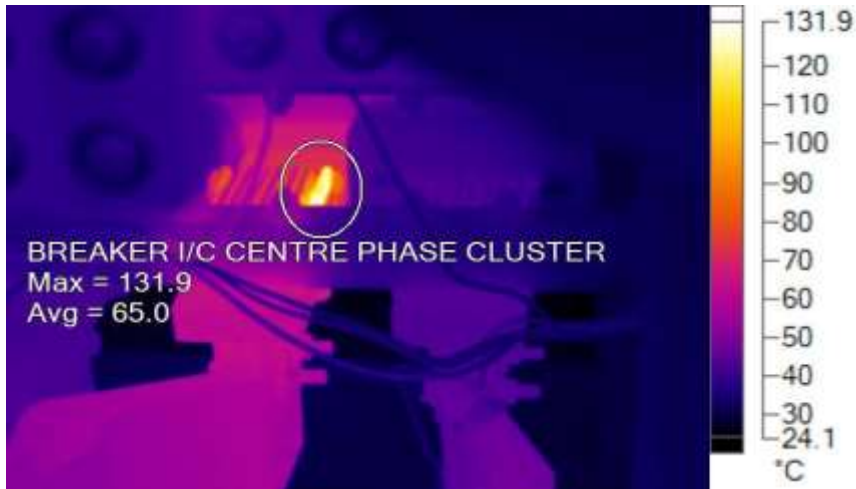
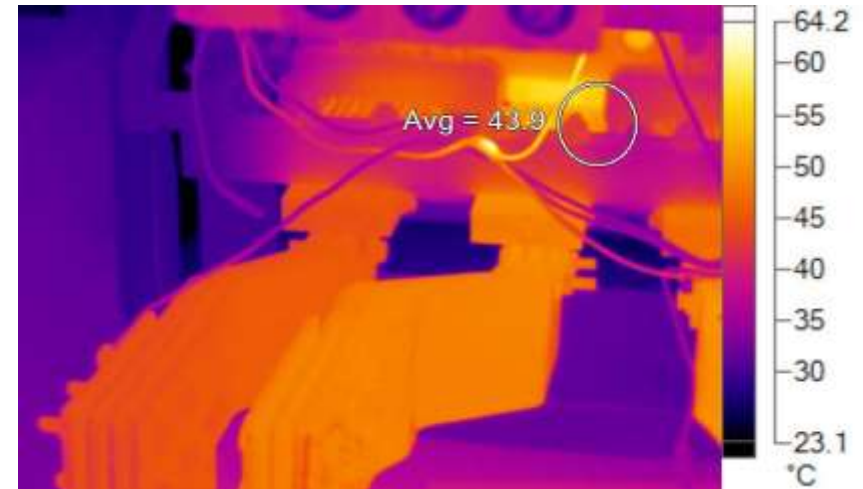
SS-15 BREAKER:

- OBSERVED HIGH TEMP ON BREAKER INCOMING Y- PHASE CLUSTER
- CHECK AND FOUND MISALIGNED
- AFTER WORK ATTENDED FOUND NORMAL

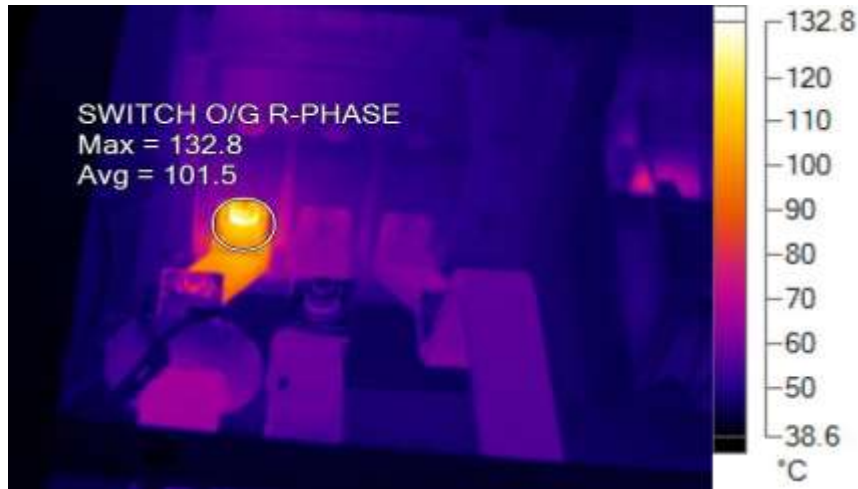
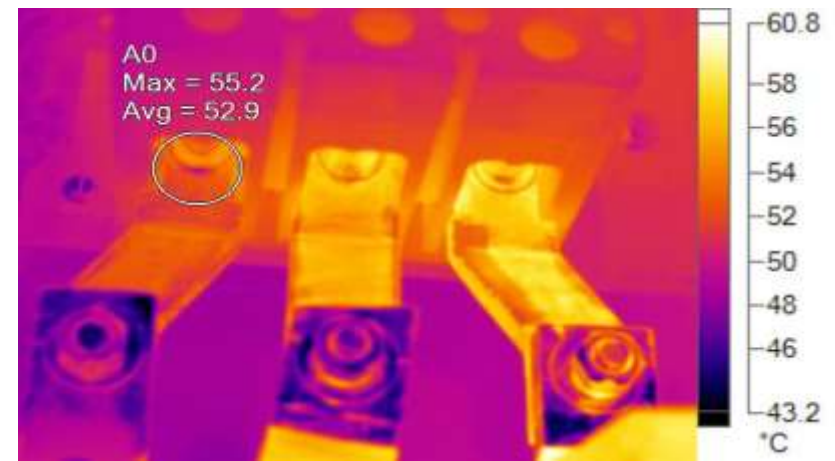
MILL WATER PUMP – 2:

- OBSERVED HIGH TEMP ON SWITCH O/G R-PHASE JUMPER
- JUMPER CLEANED AND BOLT NUT TIGHTNESS CHECKED.
- AFTER WORK ATTENDED AND FOUND NORMAL

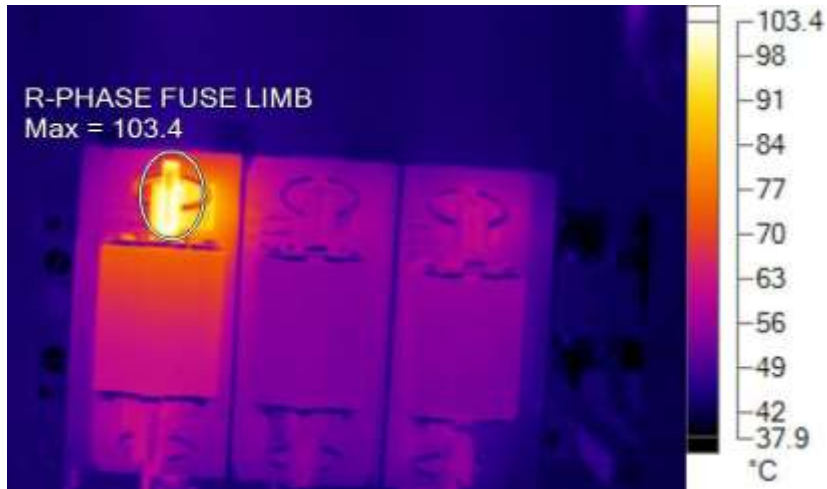
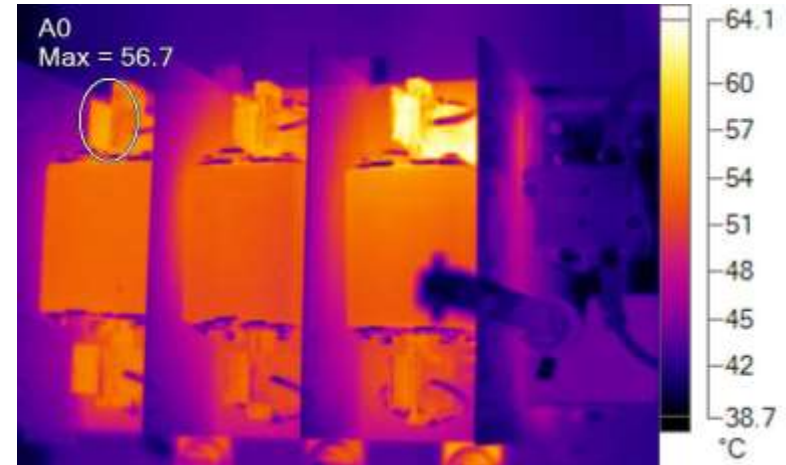
SECONDARY HEAD BOX SCREEN:

- OBSERVED HIGH TEMP ON R-PHASE FUSE LIMB
- LIMB CLEANED AND REPLUGED
- AFTER WORK ATTENDED AND FOUND NORMAL

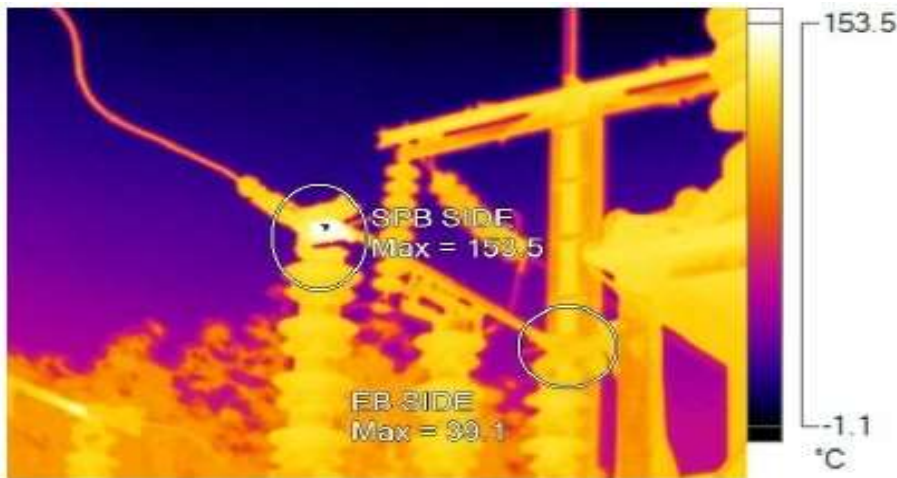
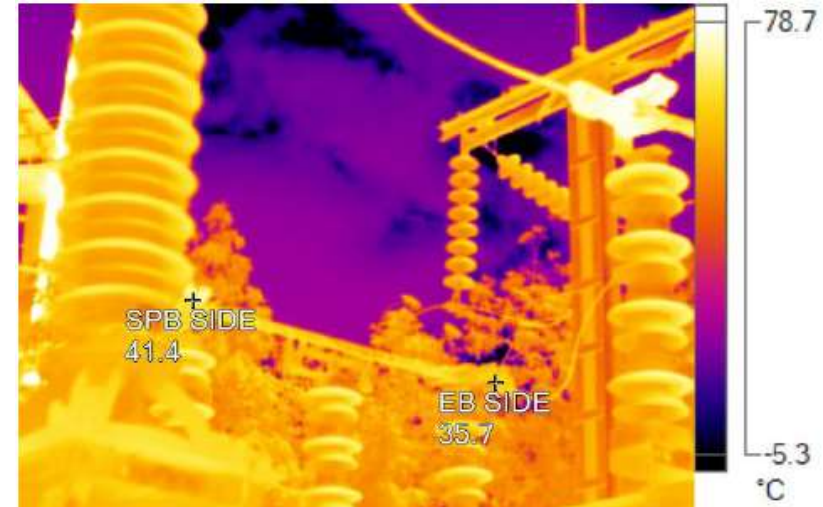
110KV YARD EB SIDE AB SWITCH

- OBSERVED HIGH TEMPERATURE ON Y-PHASE CLAMP.
- CHECKED CLAMP TENSION CONDITION, CLEAN AND GEL APPLIED.
- FOUND OK

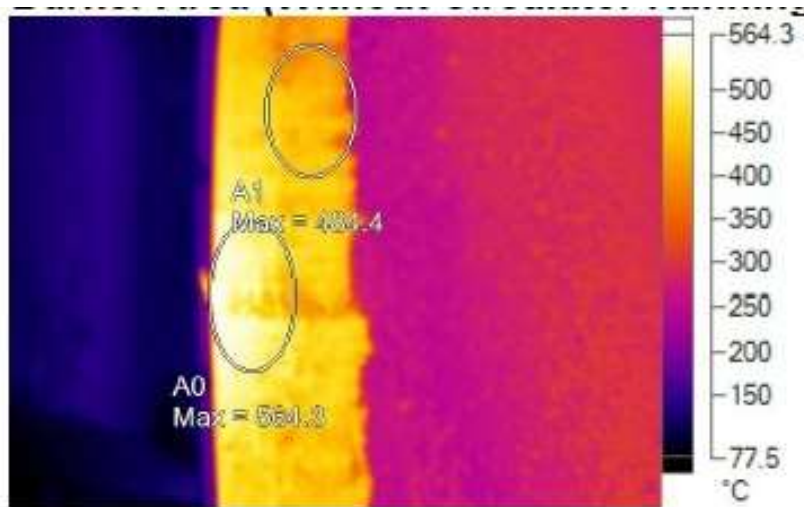
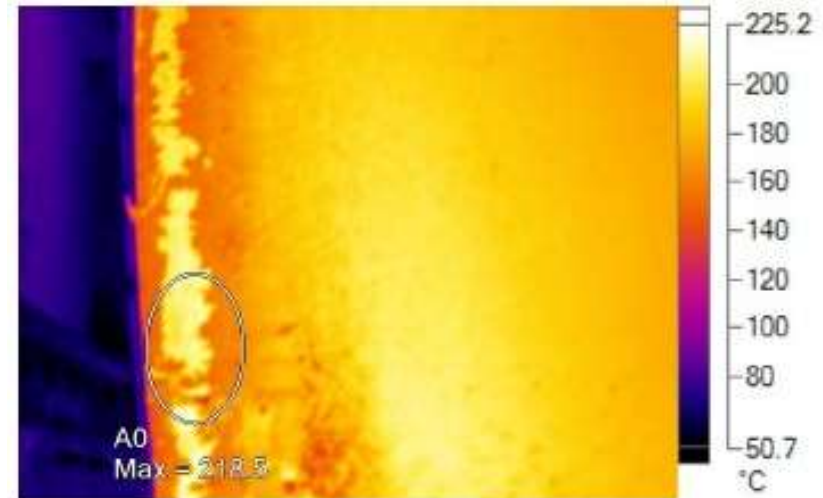
- OBSERVED HIGH TEMPERATURE (564 °C) ON LIME KILN BURNER AREA
- REFRACTORY BRICKS GOT DAMAGED.
- NEW REFRACTORY BRICKS HAS BEEN RELINED.
- AFTER WORK ATTENDED FOUND NORMAL -218 °C

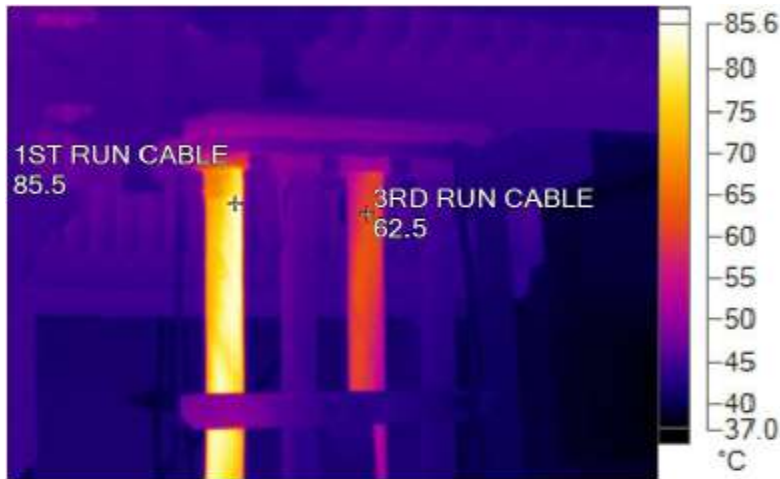
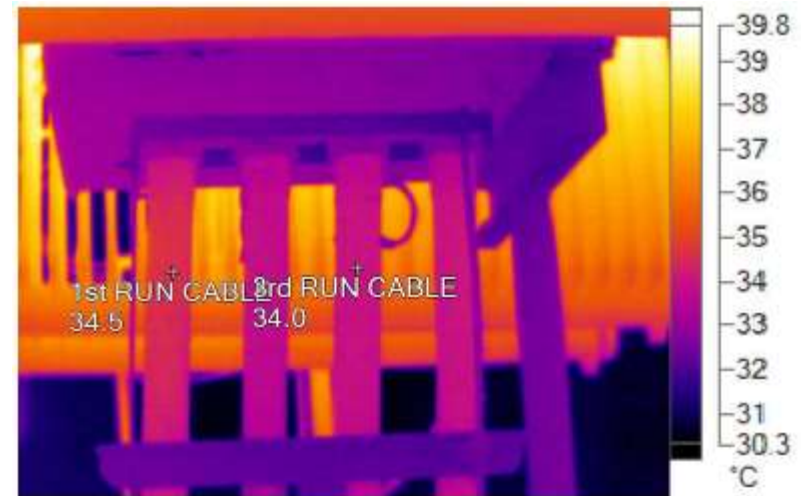
5MVA-3 TRANSFORMER

- OBSERVED HIGH TEMP ON TRANSFORMER SECONDARY CABLE TERMINATION
- CABLE RELUGED AND TERMINATION TIGHTNESS CHECKED.
- AFTER WORK ATTENDED AND FOUND NORMAL

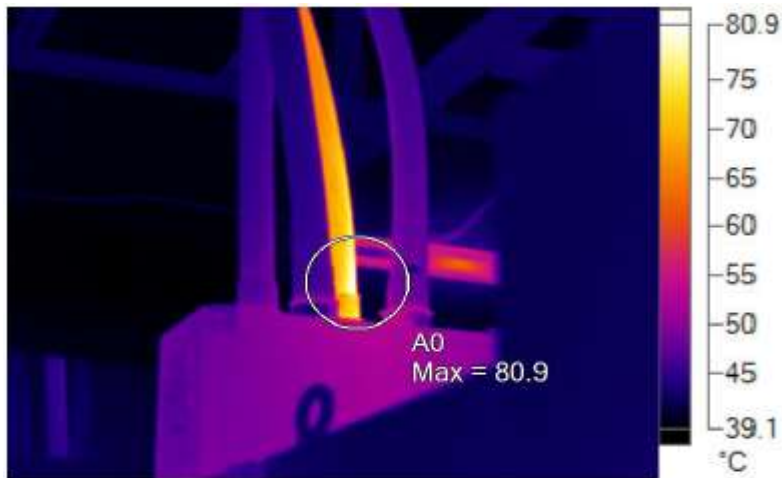
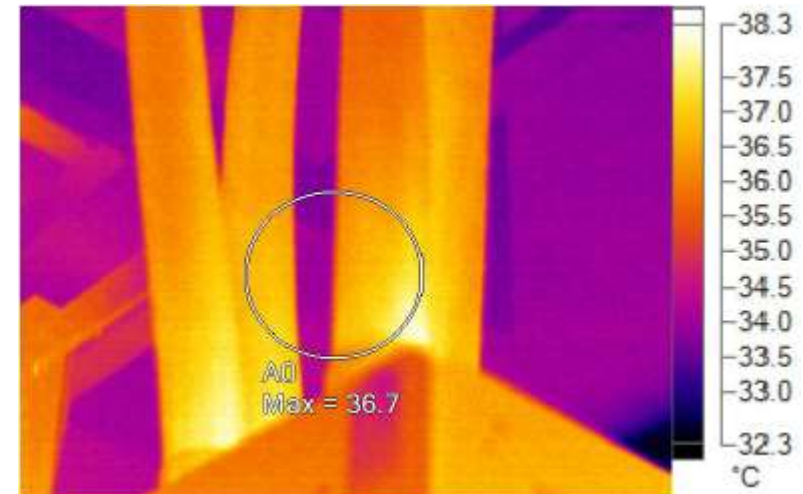
OBSERVATION:10 CPP

- OBSERVED HIGH TEMP ON TRANSFORMER SECONDARY CABLE TERMINATION
- CABLE RELUGED AND TERMINATION TIGHTNESS CHECKED.
- AFTER WORK ATTENED AND FOUND NORMAL

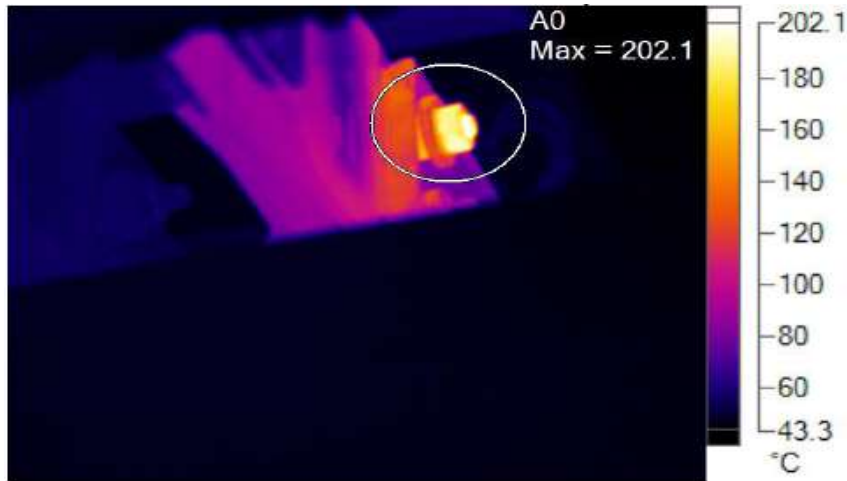
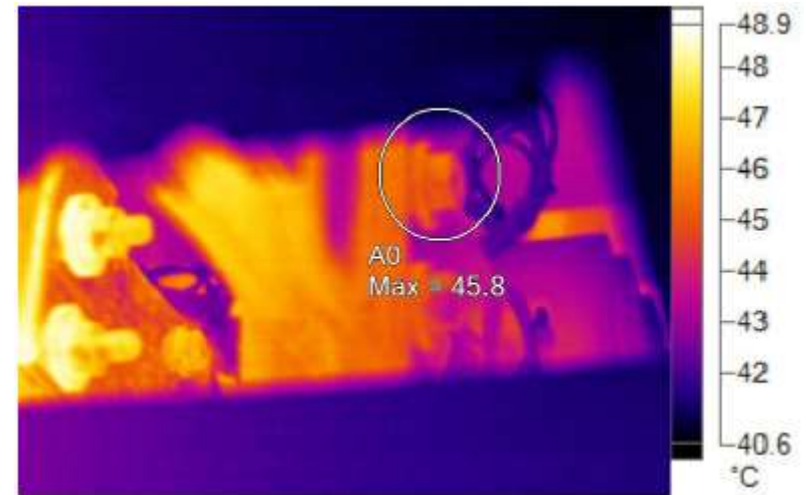
MF-3 P-502 INCOMER BREAKER

- OBSERVED HIGH TEMP ON BREAKER INCOMING B-PHASE ISOLATING TERMINATION
- TERMINATION TIGHTNESS CHECKED
- AFTER WORK ATTENED AND FOUND NORMAL

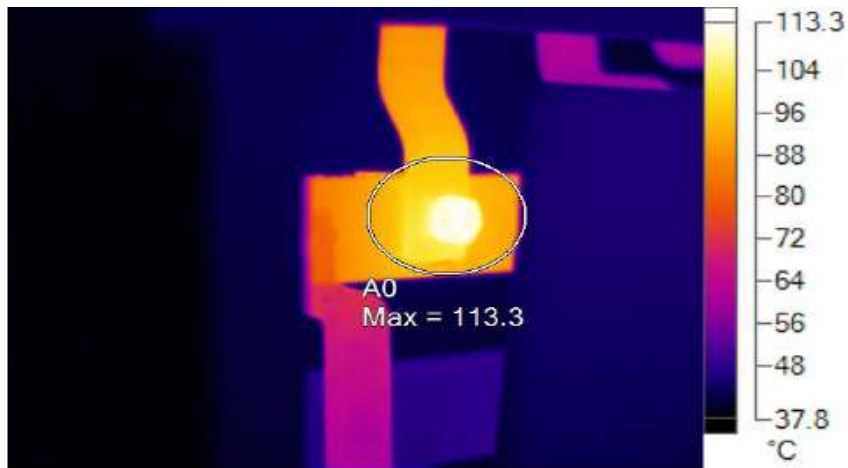
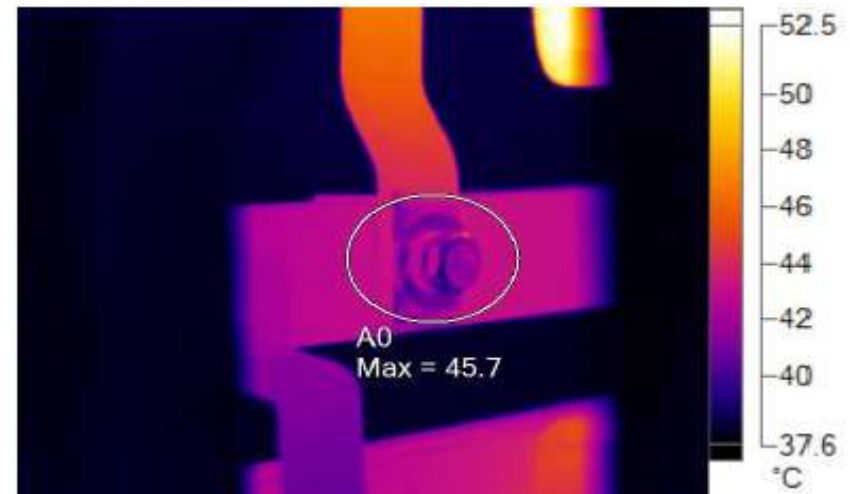
PM1-4 MF-2 NEW COUCH VACUUM PUMP

- OBSERVED HIGH TEMP ON SWITCH INCOMING R-PHASE BUS END TERMINATION
- BOLT NUT REPLACED
- AFTER WORK ATTENDED AND FOUND NORMAL
