# ESP Maintenance and its Efficient Operation-A Key to Improved Air Quality

S B Sapre, N S Saini, Ashok Kumar

### CASE STUDY-3 (ESP of JMW Recovery Boiler)

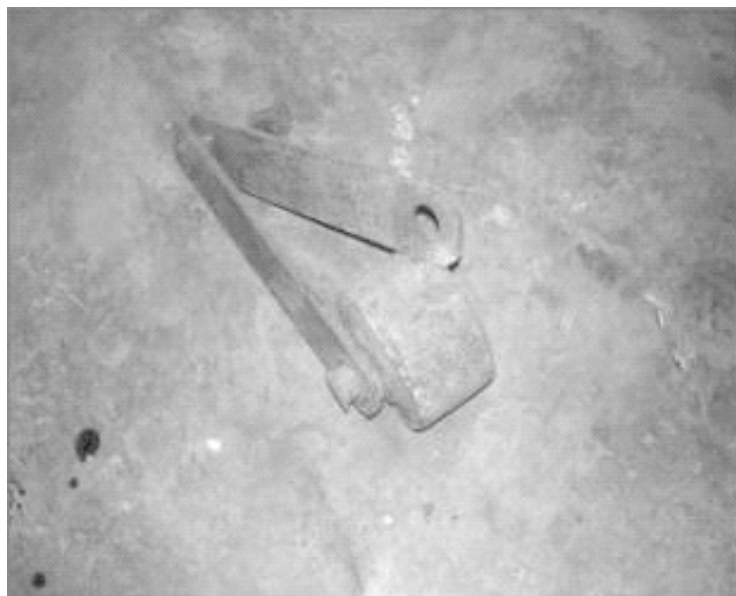
Fig. 6 Worn out hammer

- Improper cleaning of internals.
- Rapping hammers worn out resulting in deposits on plates.
- Plummer blocks supporting rapping shaft worn out resulting in misalignment & improper rapping.
- Bent collecting plates resulting in non-uniform gap between plates. Ideal gap is 300 mm.

All rapping motors were kept on for about 4 hours after shutting firing in Boiler. 12 number missing and worn out hammers replaced. (Fig. 6)

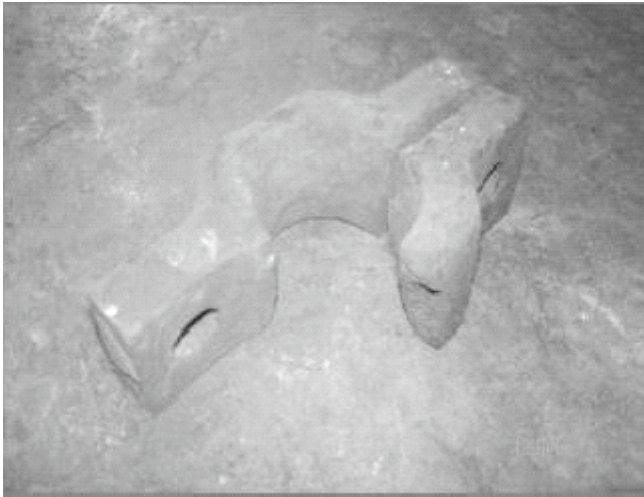
**Fig.7 Worn out Plummer block**

10 number worn-out hammer clamps and plummer blocks were replaced with New one. (Fig. 7-10) 2 number collecting plates were corroded and bent. These were removed from ESP field.

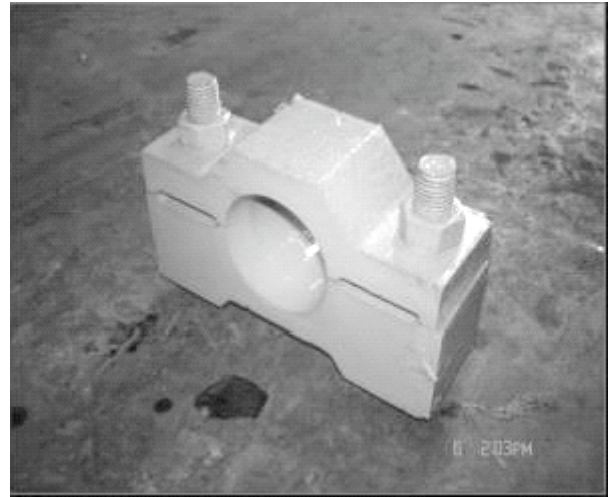
**Fig. 8 New Plummer block**

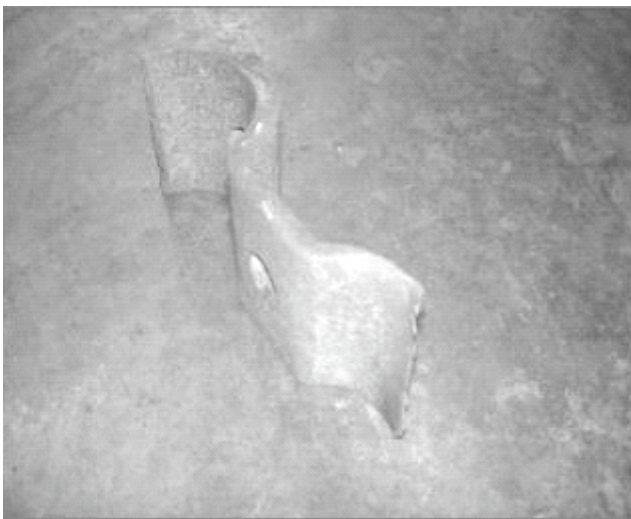
**Fig. 9 Worn out Hammer Clamp**

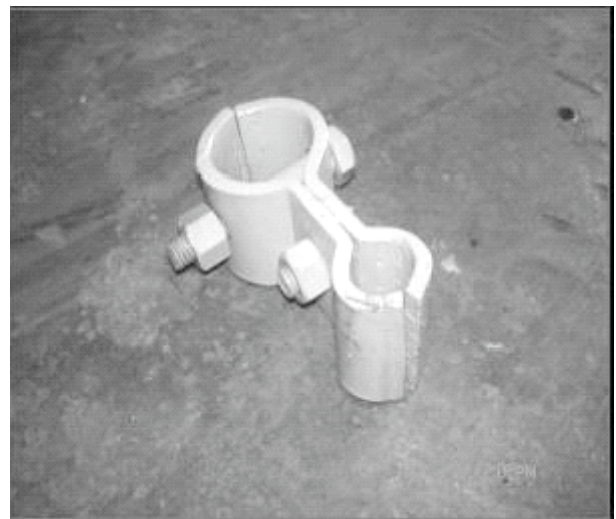
**Fig. 10 New Hammer Clamp**
