# Analysis of Wire Wear Pattern

Singhal D. K.

Chandpur Enterprises Ltd., Sargam Theatre Post: Chandpur -246 725, Dist. Bijnor (U.P.)

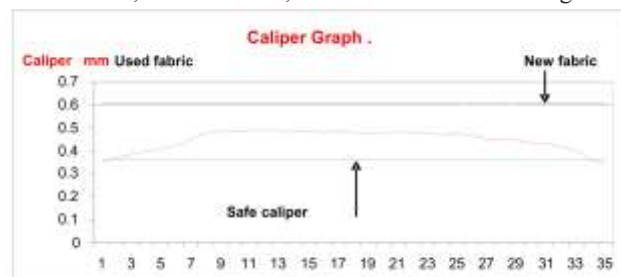
Initially, it was observed that the caliper profile was of an inverse cup shape, meaning that the wear was more at ends. A report from wire supplier suggested that this could be due to stationary elements like hydrafoil, suction box top, too dry a wire at suction boxes, or uneven surface of these. As a result, the first action planned was to check all elements thoroughly during the next wire change that was due after a few months. During the next wire change, immediately after the old wire was cut and removed from machine, the wire table was cleaned and straightness of all elements was checked. Nothing abnormal was observed, still, a couple of tops were replaced with new ones to double ensure that all elements are in perfect condition. A new wire was put, and the machine started.

After the wire was taken out after the normal life, a sample of it was sent again for evaluation. The received caliper profile was again skewed at ends (fig.1) similar to the previous wire. So it was decided to replace all the suction boxes with new ones during the next wire change that was due after a couple of months. But, the next wire, which was mounted along with

Fig.1: Wear Pattern of wire

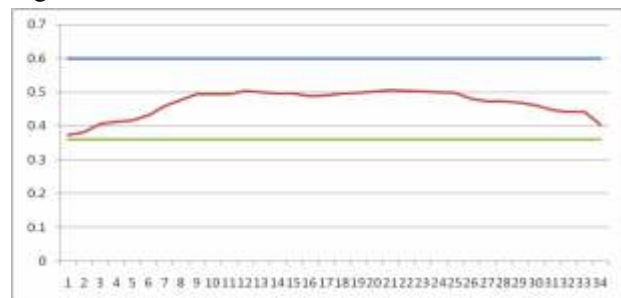
Fig.2: Wear pattern of wire mounted with new suction box tops

new suction boxes, gave exactly the same wear pattern (Fig.2)

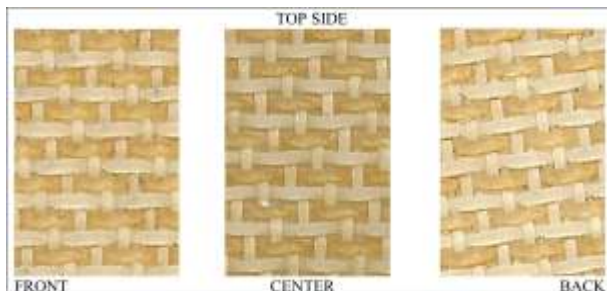
3. Front side and back side wear is visible, while center yarns are in very good condition. Again, it was observed that on the machine, the bagalley box was mounted a little upwards, thereby exerting pressure on wire. Now, every time the guide moved to guide the wire, the frictional stresses adversely rubbed the wire at either end. Most probably, this was the reason of observed wear pattern of wire.

Fig. 3: Scans of top side of wire

As a result, the bagalley box was lowered in such a way, that it just touches the wire in both extreme positions of guide roll. The next wire was mounted, after 45 days, it is showing no effect of wear at either end, unlike previous few wires.

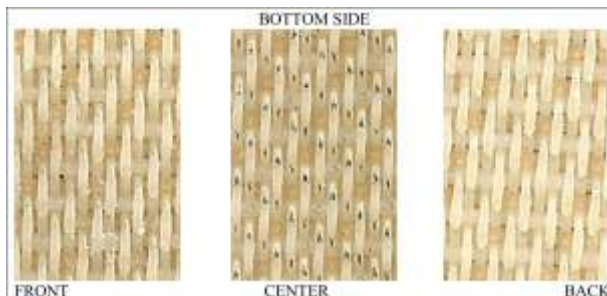
1. In some of the samples, black spots are observed at the bottom side yarns.
2. These black spots are more at the center, while front side has minor marks. Also, at the back side, the spots

are almost invisible. The black spots seemed most probably due to presence of ink particles as just before wire was removed, the machine was running with a furnish containing more ink. The same can be verified if next wire change is made after a non-ink containing furnish is being run. Alternatively, there is a possibility of melting of bottom layer of wire yarns and blackening due to inadequate lubrication.

Fig. 4: Scans of bottom side of wire
