THERMOGRAPHY AS A TOOL TO IMPROVE RELIABILITY

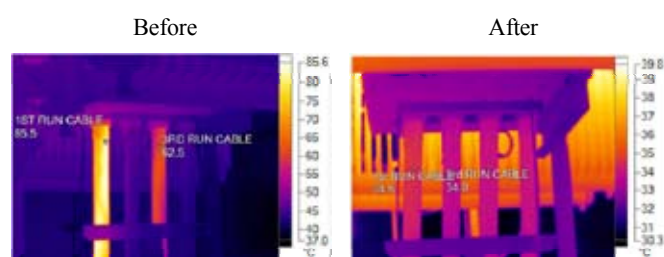
5MVA-III TRANSFORMER

- Observed High Temp on Transformer Secondary Cable Termination
- Cable Relugged And Termination Tightness Checked.
- Work Attended And Found Normal

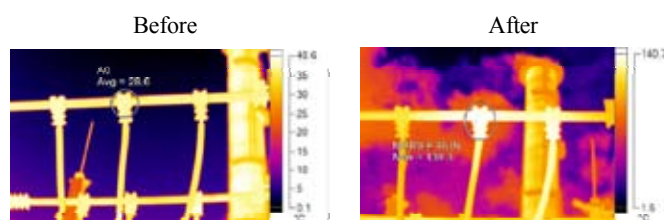
110KV YARD

- Observed High Temp On 22kv Middle Run Cable Gland
- Check And Found Crack In Gland
- After Gland Changed Found Normal

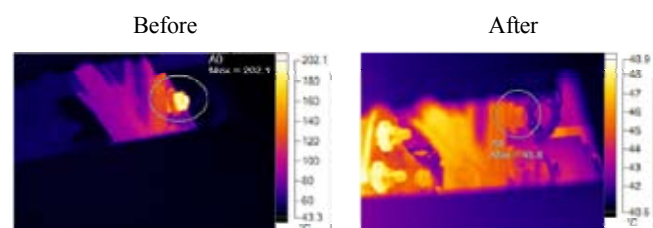
MF-III PANEL 502 BREAKER

- Observed High Temp On Breaker Incoming B-Phase Isolating Termination
- Termination Tightness Checked
- After Work Attended And Found Normal

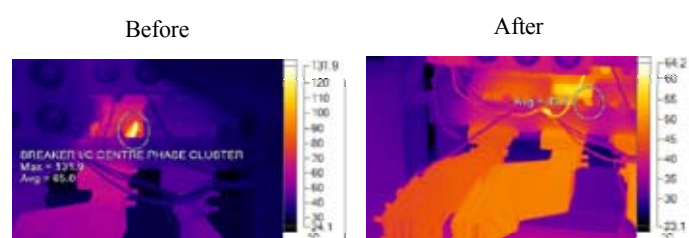
PAPER MACHINE - SS-15 BREAKER

- Observed High Temp On Breaker Incoming Y-Phase Cluster
- Check And Found Misaligned
- After Work Attended Found Normal

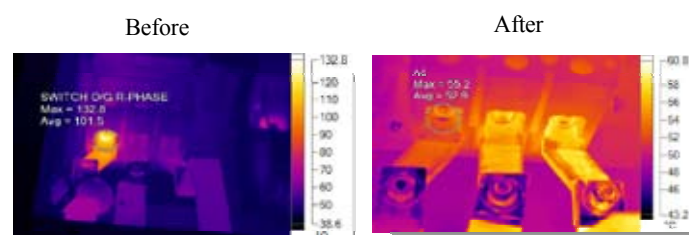
NEW PULP MILL - MILL WATER PUMP - 2

- Observed High Temp On Switch O/G R-Phase Jumper
- Jumper Cleaned And Bolt Nut Tightness Checked.
- After Work Attended And Found Normal

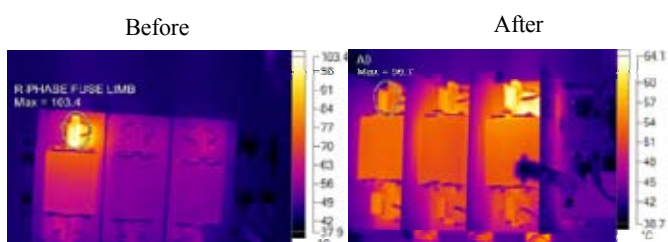
PAPER MACHINE - SECONDARY HEAD BOX SCREEN

- Observed High Temp On R-Phase Fuse Limb
- Limb Cleaned And Replugged
- After Work Attended And Found Normal

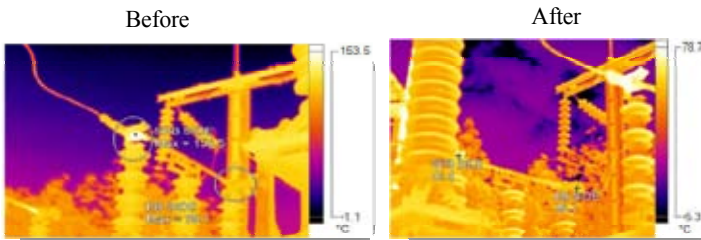
110KV YARD EB SIDE AB SWITCH

- ☐ Observed High Temperature On Y-Phase Clamp.
- ☐ Checked Clamp Tension Condition, Clean And Gel Applied.
- ☐ Found Ok .

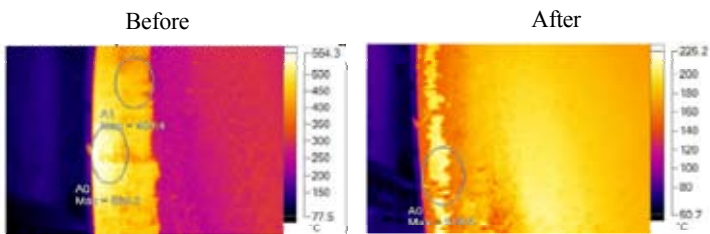
LIME KILN BURNER AREA

- ☐ Observed High Temperature (564 °C) On Lime Kiln Burner Area
- ☐ Refractory Bricks Got Damaged.
- ☐ New Refractory Bricks Has Been Relined.
- ☐ After Work Attended Found Normal -218 °C

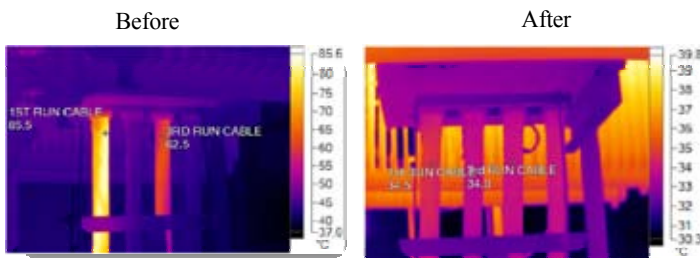
CPP - 5MVA-3 TRANSFORMER

- ☐ Observed High Temp on Transformer Secondary Cable Termination
- ☐ Cable Reluged And Termination Tightness Checked.
- ☐ After Work Attended And Found Normal

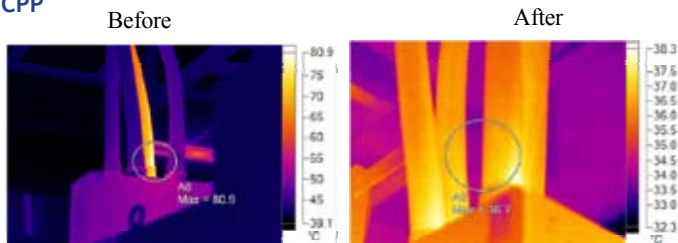
CPP

- ☐ Observed High Temp on Transformer Secondary Cable Termination
- ☐ Cable Reluged And Termination Tightness Checked.
- ☐ After Work Attended And Found Normal

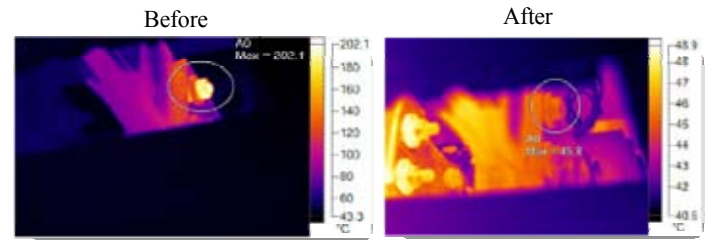
MF-3 P-502 INCOMER BREAKER

- ☐ Observed High Temp On Breaker Incoming B-Phase Isolating Termination
- ☐ Termination Tightness Checked
- ☐ After Work Attended And Found Normal

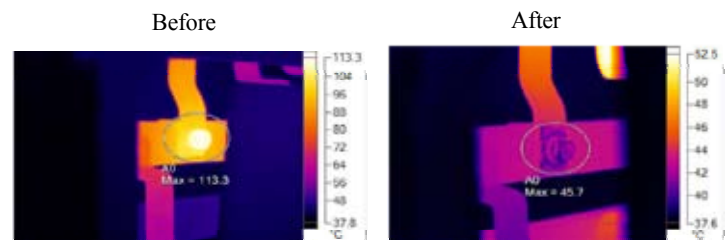
PM1-4 MF-2 NEW COUCH VACUUM PUMP

- ☐ Observed High Temp On Switch Incoming R-Phase Bus End Termination
- ☐ Bolt Nut Replaced
- ☐ After Work Attended And Found Normal
