# Analysis of Shell and Roller Failure in Dryer Section of a Paper Mill

## ABSTRACT

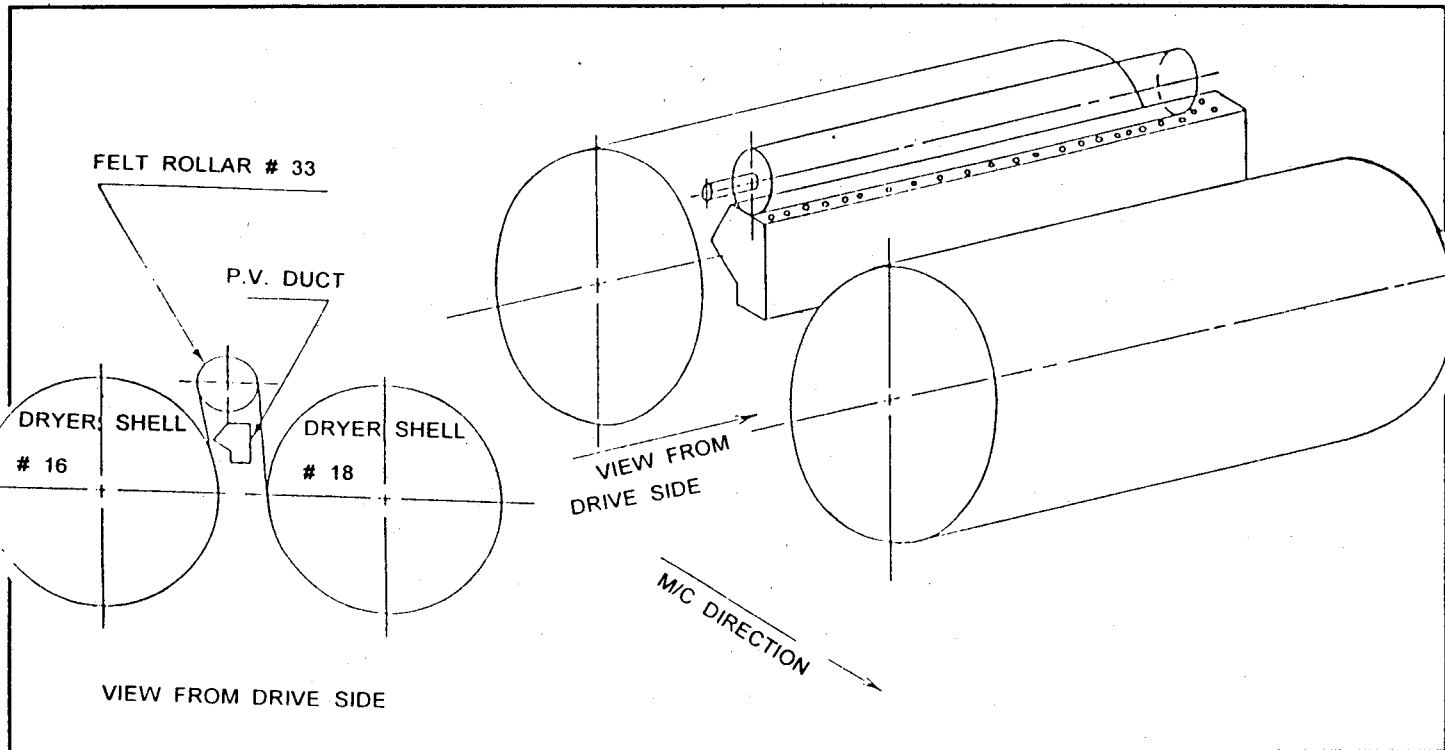
shells and the felt roller is given in Fig. 1. The relative location of the P.V. (Pocket Ventilation) duct is also shown in this diagram. The front end of the felt roller, measuring about 700 mm. in length was found lying on the operating floor while the other portion of the roller had fallen on the ground floor. To determine the cause of this failure, a comprehensive failure investigation was undertaken. Details are presented in the following sections.

**Fig. 1: A schematic diagram showing the relative configuration of the three dryer section components prior to failure**

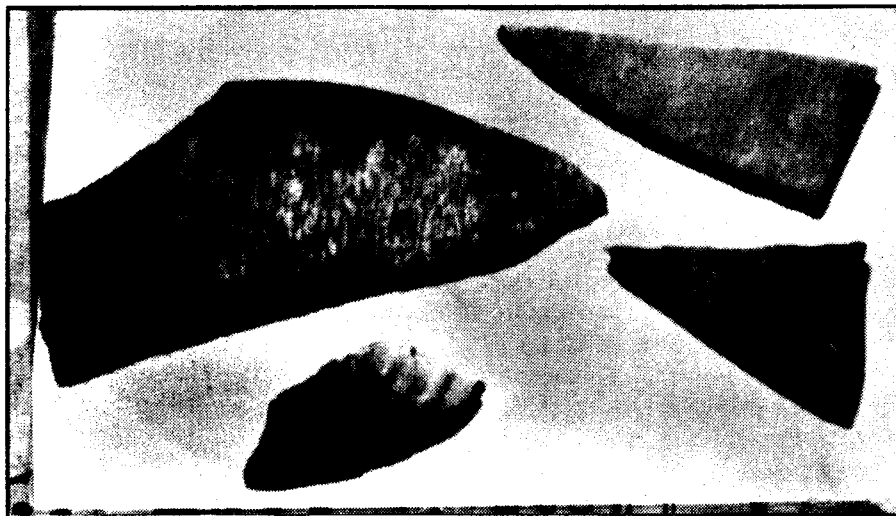
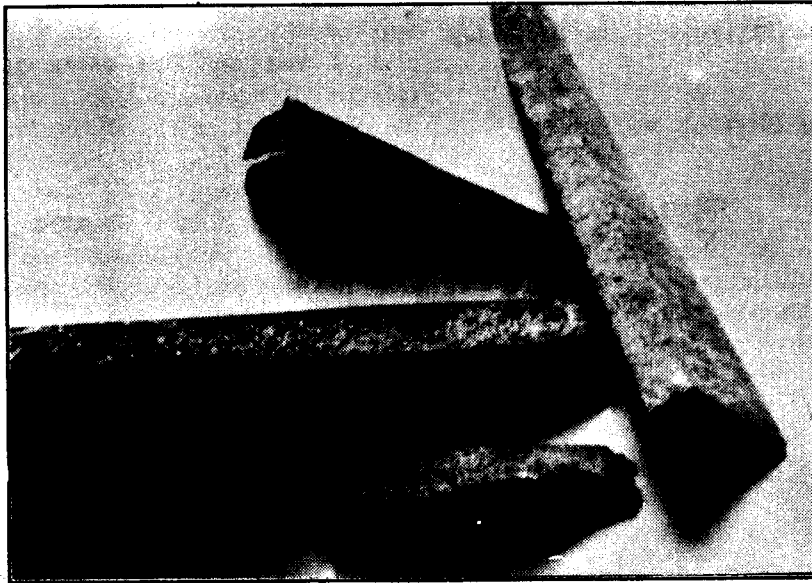
**Fig. 2: Photograph showing fractured pieces of the dryer shell**

**Fig. 3:** Photograph showing another perspective of the fractured pieces of the dryer shell.

Typical fractured pieces of the two dryer shells are shown in Figs. 2 and 3. Note the characteristic angular failure profile of all the fractured pieces shown. Examination of the concave (steam) side of the shell revealed corrosion deposit in the form of iron oxide scale. The scale was found to be quite thick in some regions.

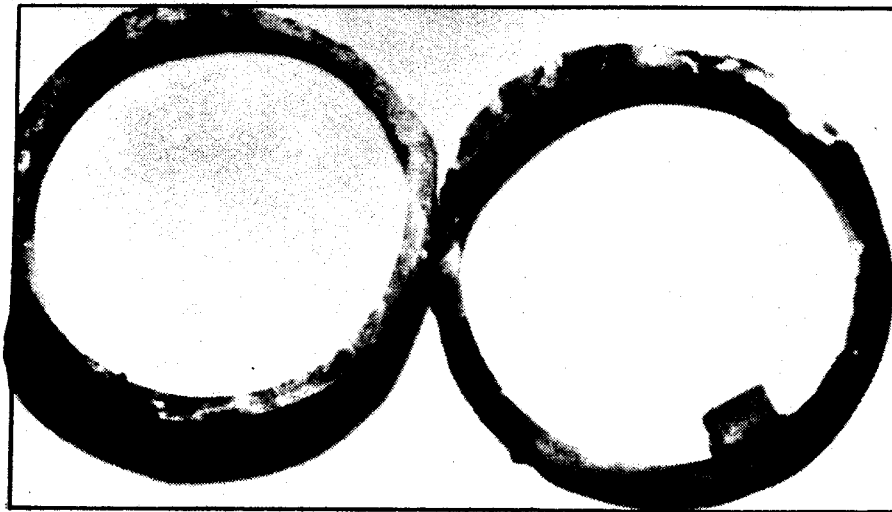
The two fractured faces of the failed felt roller are shown in Fig. 4. The presence of multiple, beach marked, fatigue segments on the fracture surfaces are clearly evident in this micrograph. Further, note that the repeat period of the beach markings is quite coarse (of the order of a millimeter). This relatively large repeat period is also clearly evident in the close-ups shown in Figs. 5 and 6. Nearly seventy percent

of the fracture surface was found to be beach marked indicating that structural integrity of the felt roller had been completely lost resulting in a complete fracture into two pieces, by a switching over of the crack propagation mode from that of fatigue to that of static overload. A slightly higher magnification examination with a hand-held magnifying glass also revealed the presence of cracks lying parallel to the beach marks. These cracks were found to run all the way to the outer surface, where they found intersected by longitudinal cracks, running parallel to the axis of the felt roller. However, it must be pointed out that the cracking was observed in only a few localized regions on the fatigued surface.

An examination of the points of origin of the fatigue segments indicated the cracks to have initially propagated on non axial planes (planes with normal axis lying at an angle with respect to axis of symmetry of the felt roller). Further, the crack initiation points were found located very close to a weldment deposit, which had been placed on the inner surface of the felt roller for the purpose of dynamical balancing.

**Fig. 4: Photograph showing fractured faces of the felt roller.**

To mitigate the probability of such a failures from occurring again in the dryer section, recommendations were made to discontinue the use of felt rollers which had been balanced by a welding operation. Further, it was also suggested that the relatively rigid P.V. duct made out of steel be replaced by a low stiffness structure, made out of a low modulus material like aluminium. These suggestion have now been implemented at the Ballarpur plant.

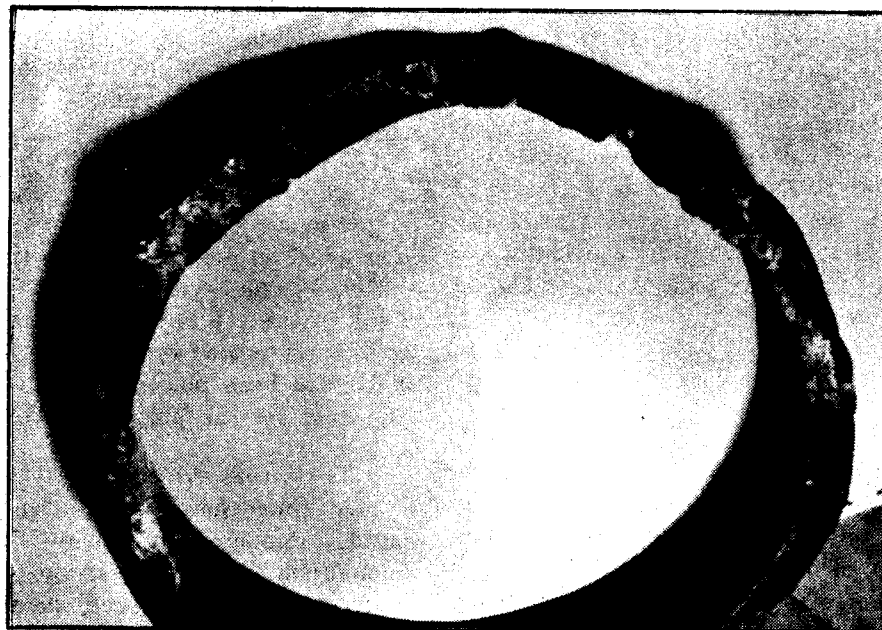
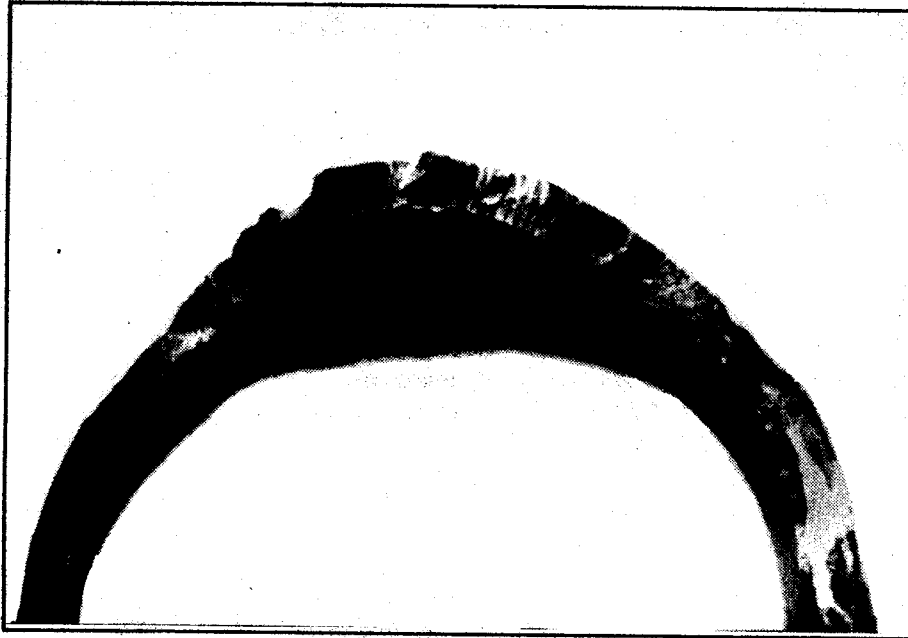
**Fig. 5: Photograph showing a close-up view of the fractured face of the felt roller.**

**Fig. 6:** Photograph showing a close-up view of the fatigue zone on the felt roller.

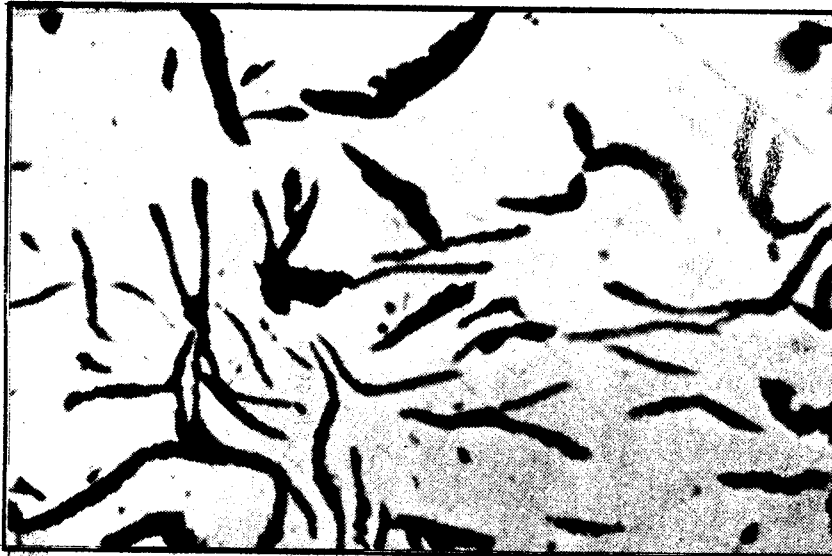
Subsequently, sections of the exposed surfaces were ground and polished using standard specimen preparation techniques. Optical examination indicated the presence of carbon in the form of ASTM type-A graphite flakes, see Fig. 7. This observation confirmed the dryer shell material to be gray cast iron. Further, optical examination indicated the steam side surfaces to be extensively crated with graphitization pits. A typical observed graphitization pit is imaged in Fig. 8. Such graphitization pitting is usually found on cast iron surfaces exposed to

**Fig. 7:** An un-etched micrograph showing the flake morphology of dryer shell material, magnification = 100 X.

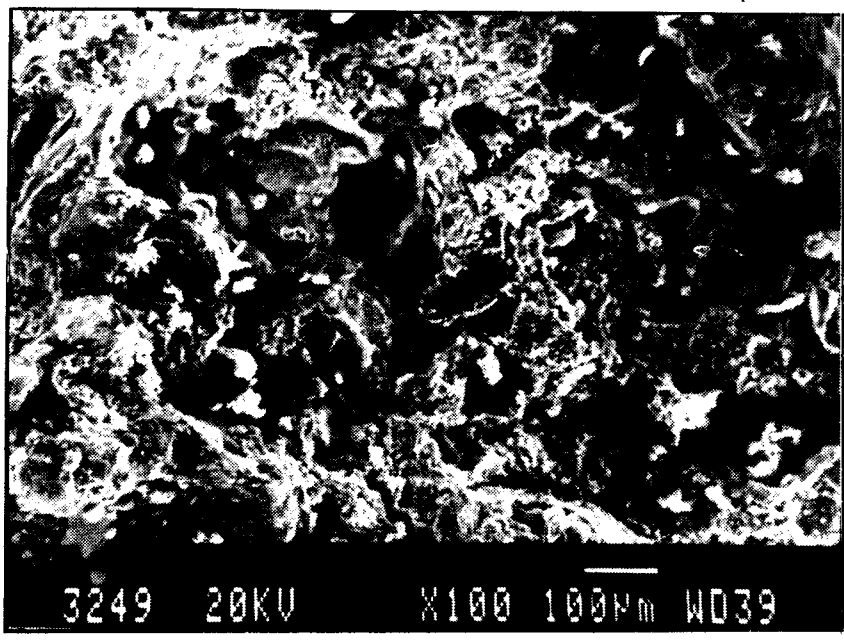
Fig. 13: A SE micrograph showing the topography of the fractured surface of the dryer shell.

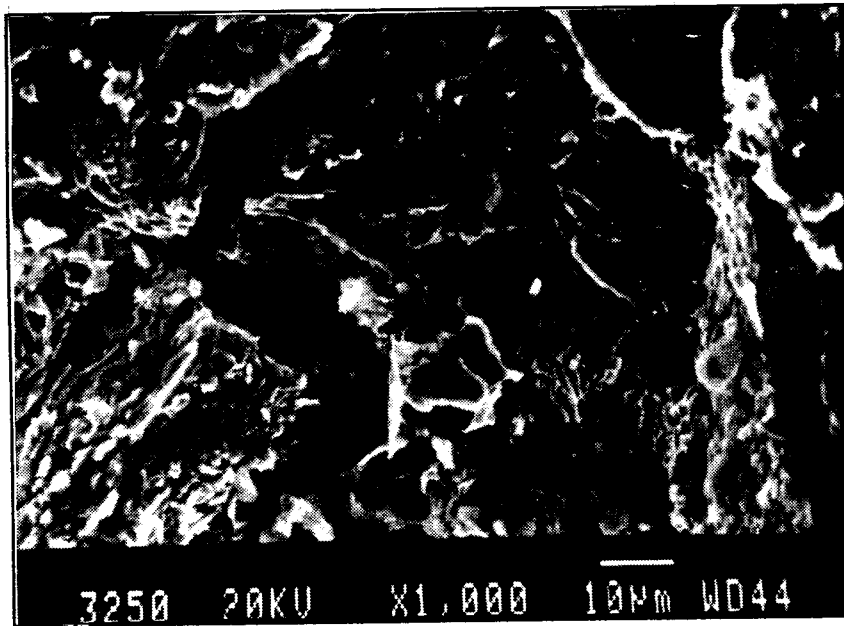
**Fig. 14:** A high magnification SE micrograph showing river marked fracture facets on the fracture surface of the dryer shell.

micrograph showing cleavage planes, crack separating ledges, and river markings, is given in Fig. 14. The low strain, brittle, nature of the failure is markedly evident in this micrograph. Clearly, these observations show that failure of the two dryer shells occurred as a consequence of nucleation and propagation of brittle cracks, possibly, throughout the wall volume

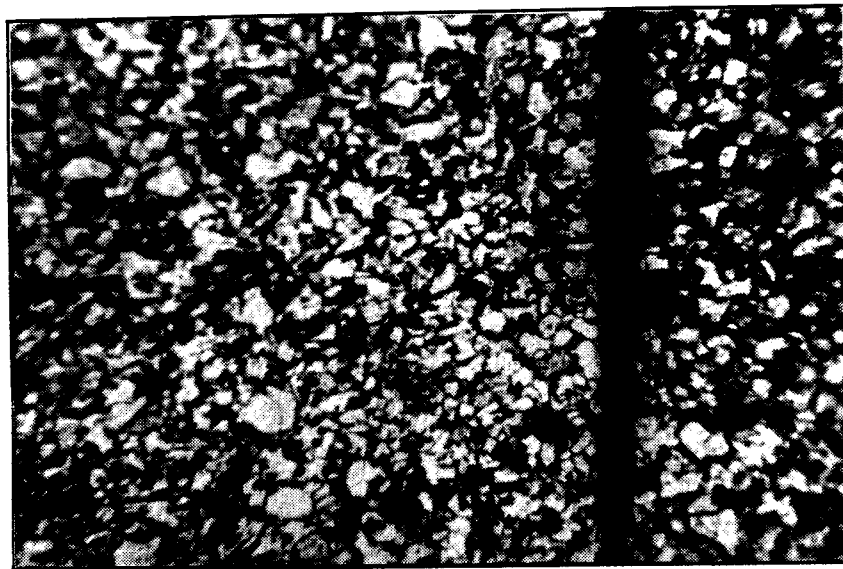
An optical micrograph showing the microstructure of the felt roller is given in Fig. 15. The predominantly bright constituent in this

**Fig. 15:** An optical micrograph showing the microstructure of the felt roller material, magnification = 200 X.

micrograph is ferrite while the darkly etching regions correspond to pearlite. In the micrograph given in Fig. 16, a typical longitudinal crack (mentioned in the previous section on visual examination) is imaged. Note that the crack appears to have propagated fairly deeply into the section shown.

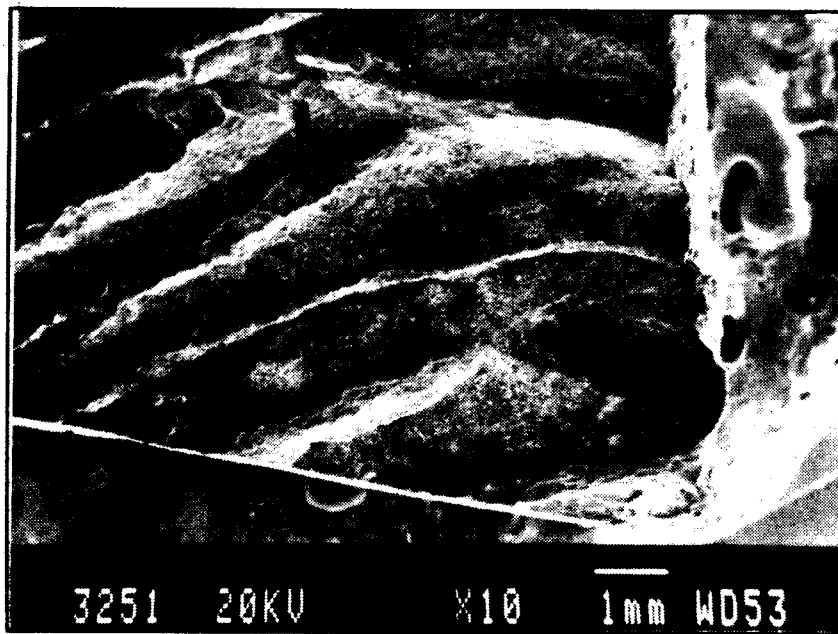
**Fig. 17:** A SE micrograph showing the topography of the fatigue zone in the felt

Finally, in Figs. 17 and 18, SE micrographs of the fatigue surface are shown. Specifically, Fig. 17 shows the origin of the fatigue crack while Fig. 18 shows the terminal region of a fatigue segment. Optical and scanning electron microscopy thus clearly confirms the failure mechanism to be that of rotating bending fatigue.

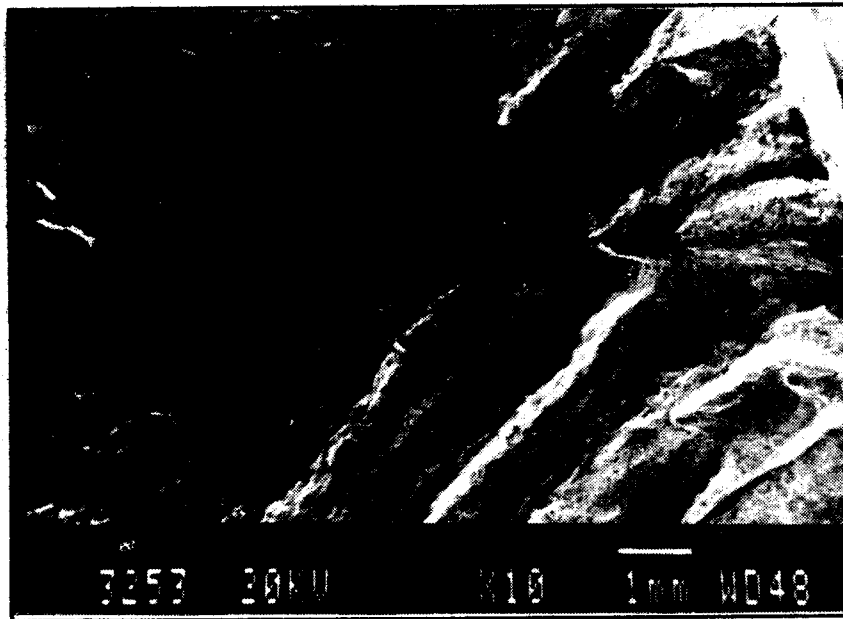
**Fig. 18:** A SE micrograph showing the topography of the terminal section of a fatigue segment on the fracture surface of the felt roller.
