Failure Analysis of An Angle Bracket of A White Liquor Sludge Rake

ABSTRACT

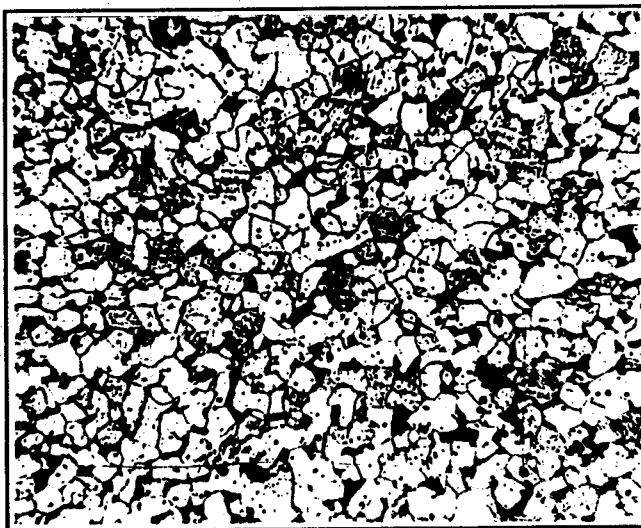
Fig-1: An optical micrograph showing the microstructure of the angle bracket material, M = 100X.
