Maintenance Improvements in Continuous Digester for Bagasse Pulping

V. Nagarajan, R. Balasubramaniam, S. Govind and K.S. Kasi Viswanathan

Seshasayee Paper & Boards Ltd., Pallipalayam, Erode-638007 (T.N.)

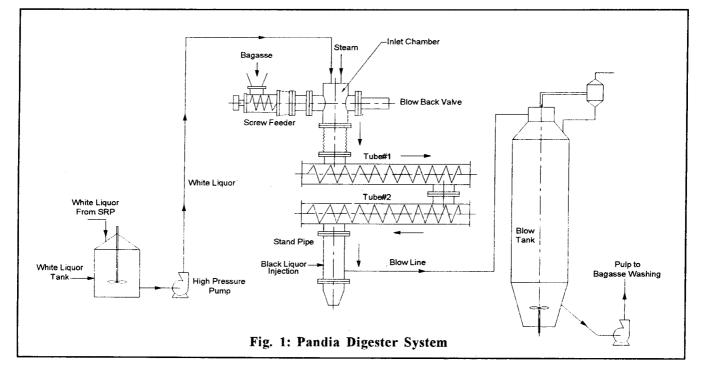
A general arrangement of the Pandia Digester operation is given in Fig. 1.

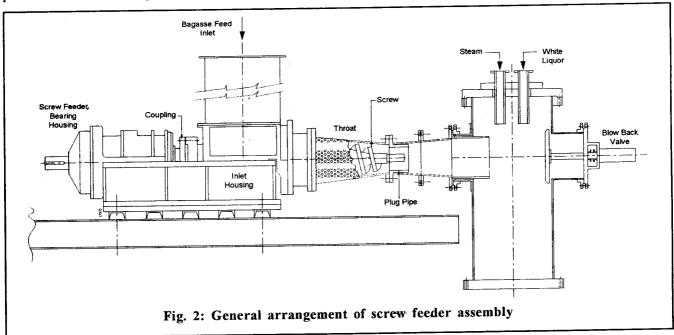
The typical arrangement sketch of the screw feeder assembly is given in Fig. 2.

With the improved running hours of Pandia Digester we were beginning to face new set of operation and maintenance problems. The screw feeder was of 20" size. The size of the screw feeder is the major diameter of screw flight. The screw was connected to the drive shaft by a socket provision. Due to the limitations of the screw rpm, pulp production rate was only 3 tph. This arrangement had the following problems.

- With the socket driven arrangement, the weight of the screw rested on the wear bar necessitating the frequent renewal of wearing parts. Mean time between screw changes was less than 400 hours. Rebuilding cost was also very high.
- Pandia digester had to be stopped for changing the screw feeder and throat involving a down time of 12 hrs.
- Grease lubrication of the screw feeder bearing housing

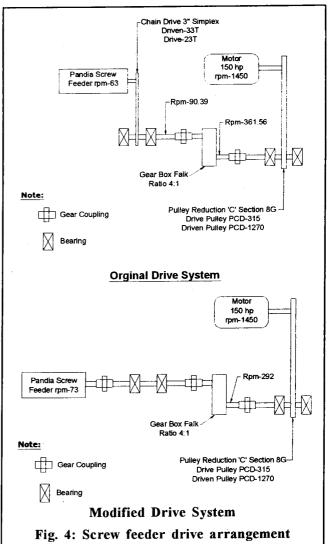
The above minor modifications ensured that the mean time between screw changes increased to 800 hours. Fig. 3 shows the salient modification made.

- The screw was now coupled with main drive shaft by means of rigid flange type coupling which avoided the screw resting on the wear bar. The screw no longer rested on wear bars and hence reduced the need for frequent renewal of wear parts.
- The size of the screw feeder was changed to 17" screw feeder to reduce the weight.
- The screw flight length was increased by about 40 mm at the convergent end for free discharge of bagasse to the inlet chamber.
- For reconditioning of the screw, chromium carbide welding electrode was used.
- All the bearings were converted to oil lubrication bearings.
- The holes in the throat were modified to provide for divergent holes for better dewatering.
- The throat was converted from a purely convergent

type to a convergent- divergent type by providing 6 deg enlarging provision at the end of the throat.

- The wear bars were located in such a manner so as to have a relief angle to ensure that the surface area of contact was reduced to a line contact on the traction side.
- The length of the plug pipe was reduced from 12" to 9".

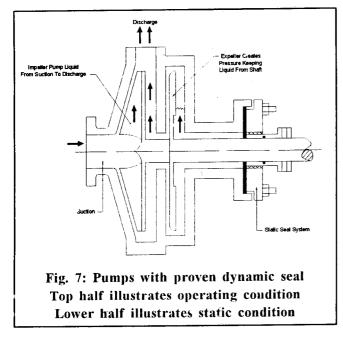
With the single stage pump pumping fluctuations were avoided but there was no improvement in failure rate. These failures were attributed to the basic design of the pump that had a lower shaft size and corresponding bearings that were not adequate to meet the process conditions. As a further development we installed a new pump with the following features

Fig 6 and Fig 7 given below show the arrangement of the rotating unit of the Double Stage and Single Stage Pump with expeller arrangement respectively. With the installation of the above pump the operation of liquor feeding pump to Pandia Digesters is now reliable.

- Higher shaft size with suitable bearings
- Modified bearing housing incorporating fans to dissipate heat
- Dynamic seal arrangement
