SUSTAINED GROWTH WITH MAINTENANCE
BEST PRACTICES AND RE-ENGINEERING
EFFORTS IN TNPL

B.Mahesh, P.PremRanjan & T.Kalaiarasan

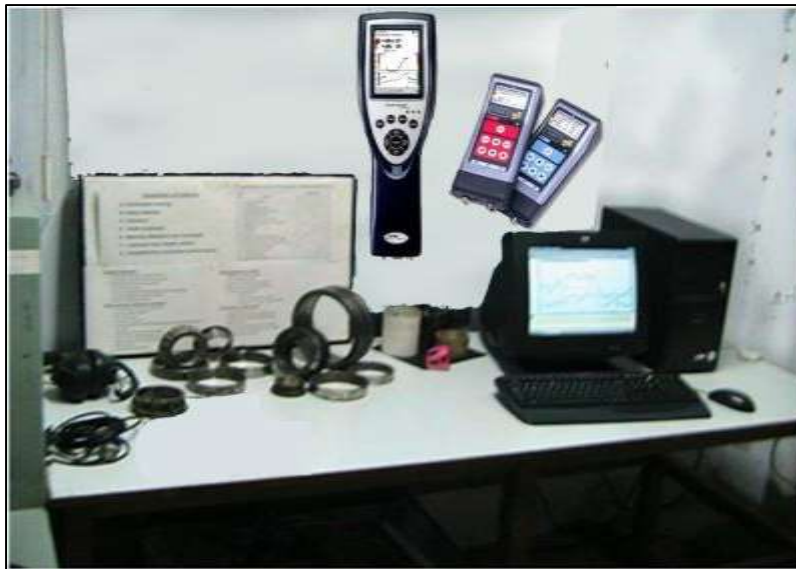
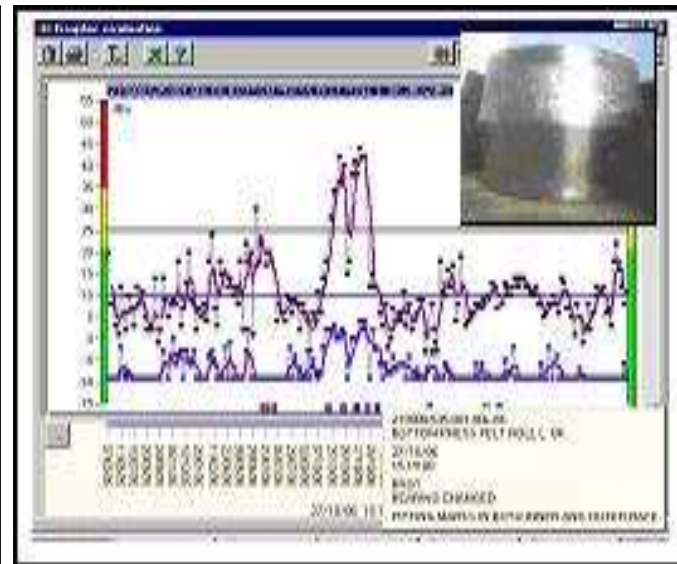
- Shock Pulse Method (SPM)
 - SPM T2001 & SPM Leonova

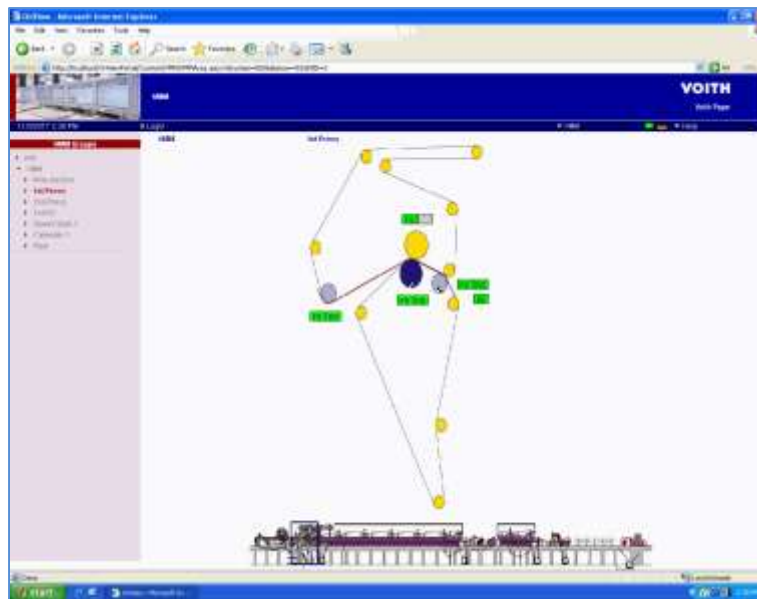
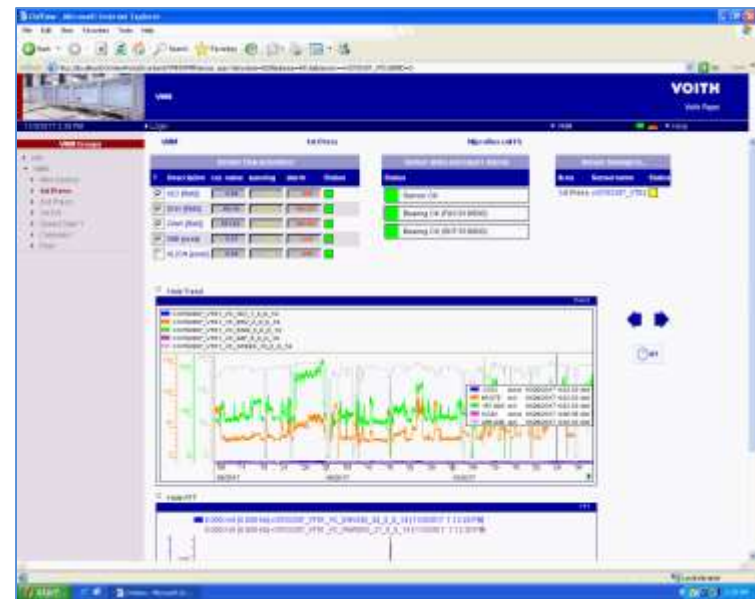
- Vibration Method
 - Online bearing monitoring system

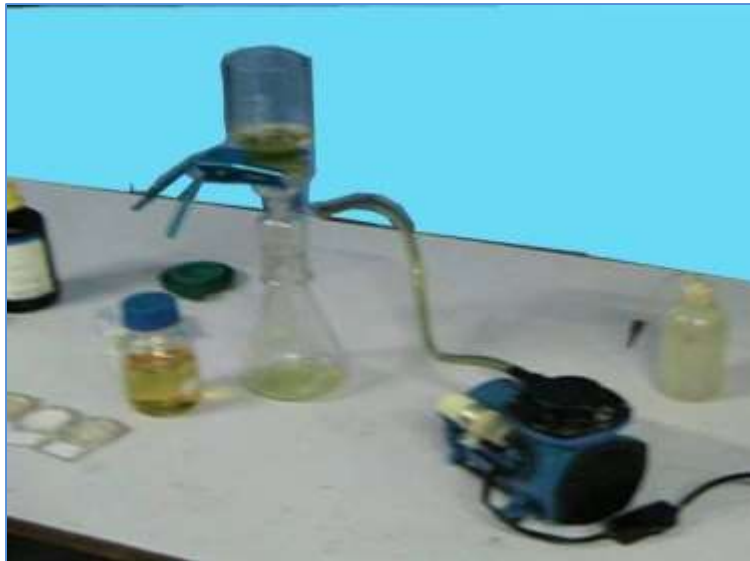
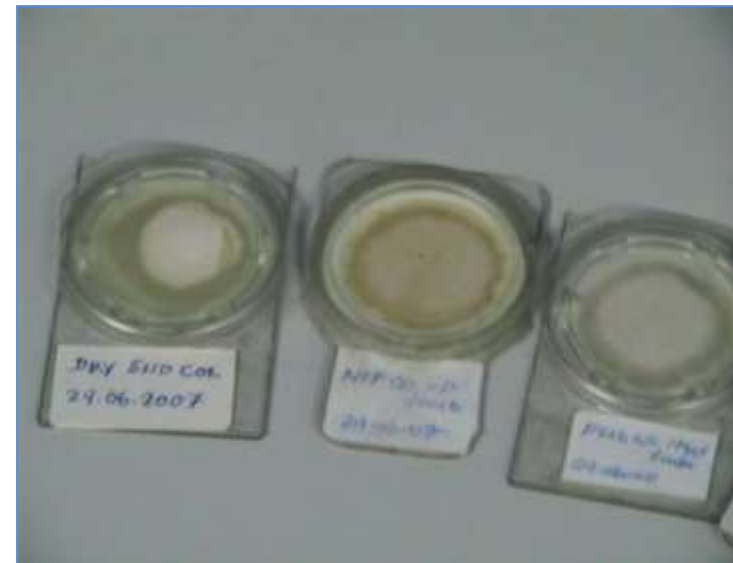
- Health of Lub & Hyd systems
 - Patch test of oil samples periodically
 - Viscosity test for oils in periodical interval
 - Spectrum analysis of oil when ever required

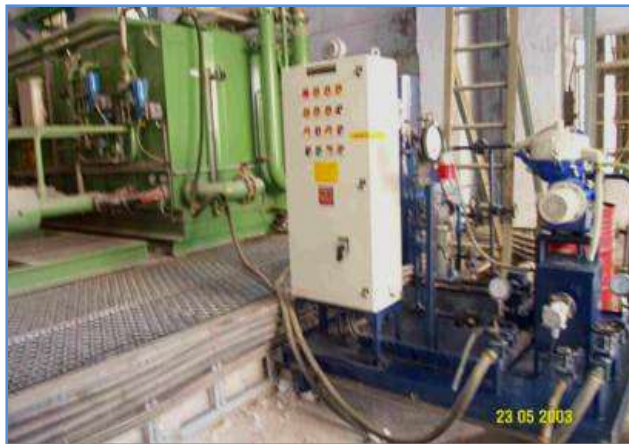
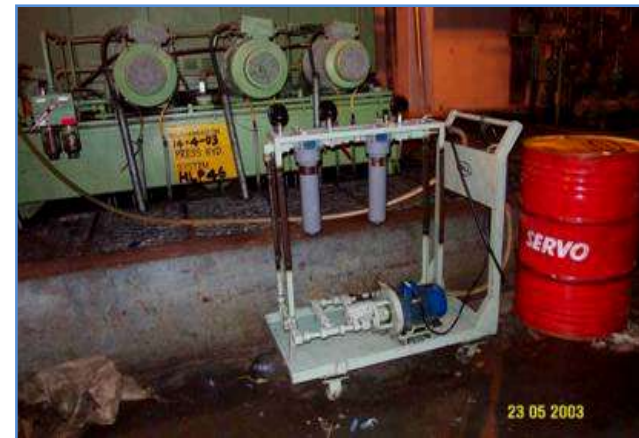
- Health of Lub & Hyd systems
 - Monitoring and controlling water level in oil
 - Dedicated oil purification system for each tank
 - Operating oil cleaners on a regular basis
 - Oil filling through filter unit

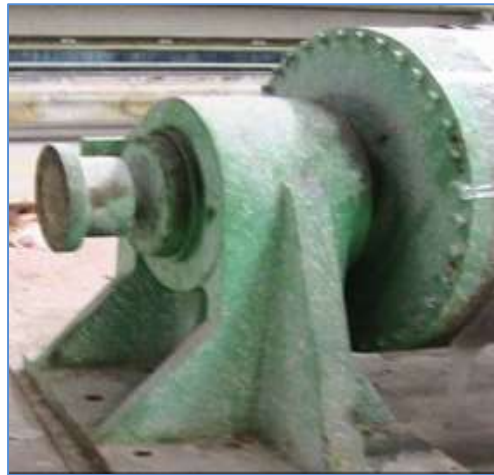
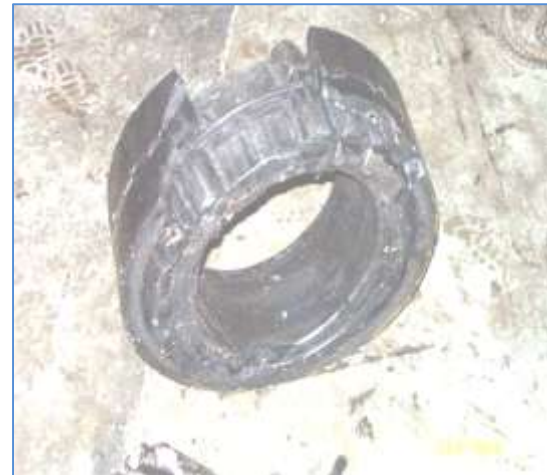
- PM1 Suction Couch Roll Back Bearing Failure
 - Average bearing life was about 250 days
 - Roll change was necessary due to bearing failures

- **Root Cause :**
 - Deviation of **260 microns** in the perpendicularity of bearing seating area with respect to the head mounting face
- **Corrective actions:**
 - Metal spraying the bearing seating area
 - Re-machining to tolerances specified by manufacturer
- **RCA Benefits :**
 - No similar failure till date (Bearing was changed after a run time of almost **2000 days**)

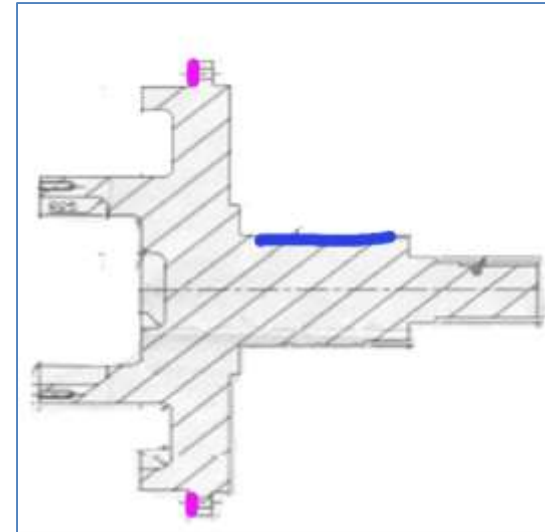
- *run-out of back head in the bearing seating area*

- *Perpendicularity of bearing seating area with reference to head mounting face*

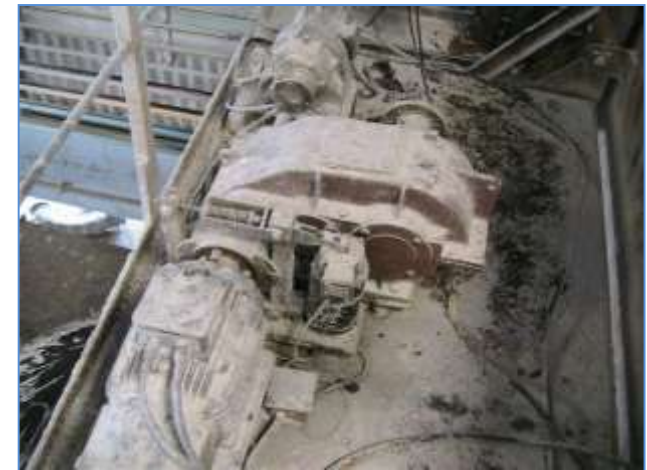
- LT drive gearboxes in EOT cranes
 - Motor-Gearbox-connecting shaft arrangement
 - Highly maintenance prone
 - Uneven movement of wheels leading to other damages

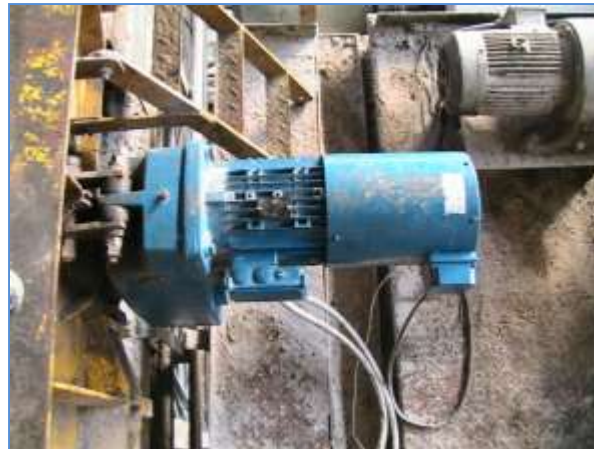
- **Modifications**
 - Shaft mounted gearmotor introduced
 - Maintenance free
 - Smooth operation
 - Power saving (5.5 kW motor replaced with 4 kW motor with VFD)

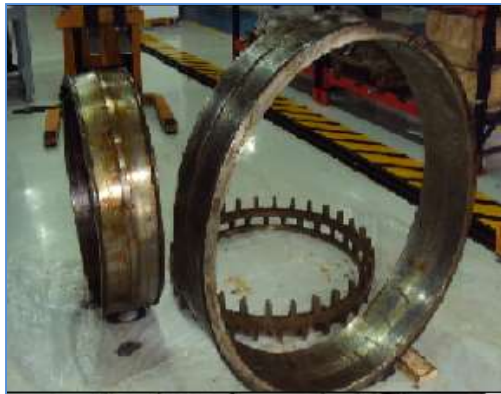
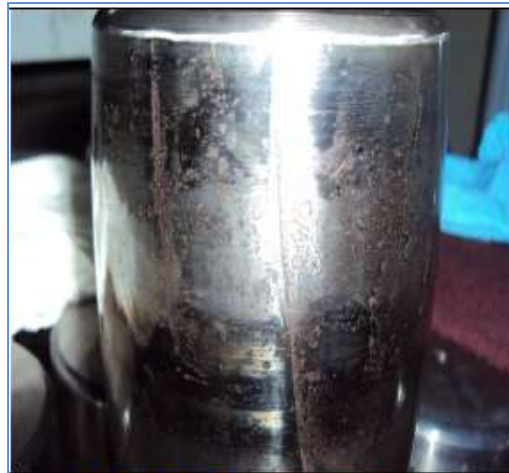
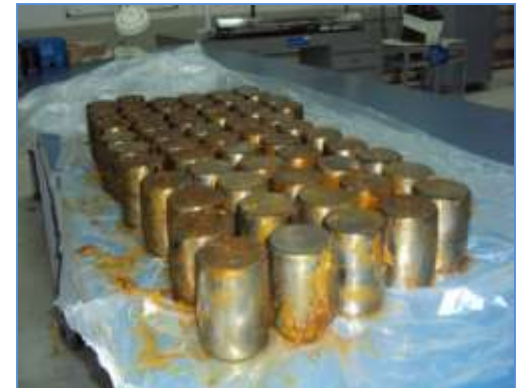
- Reconditioning of Large Size Bearing
 - Bearing 230/850 CAK/C083W33
 - Technology available with bearing manufacturers .

- Cost of new bearing (approx) = Rs. 30 lakhs
- Cost of reconditioning = Rs. 11.2 lakhs

- Bearing installed during April 2013
- Running time of over 1000 days
- Condition found good till date

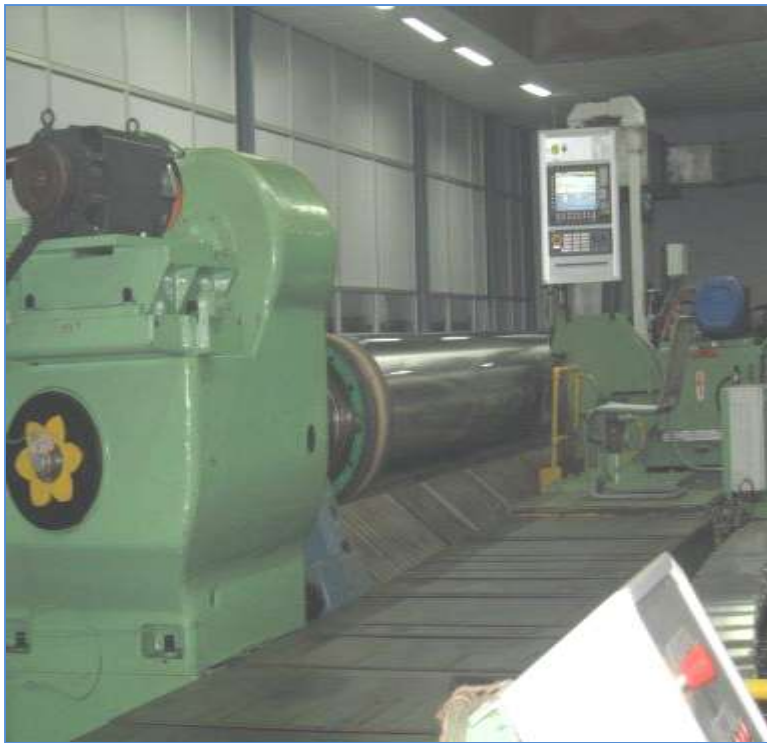
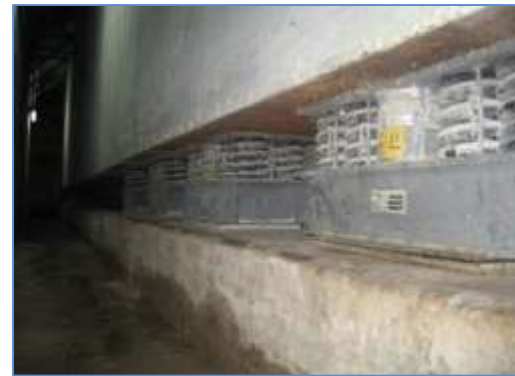
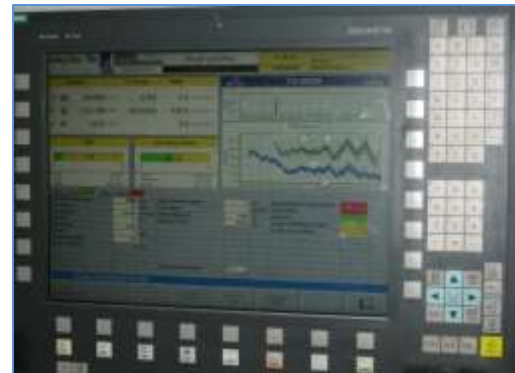
- Efforts to reduce vibration dampening in winder failed
- **Shifting of RG Machine** was the only option
- Floating concrete bed was made ready weighing **450 MT**
- Concrete was laid over **10 springs** to dampen vibrations
- RG Machine alignment done
- RG Machine was upgraded with **CNC controls**

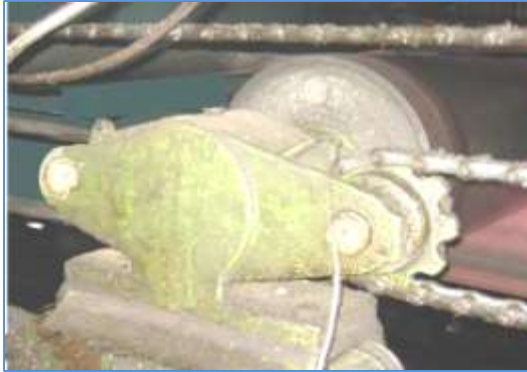
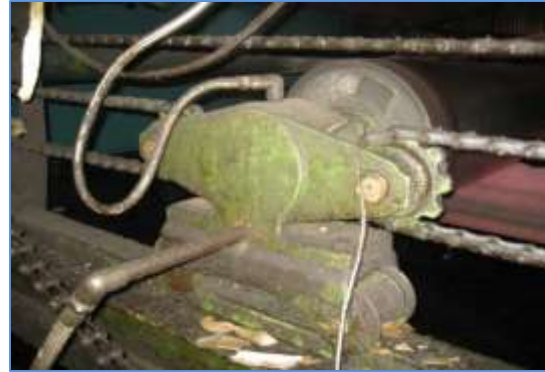
- Concept, Changes and Benefits:
 - Felt rolls in screen stretcher circuits were with **grease lubrication**
 - **Life** of oil lubricated bearings are higher than grease lubricated bearings
 - **Re-engineered** bearing housings to suit oil lubrication
 - Benefits of **lower bearing failures**

Period	Maint.Type /Lubrication	Bearing Population	Bearing Location	
			Drive side	Tender side
			14	14
1985 to 1998	Preventive / Grease	Changed as per Schedule	3	3
		Breakdown	2	1
		Total replaced	5	3
1989 to 2002	Predictive / Grease	Changed as per SPM value	27	23
		Breakdown	0	1
		Total brgs replaced	27	24
2003 to 2016	Proactive / Oil	Changed as per SPM value	4	2
		Breakdown	0	1
		Total brgs replaced	4	3

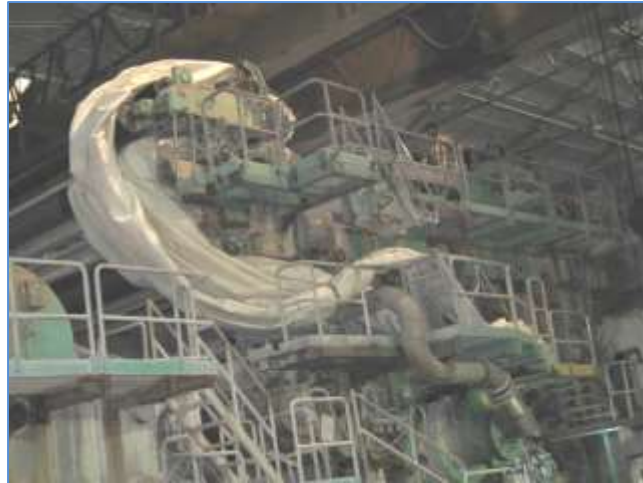
- Cause and Effect:
 - Audit of entire wet end for structural stability
 - Identified structures to be weak
 - **Re-engineered** frames to introduce cantilevers
 - Project taken up as 'Life Cycle Extension'

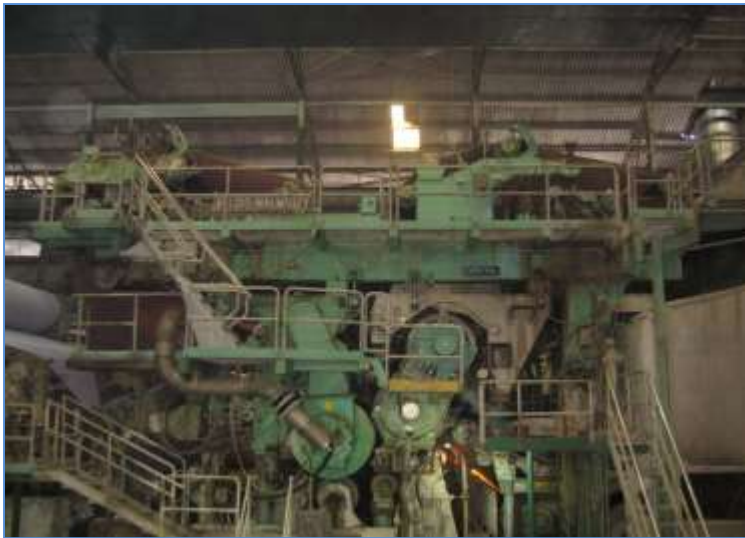
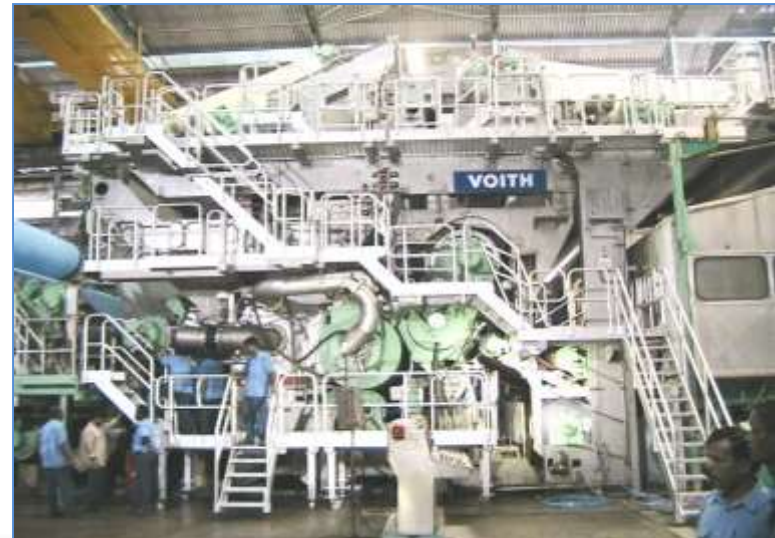
- Benefits of Re-engineering
 - Stable structures. Hence **higher machine speeds**
 - Easy felt changes. Hence **lower downtime**
 - Better **operational control** with hydraulic systems

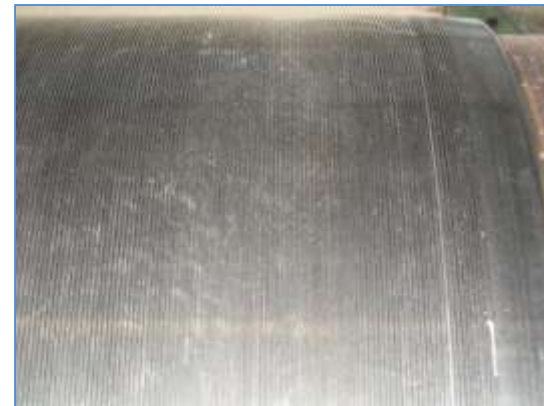
- Re-engineering with Value Engineering:
 - Original shell – **Wound steel wire**
 - Groove depth decreased and recovering was due
 - **Alternatives** Identified:
 - Steel Sleeve
 - PU cover
 - Composite cover
 - **Evaluation** done based on
 - Grinding Interval
 - Heat and Chemical resistance
 - Physical impact resistance

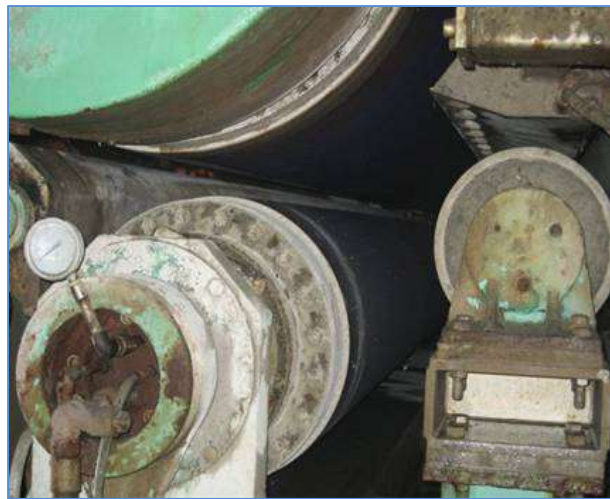
PM1 Press Part CC Roll Covering ...

- Results:
 - PU cover **technically** meeting the requirement
 - Cost of PU cover is just **1/3rd the cost** of steel covering
 - Recovered in 2005 and **no significant damage** till now
 - Properties of paper maintained with slight increase in bulk

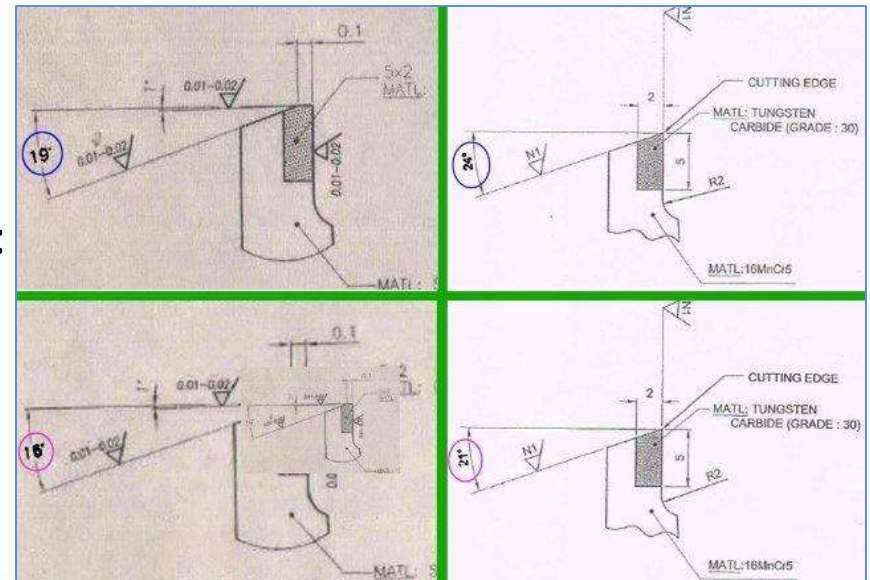
- Top knife angle = 24° ipo 19°
- Bottom knife angle = 21° ipo 16°

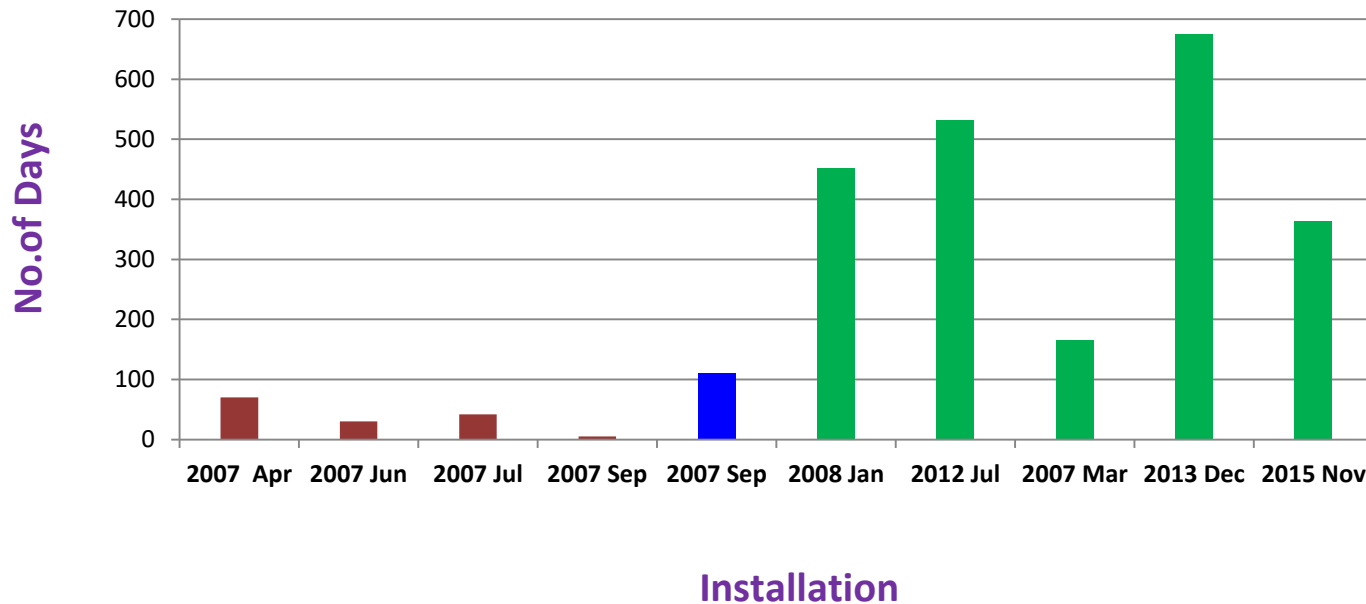
Beilomatik Cutter Knives Regrind Interval

- Phenomenal increase in knives regrind interval

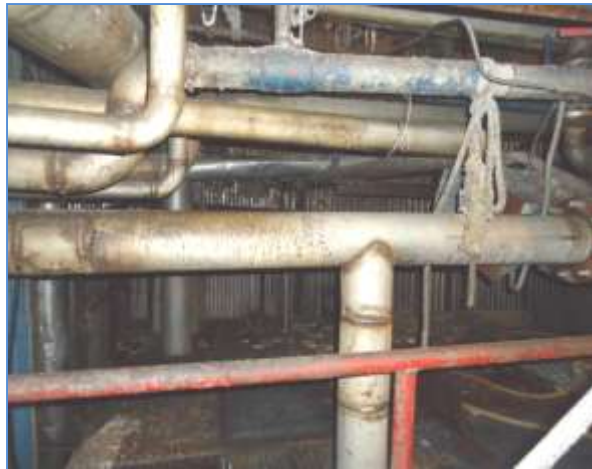
- **Issues Encountered:**
 - 4 vibrating screens in a confined area
 - Restricted work space and difficult to approach
 - Due to want of space valves in wrong positions
 - Dry run of Speed Flow rolls
 - Frequent damages to vibrating screen mesh

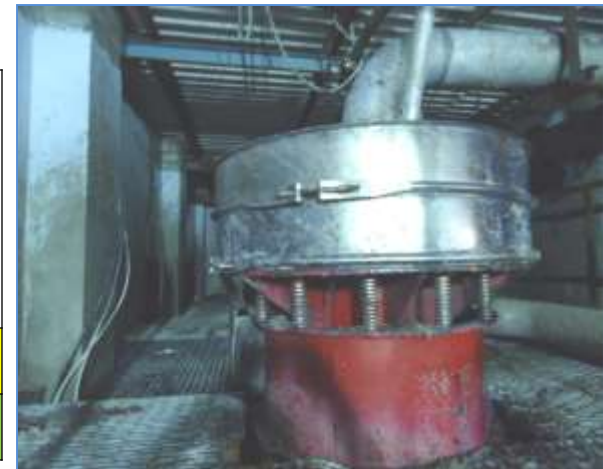
- **Modifications done:**
 - All 4 vibrating screens shifted to a new are with ample workspace
 - Valve positions shifted near the roll by rerouting pipes
- **Benefits obtained:**
 - Dry run of rolls avoided
 - Life of vibrating screen mesh increased
