ITC Limited - PSPD Unit – Kovai

Re-Engineering & Best Maintenance Practices

Case Study 1 - Reliability Action for Bearing consumption reduction

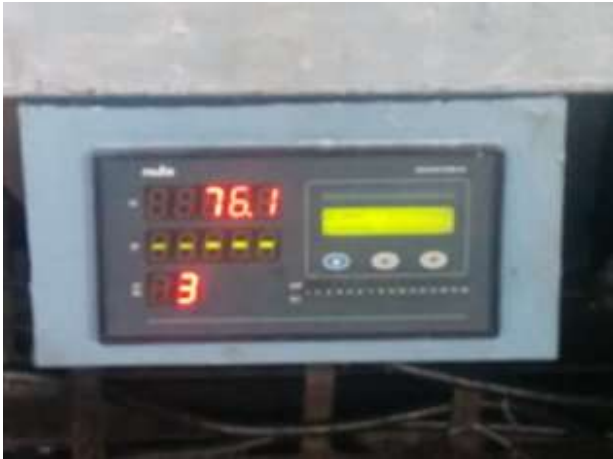
Temperature Scanner for dryer felt roll bearing

- In Paper Machine, dryer hood rolls are grease lubricated.
- Since its within hot hood, human accessibility is not possible for bearing checking.
- Installing remote vibration sensors is a expensive solution.
- RTD scanner is cheapest solution for monitoring felt roll bearings. Any abnormalities can be identified thru temperature profile.

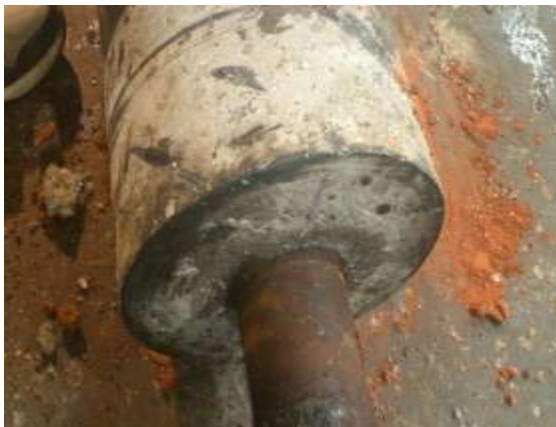
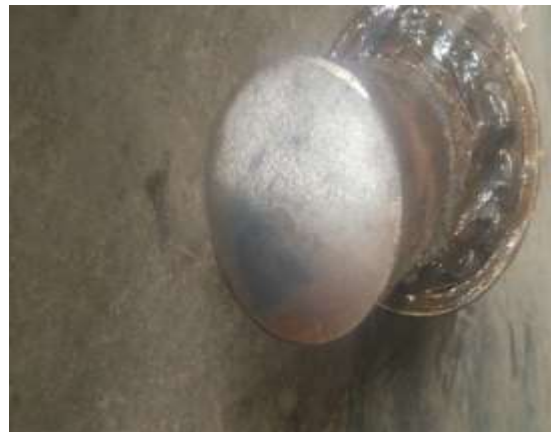
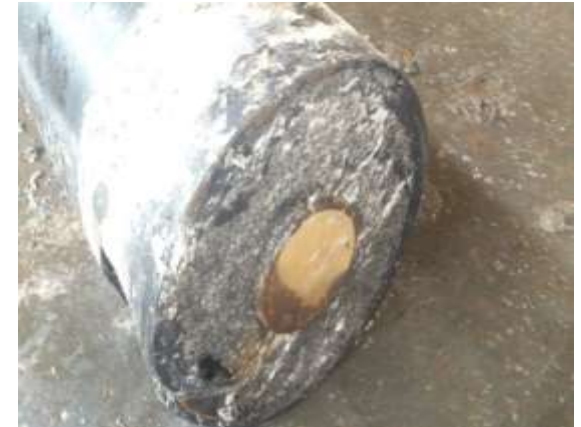
Problem : Failure of Felt Rolls due to Journal cut.

Constraints : With the present condition monitoring technique , defects in the journals cannot be detected. Every failure results in downtime and damage of the felt or screen

- NDT test was carried out for all Press & wire rolls to identify journal defects.
- And subsequently for all supporting bolts

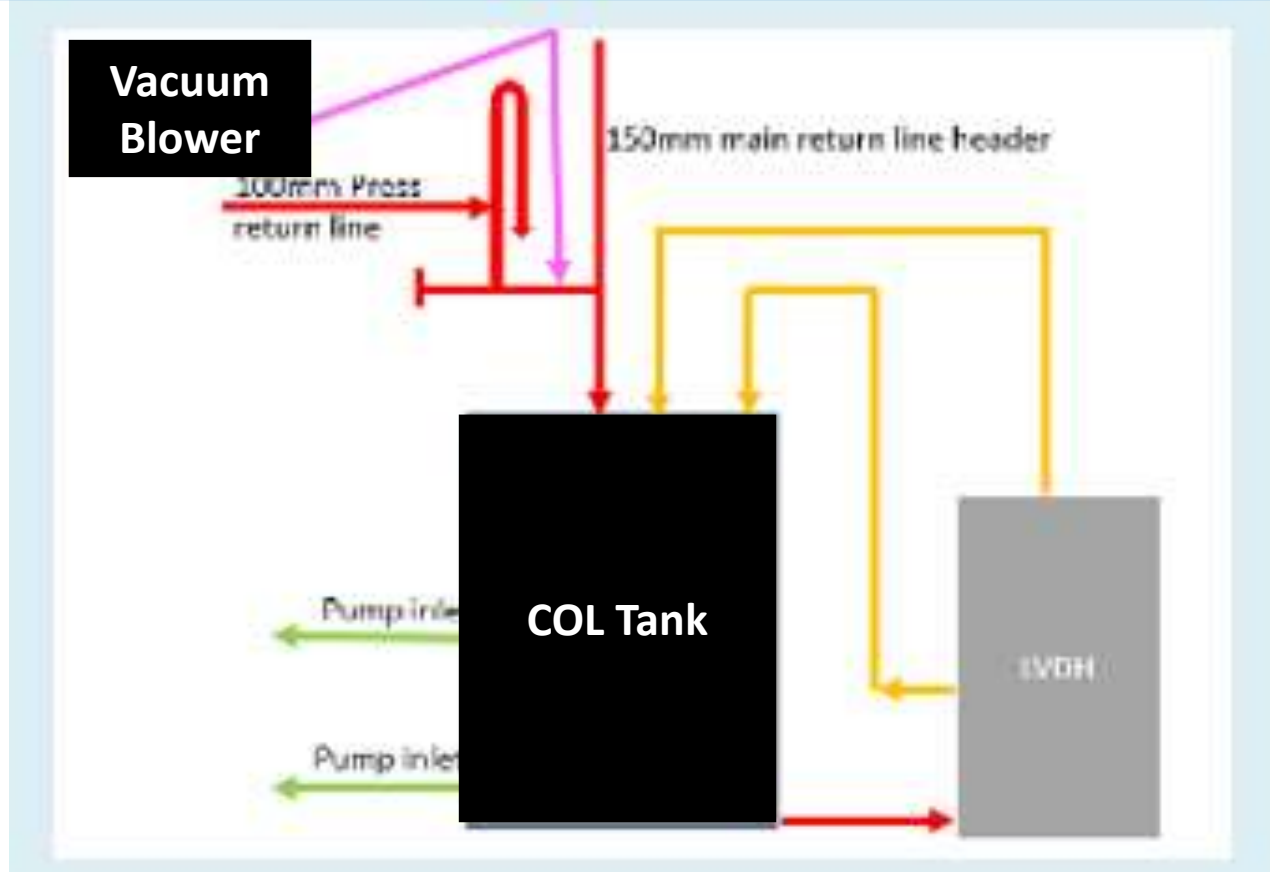
After Improvement

- Board Machine cylinder bearings are oil lubricated.
- Bearing failure was persisting and root cause identified was insufficient oil flow to bearing block.
- The Oil flow to the dryer bearings is quite low than required
- If the flow is increased, then there is an overflow from the dryer bearing housing.
- Oil leakage was also observed from bearing blocks & joints.
- **Root Cause Identified**
- Insufficient slope in return oil header to COL tank

- ❖ Blower has created a negative pressure in return line.
- ❖ It helped in increased oil flow to bearing blocks
- ❖ Also oil leakages were eliminated from circuit

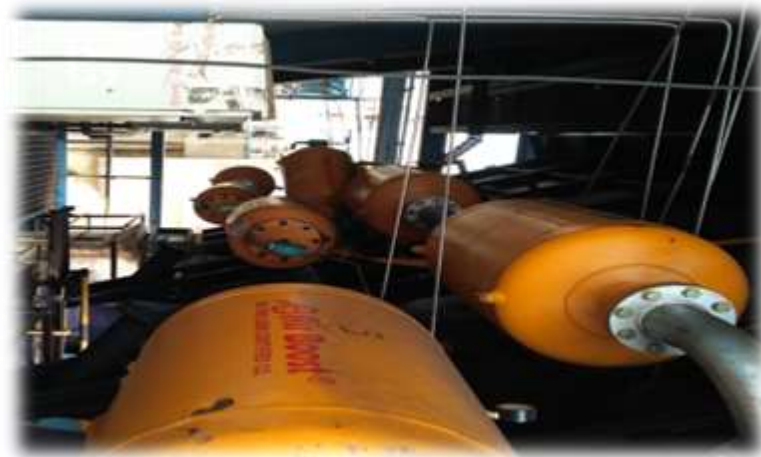
Objective : Boiler bunker capacity is 300 Mt, But due to sticky nature (45% Moisture) of fuel, not able to utilize the bunker capacity beyond 30%.

Coal handling was operated in all 3 shifts for about 3 hours/shift.

- **Air blaster Installed to avoid stickiness of fuel in bunker.**

- Coal Handling A & B shift operation eliminated.
- Fuel flow ability improved from bunker to drag chain feeder without any intervention.
- Manpower reduction
