Operational Experiences & Process Optimization for Supercalender

Singhal D. K. , Gaur M. S.

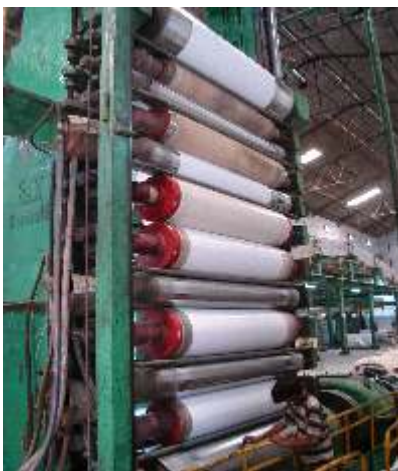
During the same period, it was appearing that a lot of time is wasted in tail feeding during reel change or after a break. Conventionally, the paper rolls are fit in order to cool the paper between the two consequent nips. Bypassing the paper rolls was a risky trial as due to increase in web and roll there was a possibility of deterioration of paper quality as well as damage of rolls. For the same, initially half the reel was run in the conventional way, and then the second half of the reel was run bypassing paper rolls. Around 10 samples were drawn from each part of the reel and evaluated for Gloss, SOA and bulk. Surprisingly, the results were same. For a couple of days, 5-6 reels were tried in the same way. It assured that bypassing paper rolls does not affect paper quality.

The second aspect was of roll performance. For the same, it was decided to run the calender bypassing all paper rolls, and having a close look on roll condition. For this, during every reel change, the temperature of cotton rolls was recorded using a non-contact type pyrometer. The increase in temperature was only 5-6°C compared to that when paper rolls were in operation. This problem was solved by the method describe later in this paper.

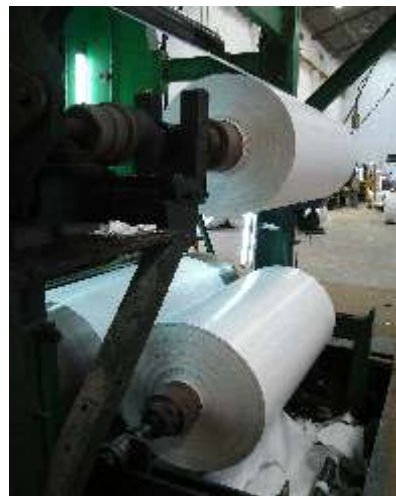
Most of the time, samples are drawn from the calendered roll to check for gloss. The sample is then sent to QC Lab for testing. To avoid the time consumed as well as a joint in subsequent reel at rewinder, a couple of tube lights were strategically installed so that the reflection of these is visible to operator. This acted as a low cost

simulation of on-line gloss measurement, and helped operators to do the needful in case the gloss is low.

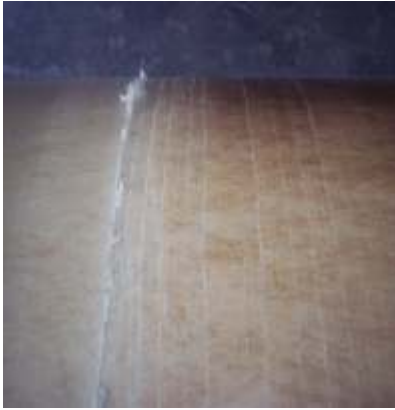
Another problem observed that was slicing of discs of the rolls. This can be seen in figure. Most of the time, slicing affects the complete roll, and the roll becomes unusable even after a deep cut during grinding. Normally, this problem developed in previously ground rolls.

Cotton rolls are made by mounting a lot of cotton discs on a central shaft, and pressing it to a very high pressure. When a roll runs in a particular direction, some stresses are developed. If after grinding the roll is made to run in opposite direction, the slicing may take place. For the same, each of the roll was marked in the direction of first run, and it was ensured that care is to be taken that the roll runs in the same direction after it is mounted again. This solved the problem of slicing completely. To avoid any error due to negligence, paper strips cut in arrow shape are pasted on both sides of the journal so that the rotational direction is clearly visible. Identification number is written on these strips.
