A Case Study at Emami - Low Cost Technical Solutions Adopted For Improving The Performance Of Imported Second-Hand Newsprint Machine For Operating Beyond The Designed Speed

Choudhury B.

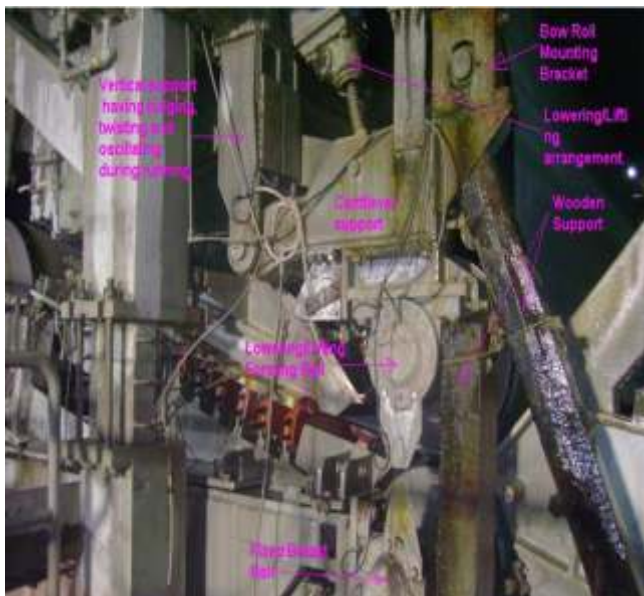
Temporarily, by providing the wooden supports under forming roll bearing housing mounting bracket, the forming roll vibrations were dampened and machine speed was raised to 1100 meter per minute at pope. With such temporary arrangement it was not possible to operate the machine for long and hence root cause analysis was done from the design point of view. The bending moment diagram of forming roll mounting cantilever bracket confirmed that higher vibrations in forming roll was due to more deflection of roll supporting cantilever beam at free end at higher machine speed.

Before Modification (wooden supports)

After redesigning, the mounting location of rubber expander roll was relocated and fixed in existing cantilever beam in the same axis of forming roll bearing housings by modifying the mounting brackets of bow roll. The length of supporting cantilever beam was shortened i.e. centre to centre distance between the pivot pin and rubber expander roll

bearing housing, which in turn minimize the deflection at free end of the existing cantilever brackets. After the modification the vibration amplitudes of forming roll had reached the permissible limit.

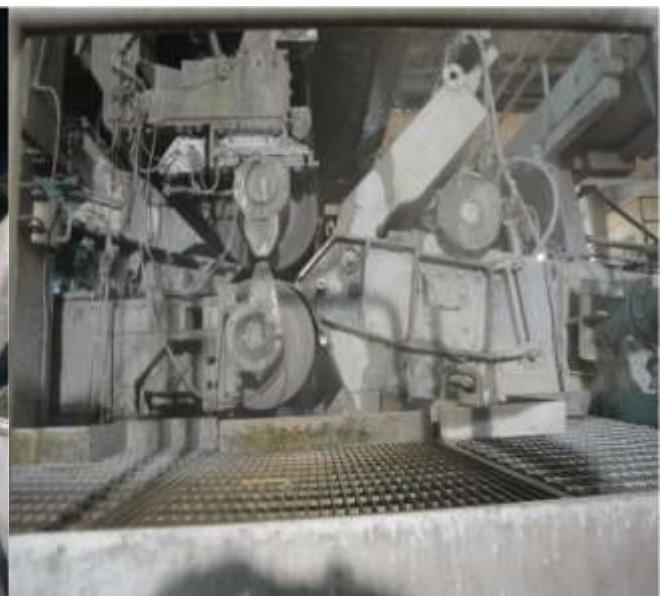
After Modification (Without wooden supports)

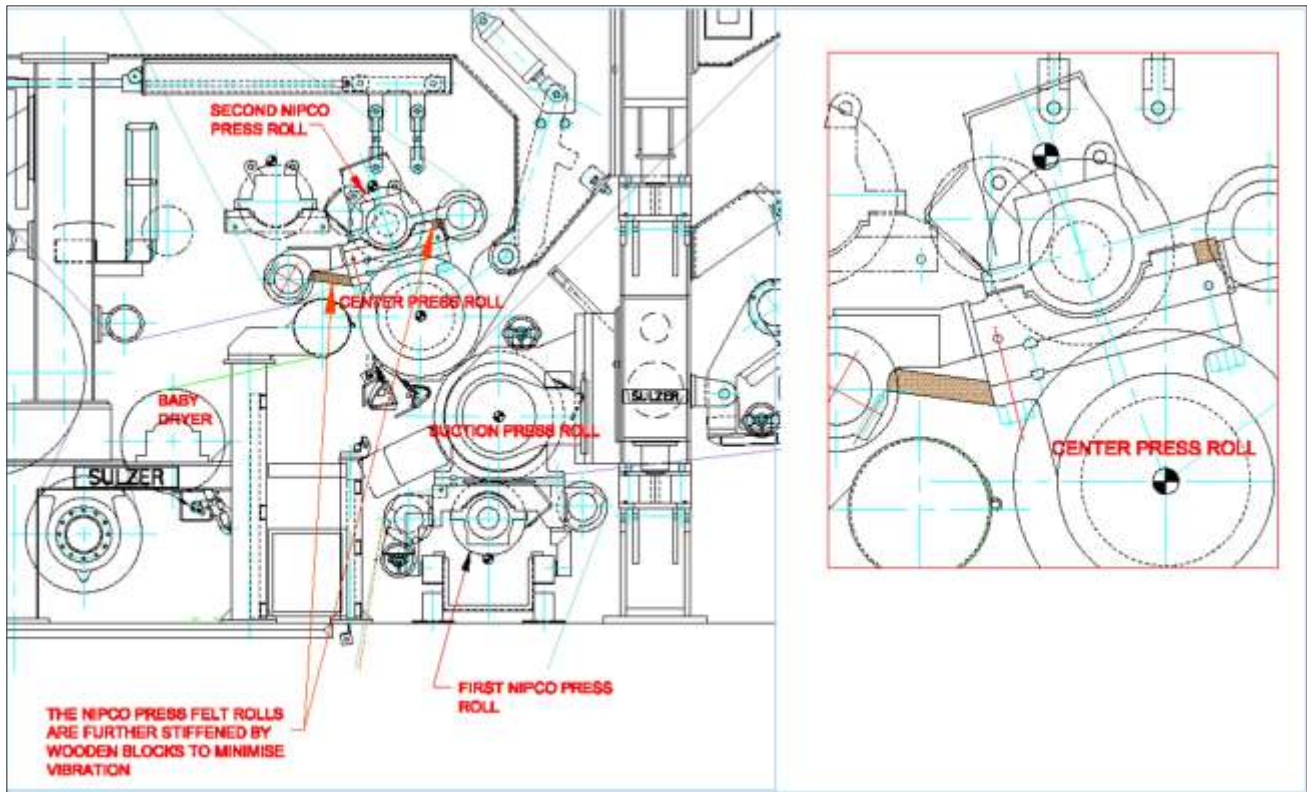
In-house modification was carried out in press section which includes changes in design of two press felt rolls mounting brackets in top felt circuit. Both press felt rolls are mounted in top nip-co bearing housing pedestal support in cantilever frame, hence amplifying the vibration amplitudes in rotational frequencies. The existing cantilever support was modified and this modification had helped to minimize the vibration, subsequently barring impression reduces in top nip-co/ceramic coated centre press rolls surface. After the modifications the roll change frequency has improved to 9 months from 3 to 4 months.

By modifying the press felt roll mounting configuration the force frequencies responsible for higher

vibration amplitudes in top press nip loading rolls are reduced and barring mark on roll surface are totally avoided. The barring phenomenon in top press nip rolls doesn't appear even after 1 year of operations.

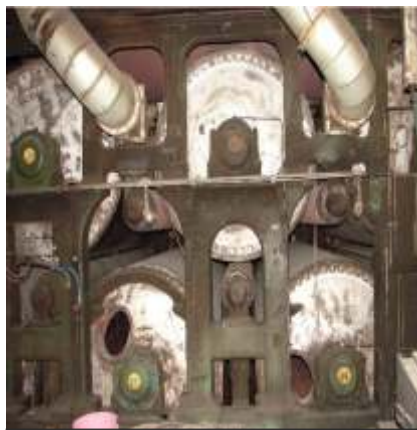
BEFORE : Original Dryer Frame configuration

Higher vibrations of dryer frames.

To avoid higher vibration amplitudes in dryer sections the existing dryer frames were modified by adding additional arch beams in the original frame and dryer doctors were added and mounted on the arch beams. In original machine did not have many dryers with doctor system due to virgin pulp furnish, but for waste paper furnish doctoring must be one in all drying cylinders.

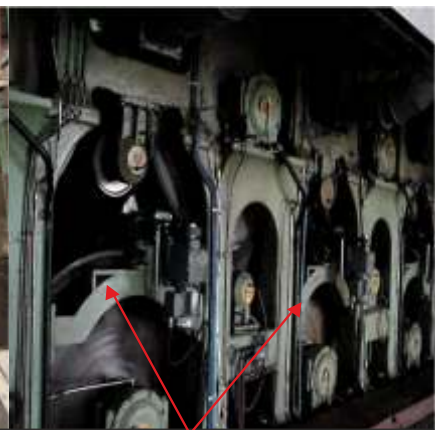
AFTER: Dryer Frame configuration with addition of Arch Beams

Rigidity of dryer frames has been improved by providing arch beams and additional doctoring system has helped to keep dryer surface clean and increases the machine efficiency.

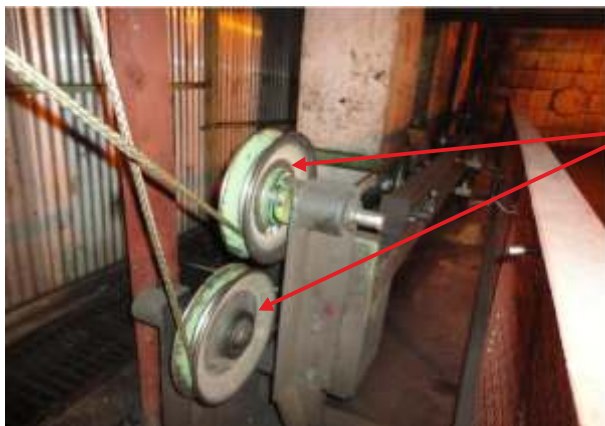
The rope stretcher assembly were redesigned and converted to vertical mounting configuration by changing the orientation of pneumatic cylinders in two tier arrangement during erection stage subsequently space constraint was resolved.

Two tire design of rope stretcher systems occupied lesser space and are maintenance friendly.

Two tire design of rope stretcher systems

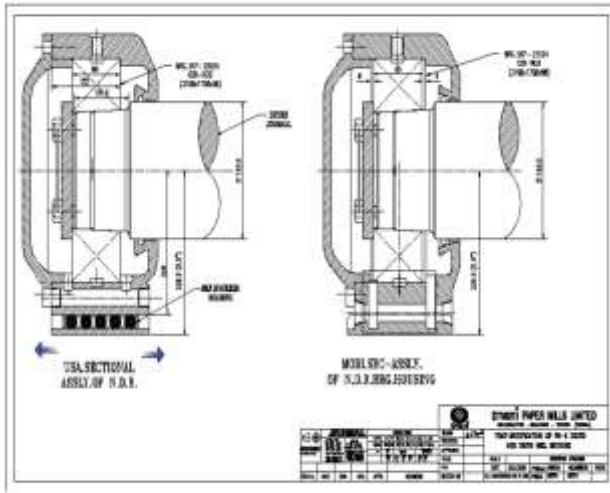
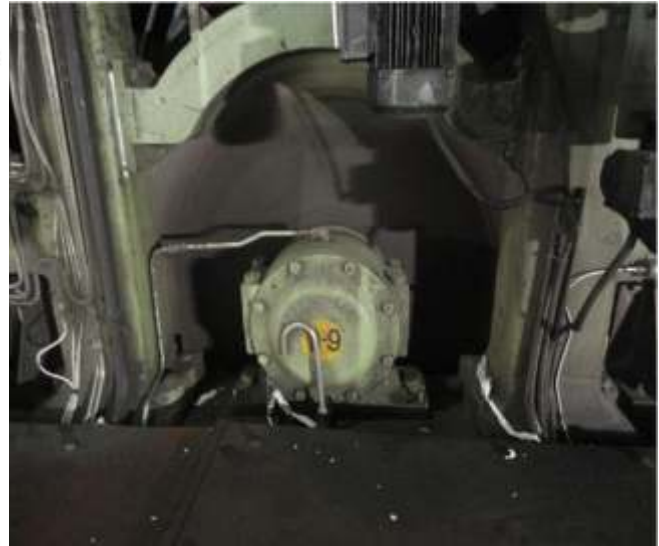
(Modified bearing housing -Front side)

were fixed bearing. The existing non drive end dryer bearing housings were of very old design and were constraint for operating the machine at higher speed.

The front side bearing housing of dryer cylinders were replaced with standard bearing housings with bearing floating arrangement. The bearing housings of dryer cylinders were manufactured in local workshop.

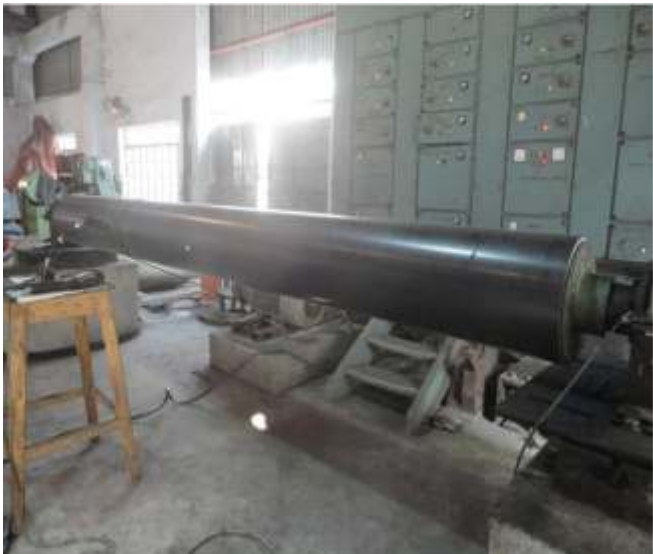
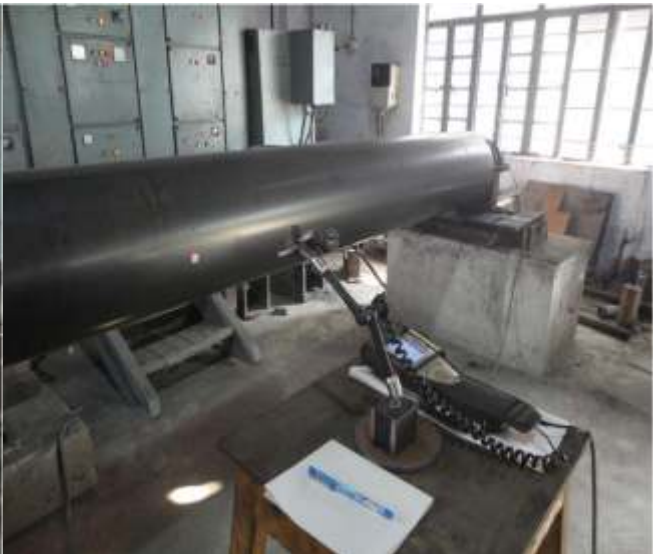
The dryer fabric rolls had been installed in suitable locations of dryer frames after redesigning the dynamic loads of fabric rolls. The fabric rolls were also balanced at 1200 meter per minute speed at our site. The balancing of rolls was carried out in the developed balancing test rig at site by offline vibration logger having facility of dual plane balancing system.

(Dual plane balancing is done at both side of roll by a trigger and Vibration sensor, connected to a vibration logger having software of dual place balancing)

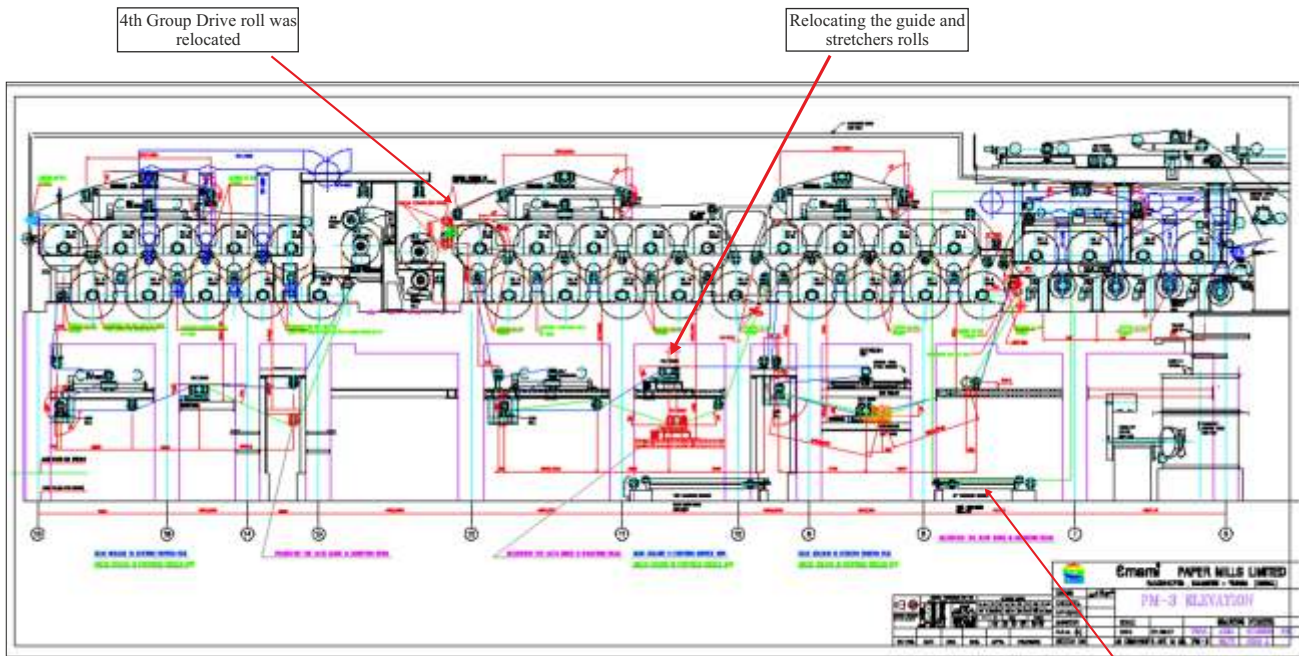
MODIFIED RELOCATED FABRIC ROLLS (MENTIONED IN RED LOCATIONS)

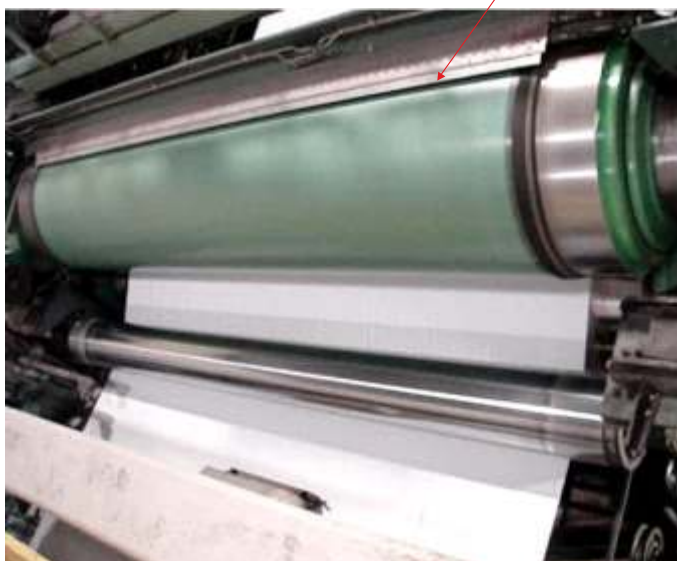
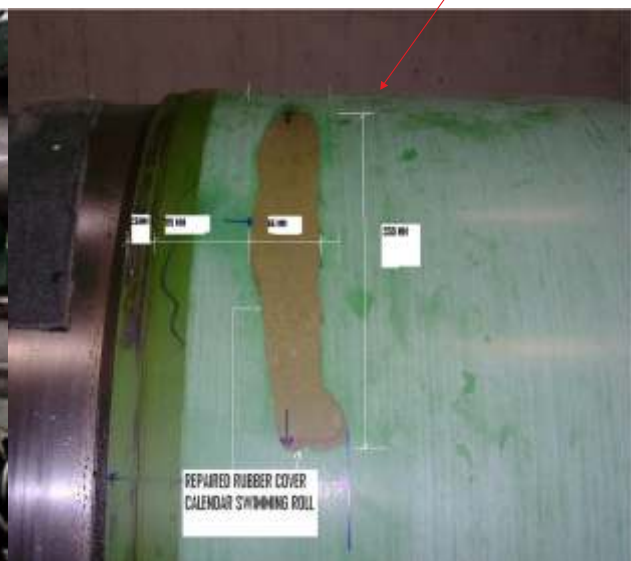
In house repairing of softnip roll surface

Immediately after commissioning of machine soft-nip cover of 2nd stack swimming roll has partially peeled off at drive end due to paper wrapping on roll surface. The matter was brought to the notice of leading international machine manufacturers and the suggestion was for re-aligning of the doctor for avoiding the failure of composite cover. Even after realigning the doctor in both stacks, the peeling of composite cover could not be avoided. By seeing the type of failure, Emami

Repairing procedure of swimming roll composite cover The damaged composite cover was inspected and found that the peeled off surface was around 350 mm long, 65 mm wide, 7 mm deep. Since the extent of damage was more and it was a special covering, the offer was obtained from renowned composite cover manufacturing company. The minimum cost of composite cover was approximately Euro 43,000.00 (excluding Transportation, customs duty etc) and the recovering and to and fro transportation time was almost 05 to 06 months. Considering the cost and recovering time, the repairing works was carried out at site on trial basis and was successful. The repaired cover had same hardness as of original and was installed back on the machine and operated as per required nip load.
