Efforts Taken at EPML for Better Maintenance Practices

Khatua G, Patra Tapan, Mukherjee Himasish, Mitra Tapas Kanti & Khuntia Ramesh

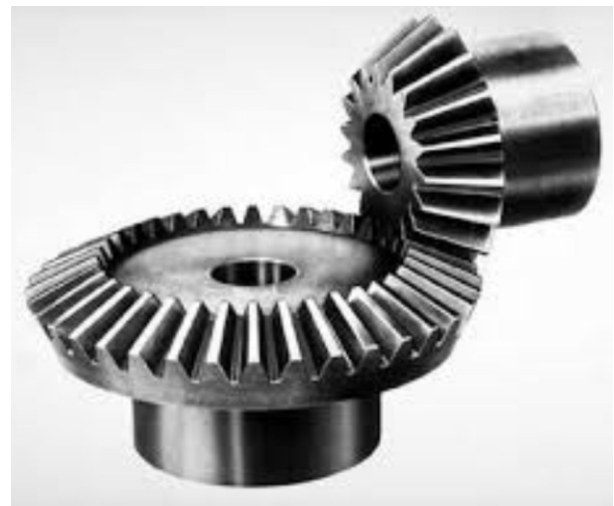
BEFORE

PM1 Clutch and Gear

BEVEL

- Failure of Drive gearbox and Pneumatic clutch of Line shaft drive arrangement is another reason for mechanical downtime of machine. After replacing the Gearbox gears from Bevel to Helical gear and redesign of pneumatic clutch installation these breakdowns almost eliminated.
- Paper breaks at couch lead roll was reduced by redesigning the couch draw roll system. Previously the couch lead roll was 110 mm diameter without drive. For high RPM and low diameter and without drive paper breaks was occurred and incurred downtime daily about half an hour to one hour. This downtime was saved by increasing the lead roll diameter and VFD drive arrangement.

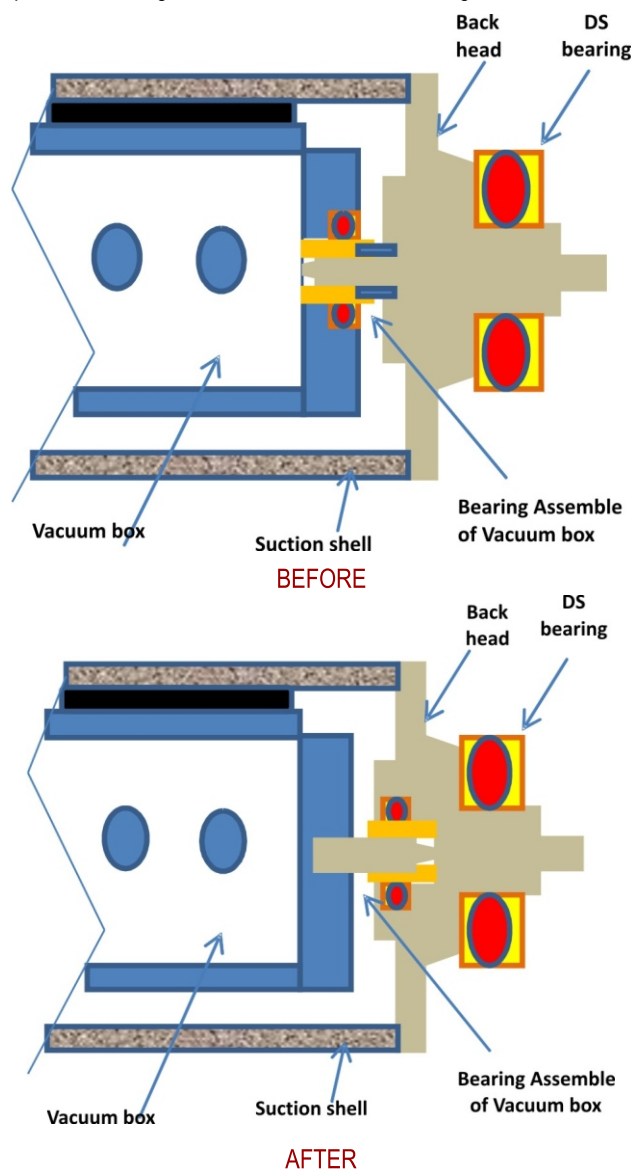
The main downtime occurred in suction couch and suction pick up roll. Both the rolls were designed for 400 mpm and primitive type, where internal bearing are located in vacuum box and stud was on drive head. Number of pins fitted at drive end for locking. Downtime occurred due to shear of those pins. With in-house design, the box bearing installed at drive head and the stud fitted with vacuum box, pins removed. All those jobs carried out in our work shop. Since then there is no breakdown for suction rolls.

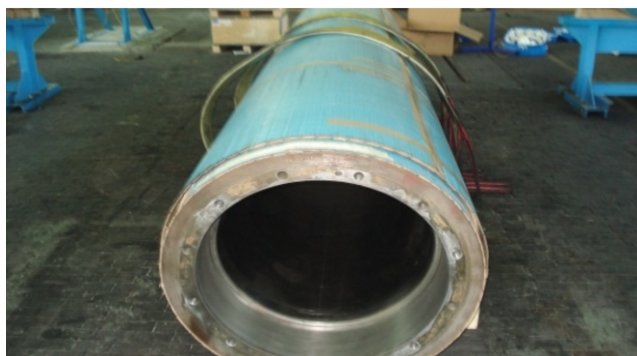
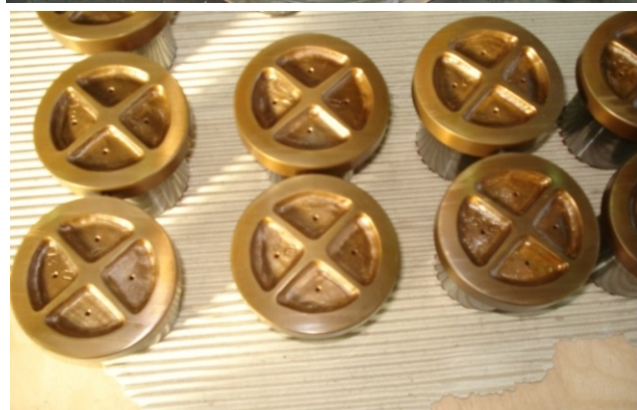
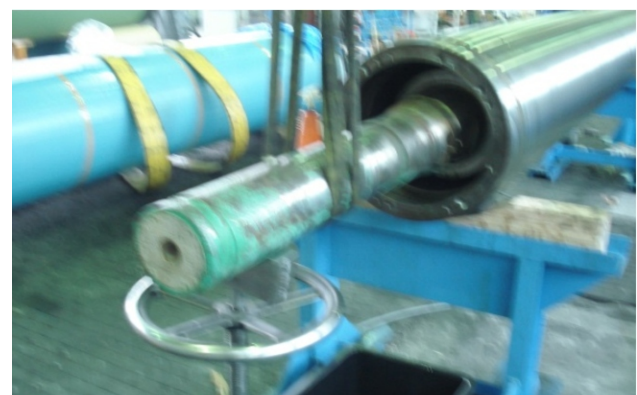
In house overhauling of swimming & nipcoroll reduces foreign experts cost:

Previously the Swimming roll and Nipcoroll servicing was carried out by sending the rolls to Europe. We have developed in house facilities for overhauling & maintenance of same.

5. In-house plastic handling system reduces the manpower & nuisance in the Plant.
6. In house overhauling of swimming & nipco roll Eliminated supervision and experts cost Rs. 10 lacs/annum.
