# Best Maintenance Practices In Pulp And Paper Mills To Improve Profitability

Agarwl N.K., Goswami S., Khanna N.K., Bhavsar Ranjit, Dode Devendra D & Joshi Sandesh

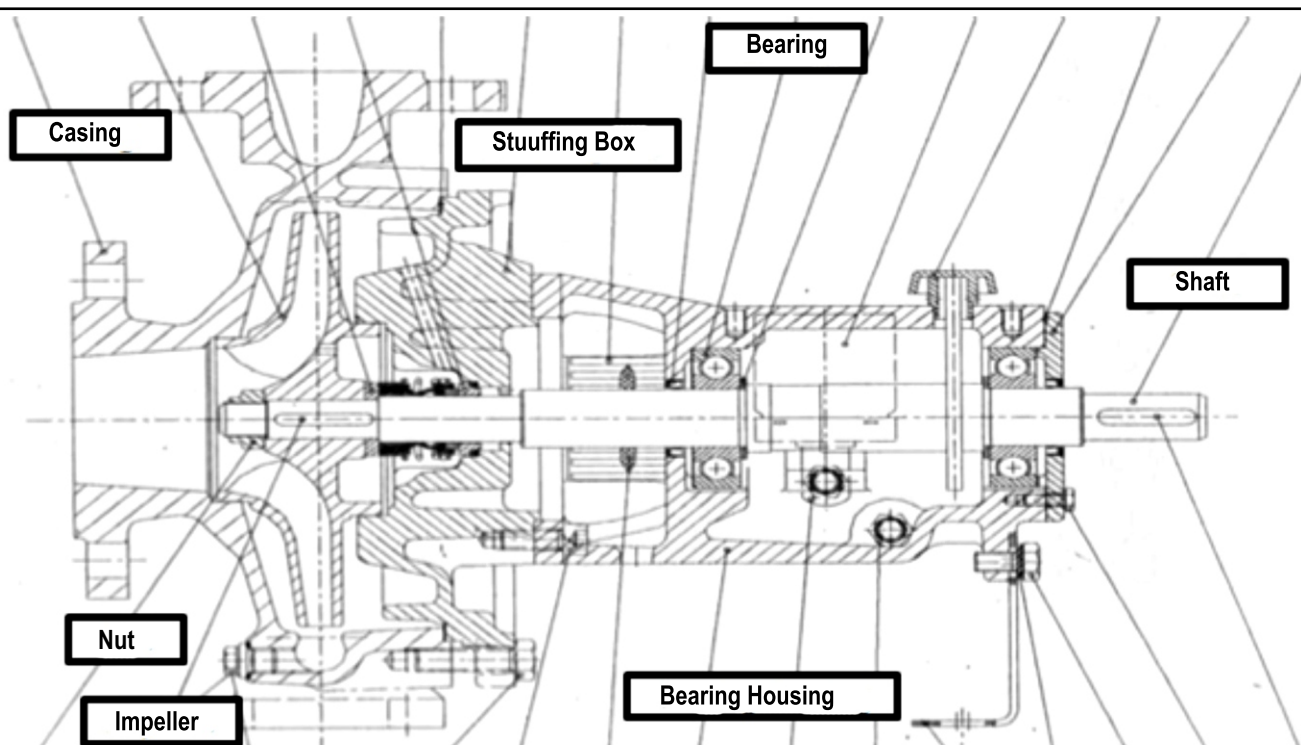
STANDARD OVERHAULING PROCEDURE	
EQUIPMENT NAME	BOTTOM LAYER RICH WATER PUMP - ABS SCAN - NL 80160
LOCATION	APPROACH PROCESS WHITE WATER TANK
EQUIPMENT CATEGORY	B

Dismantling Procedure	Assembling Procedure
1. Drain Lubrication oil in container	1. Bearing Inner race pre-heated in induction heater & Fitted on shaft
2. Remove coupling by Puller	2. Assembled shaft fitted in Bearing Housing

3. Remove Stuffing Box bolt & Part off Casing Bearing housing	3. New Oil seal fitted in cover & bolt up on Bearing Housing
4. Remove Impeller lock nut, Impeller & Mechanical Seal unit	4. Stuffing box boltup to Bearing housing

5. Remove Bearing Housing & Stuffing Box connecting bolt	5. Mechanical Seal fit on shaft.
6. Remove both end cover of bearing housing	6. Impeller & Impeller Nut fitted on shaft. Maintain clearance in between Impeller & Stuffing box face.

7. Remove Shaft with bearing. Bearing r	7. Assembled Bearing Housing boltup to Pump casing & check for free rotation
8. Clean all dismentle parts	8. Coupling fitted on shaft
Check up	PPE use

SOP sheet contains details like Dismantling and Assembling Procedures with check points, Tools uses

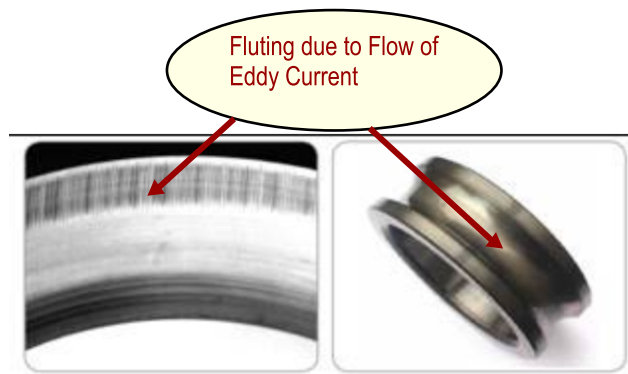
*Fig: Bearing Outer and Inner Race Fluting.*

The Bearing problem is shown in the figure below.

There are 108 drives installed to run the board machine. There were several incidents of premature failure of drive motor bearings. JK Paper Unit: CPM consults with bearing manufacture for such premature failure of bearings. They gave feedback that leakage current is passing through bearing which leads to bearing failure.

The leakage Eddy currents when flow through the rotor bearing, give rise to the failure of the Bearings of the motor.

maintaining proper earthing of multidrive system. Team separated the earthing electrodes only for the drive section and that also connected in parallel, ultimately proper earthing was provided for our multidrive system which is having less resistance and proper conductivity and also connected double sided earthing to drive motors. Due to above modification, Actual life of bearing is achieved and avoid the premature failure of bearings which lead to unplanned shut of machine and loss of manpower that was incurred for replacement of motor or bearing.

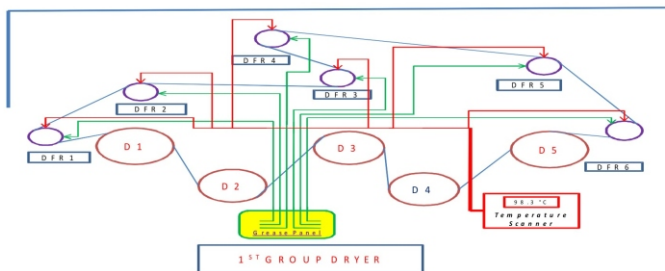
#### DFR Temperature Sensor Layout

There are some locations at dryer section fabric rolls bearing in closed hood, which are difficult to access due to high temperature in running condition of machine. To monitor such locations RTD was installed on the roll bearing housing and taken the signal to the group supervisory unit which gives alarm to DCS if the temperature of the bearing rises above the desired level for the appropriate action. This is one of the unique cross functional initiatives for measuring the temperature of the running roll bearing.

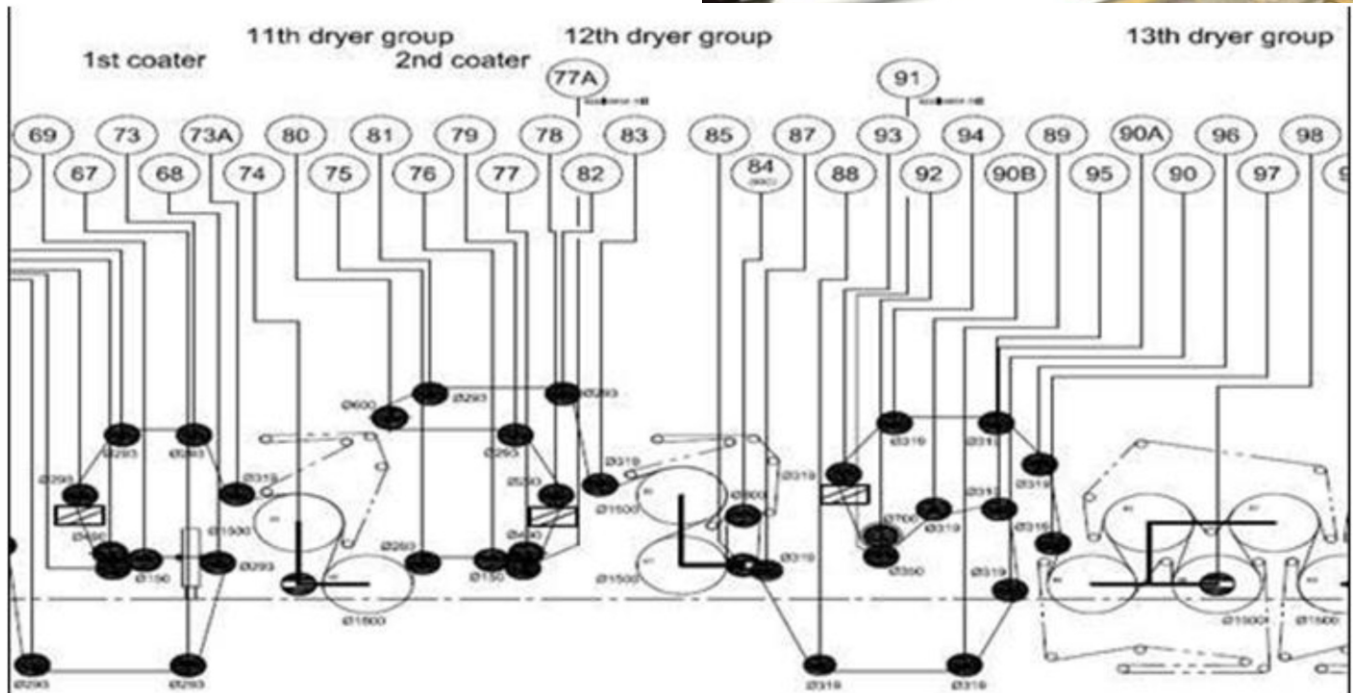
Fig: Paper Roll Overview

At higher Machine speed, Board machine Coater area, Machine structure rattle with high vibration. Vibration of structure found 6mm/s Paper roll and Dryer fabric roll bearing failure is high. On vibration analysis figure out protruded Brackets at height rattle with vibration. Increased Vibration level in equipment means abnormalities induced in Equipment. Periodically conducting Equipment vibration measurement and analysis is very essential for healthy maintenance practice. Fabricated tie rod installed on M/c cross section to strengthen structure.

Thus after installation of tie rods vibration level reduced to normal level.

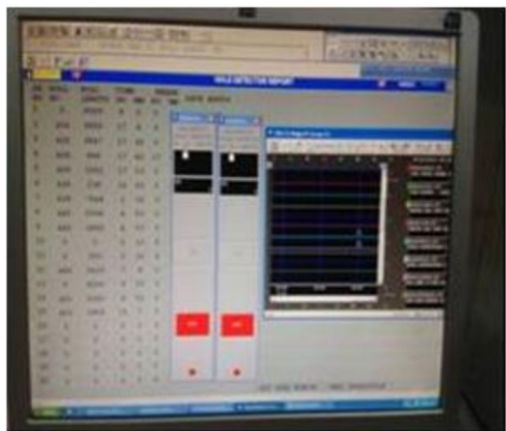
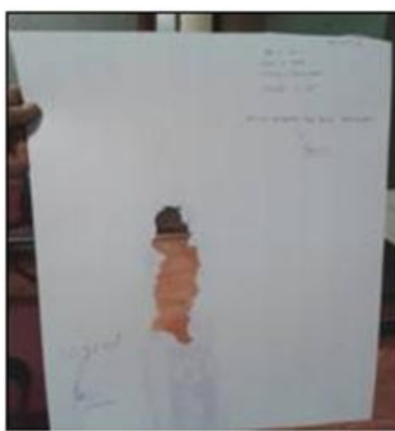
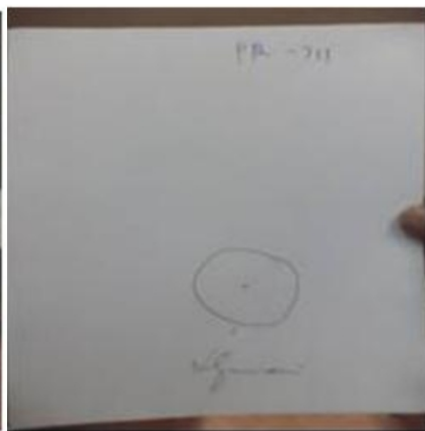
#### Hole Detector Report and Trends in DCS

In spite of all the physical and cognitive efforts by the team, some physical defects like blotches and stamping, which are predominant in board manufacturing process, are escaping to the customer. Due to this, customers have to incur loss as it damages the blankets of the printing machines which increase their down time. During our introspective brainstorming sessions it was felt to go for engineering solution for this problem. The solution for this in the market is "Web Inspection System" which inspects the physical defects of the paper board but it is an expensive system and it costs around \$200000. So it was thought to have some indigenously developed solutions to curb this holes problem in paper board. Our Instrumentation Department has developed sensor from Banner to detect small hole (>9mm) which works on it based on the principle of Triangulation. This system consists of laser beams and sensor fitted across the deckle of machine just after the Pope Reel Scanner. As soon as there is Hole in paper due to blotch the laser passes through the holes which is sensed by the sensor and the feedback is given to DCS system. In-house online blue (die) color marking system on the edge of web has been developed to remove defected material at Rewinder. Also on the outside of the Dry End control room there is an alarm is provided which is acknowledge from hooter, this system helps to machine floor operator for cleaning all coater blade, HNC and SNC blade to avoid further Stamping defect. In the DCS there is a separate page developed to understand exact location of blotch / defects.
