# MAINTENANCE STRATEGIES COST REDUCTION AND QUALITY IMPROVEMENT

## TIMELY CORRECTIONS - BY CONDITION MONITORING

#### A STUDY ON PAPER MACHINE AT TIRUNELVELI

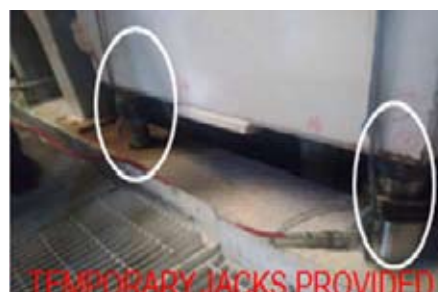
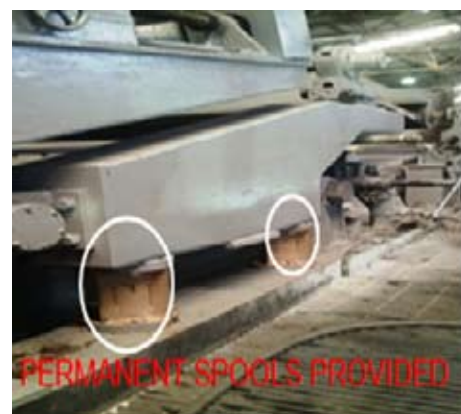
- As a temporary measure, two jacks were provided for the structure with overhang at NDE, to improve the rigidity.
- Vibration levels were measured after jacking up the structure to check the effectiveness of the additional support.
- Significant reduction in vibration levels, from 16.8 mm/s to 5.8 mm/s, was observed after jacking up the overhung portion of the 3rd press structure.

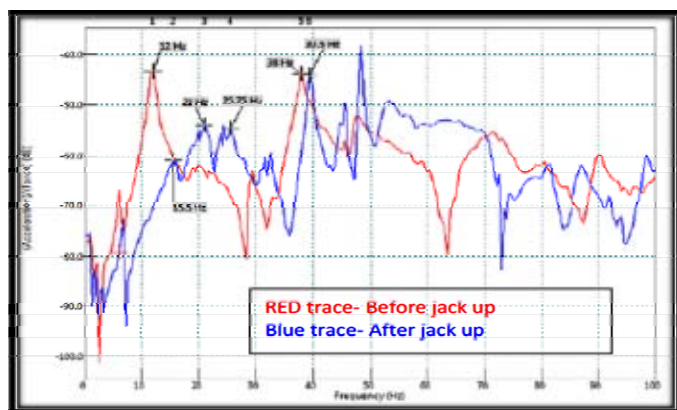
## FRF SPECTRUM OF STRUCTURE B BEFORE AND AFTER JACKING UP

- ☐ Hammer test was carried out to identify the resonance frequencies of structure B after jacking up at NDE side.
- ☐ Typical FRF spectrum for structure B are shown in fig.,
- ☐ It may be observed that the 12 Hz resonance frequency got shifted to 15 Hz with the jack up condition with significant reduction in compliance in structure B

- ☐ From vibration severity point of view, with permanent support provided for structure B
- ☐ From the spectrum (15Hz) machine is safe to run at 850mpm
- ☐ The machine speed increased to 730 mpm from 680 mpm.

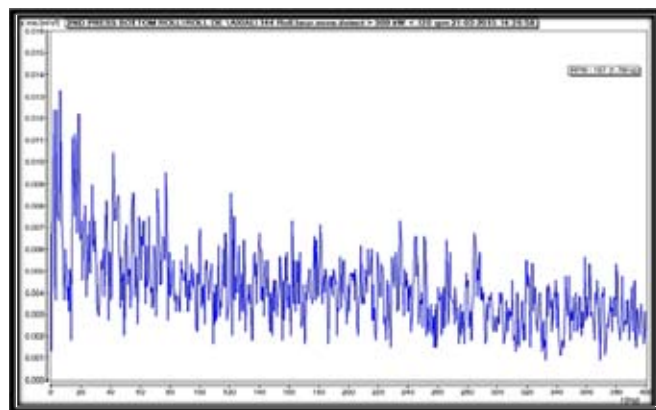
Location	Vibration Velocity In mm/sec		
	Horizontal	Vertical	Axial
ROLL DE	0.97	1.26	1.23
ROLL NDE	1.36	1.28	1.16
