RE-ENGINEERING AND BEST MAINTENANCE PRACTICES

Sharing some case studies on Re-Engineering and best practices in predictive Maintenance at ITC Ltd PSPD Unit Bhadrachalam.

Re-Engineering of Paper Machine #2 to Increase Machine speed and Reliability

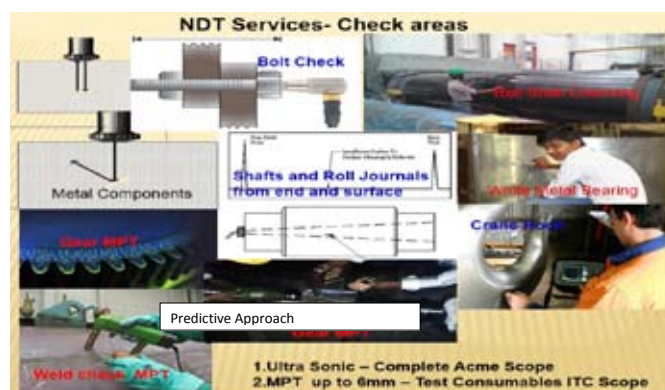
Applications being used at Bhadrachalam..

- Hidden cracks in bolts
- Roll journal inherent cracks
- Inspection of Components before assembly
- Inspection of incoming material defects at Engineering stores quality cell.
- Lifting Equipment Hooks, D-Shackle and Crane hoist drum
- Weld Joints
- Uncovered Roll shells etc.

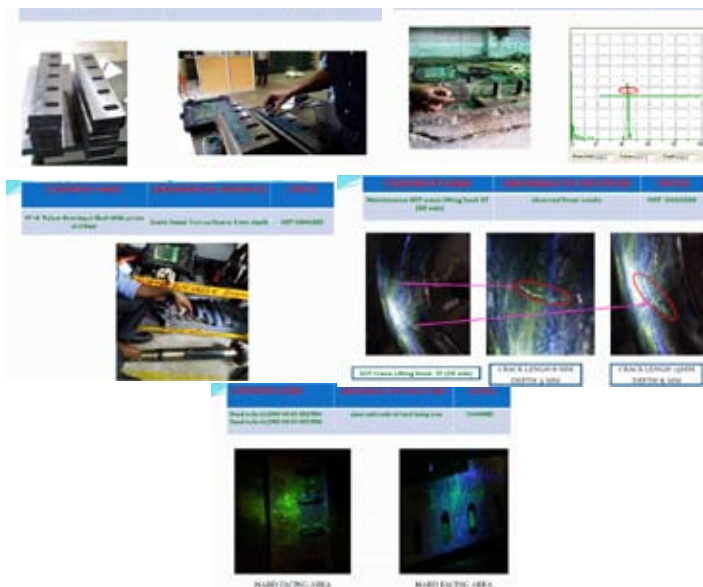
Some of the identified defects are shown in below.

After implementation of the initiative for testing & inspection of old spares, operating machine, during shut down period and incoming material, number defects predicted about 160. The technique helped in replacing the items early stage of failure and rejection of even newly defective received materials. This predictive approach is helping the maintenance crew with huge benefits in terms of Cost saving, safety conditions improvement and elimination of unplanned stoppages.

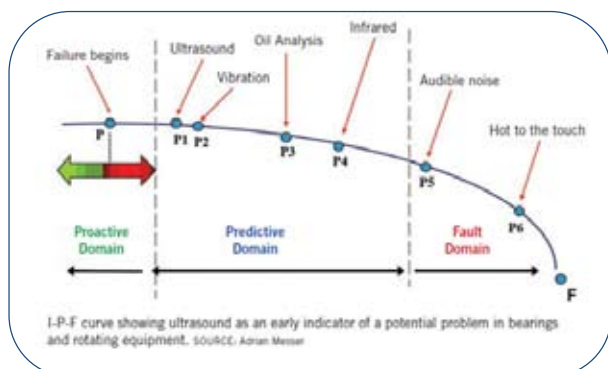
Ultrasound is defined as sound waves that have frequency levels above 20 kHz; higher than what the unaided human ear can normally hear. Most machines emit consistent sound patterns under normal operating conditions. These sonic signatures can be defined and recognized, and changes in these signatures can be identified as components begin to wear or deteriorate. This enables technicians to identify and locate bearing deterioration, compressed air or hydraulic fluid leaks, vacuum leaks, steam trap leaks and tank leaks [26]. Acoustic emission operates in the lower ultrasonic spectrum of 20 kHz to 100 kHz. A compressed gas or fluid forced through a small opening creates turbulence with strong ultrasonic components on the downstream side of the opening. Also vacuum leaks produce turbulence similar to pressure leaks; however, the ultrasound is generated within the system. Poorly sealed valves can also be detected.

It is worth noting that the Acoustic Emission (AE) technique also deals with signals in the high frequency range and has been increasingly used for condition monitoring of rotating machinery as well as structures. However, the AE technique differs from the ultrasonic technique in terms of the frequency range of interest and parameters for condition assessment. The AE technique generally operates in the 100 kHz to 1 MHz while the ultrasonic technique focuses on the frequency range of 20 kHz to 100 kHz. Parameters such as ring down counts, events, rising time, duration and peak amplitude are normally used in the AE technique to examine abnormality. In the ultrasonic detector, abnormality is usually detected by listening to the characteristics of sound or RMS indicator on the panel.

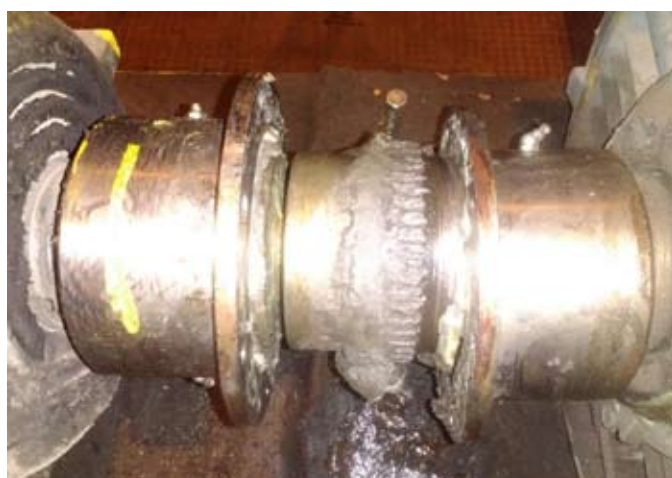
Geared Coupling requires regular maintenance in terms of greasing, physical inspection at scheduled intervals. In spite of regular maintenance, Gear teeth wear out and coupling failures are quite common in drives which result in planned and unplanned stoppages.

PM2,4&5 drives were Equipped with Geared Couplings and one or two breakdowns on account of gear couplings in a year were common.
