RE-ENGINEERING AND BEST MAINTENANCE PRACTICES

We at PSPD Kovai unit adopted TPM as Business model. TPM is a great competitive weapon that reduces costs, improves quality and improves bottom line. TPM Practices are the current system of operation, which cover all the employees and managers of the plant and works on the multi-skilling concept.

ITC Limited, PSPD, Unit Kovai is situated at Mettupalayam, in the Coimbatore district of Tamilnadu. The Unit was taken over by ITC in the year 2004. The Plant is having a production capacity of 1.2 Lac tons per annum coated paperboard with 100% recycled paper. The Unit has a full-fledged waste paper processing plant, along with a 3 liner multi wire Board Machine with Machine Glaze (MG) and on-line coating.

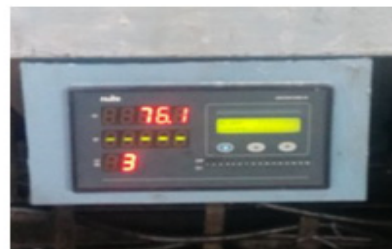
In Paper Machine, dryer hood felt rolls are grease lubricated. Since its within hot hood, human accessibility is not possible for bearing checking. Installing remote vibration sensors is a expensive solution. RTD scanner is cheapest solution for monitoring felt roll bearings. Any abnormalities can be identified through temperature profile.

Temperature Indication

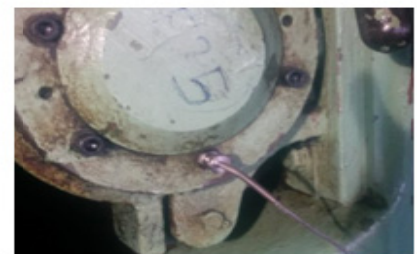
Sensor Installation

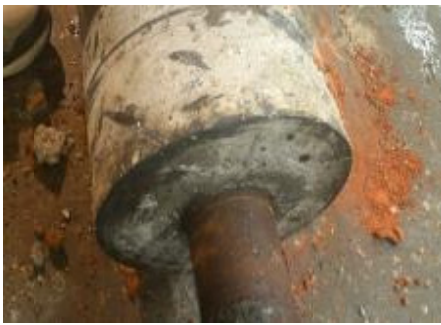
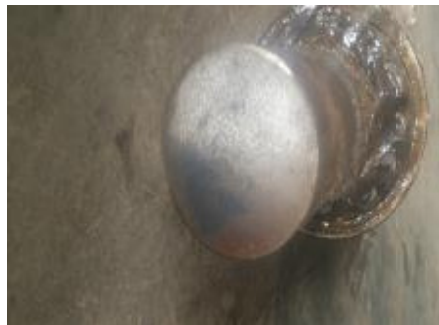
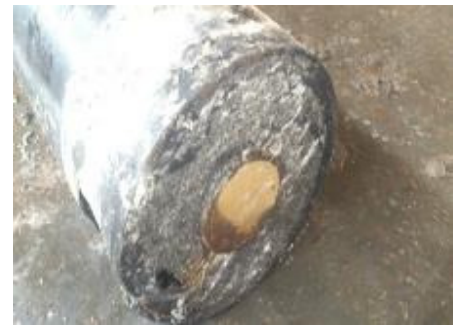
Problem: Failure of Felt Rolls due to Journal cut.

Constraints: With the present condition monitoring technique, defects in the journals cannot be detected. Every failure results in downtime and damage of the felt or screen

Solution:NDT test was carried out for all Press & wire rolls to identify journal defects.

Images of the defect identified

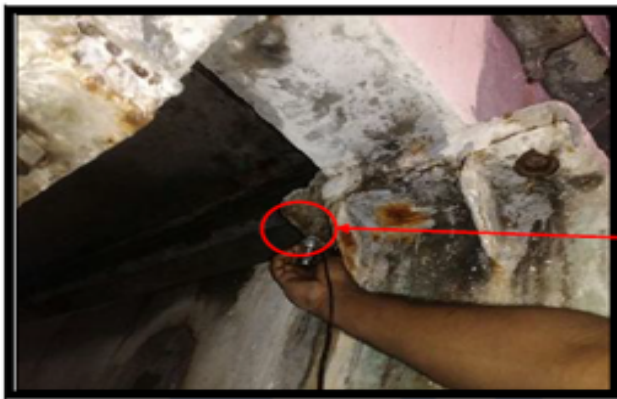
Defect Bolt

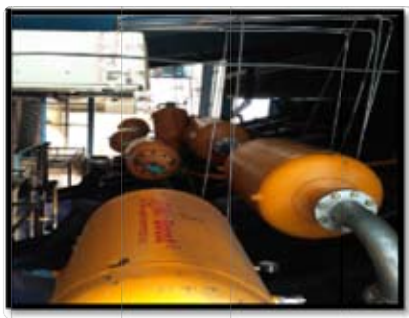
Objective: Boiler bunker capacity is 300 Mt, But due to sticky nature (45% Moisture) of fuel, not able to utilize the bunker capacity beyond 30%. Coal handling was operated in all 3 shifts for about 3 hours/ shift.

Outcome of RCA tool - Air blaster Installed to avoid stickiness of fuel in bunker.

Benefits Outcome - Coal handling oneshift operation eliminated. Fuel flow ability improved from bunker to drag chain feeder without any intervention thus resulted in Manpower reduction also.

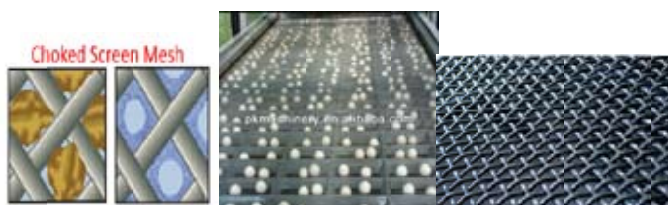
such high moisture fuel, self-cleaning type screen is installed which will clean mesh by itself. Overall system throughput increased and operating hours has come down drastically and proportional energy savings achieved.

Past Scenario: Lignite is our predominant boiler fuel and lignite naturally has high moisture (>50%) and it chokes existing flip flop screen mesh openings (8mm). Because of mesh blockage, screen throughput came down drastically and screen acts like a bottleneck for other conveyors.

Present Scenario: Through root cause analysis, to handle
