# SUSTAINED GROWTH WITH MAINTENANCE BEST PRACTICES AND RE-ENGINEERING EFFORTS IN TNPL

**Key words:** Maintenance techniques, Best practices, Continual Improvement, Re-engineering

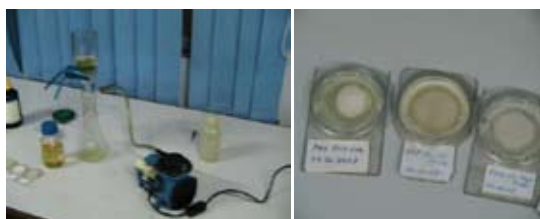
Fig 2 : Oil Patch Testing kit and result

- Testing of hydraulic and lubrication oils in various powerpacks, in a periodic manner, to evaluate the oil

cleanliness level in lubrication and hydraulic systems. Test kit and sample patch test results are shown in Fig.2.

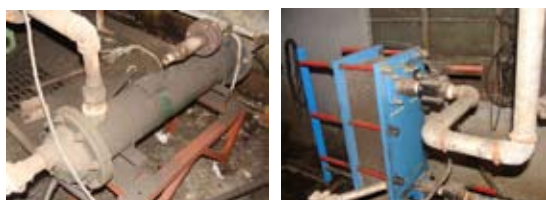
Fig 3 : Heat Exchangers (Shell & Tube and Plate Type)

- Adopting suitable oil purification measures, online and offline to ensure proper quality of oil. This is achieved using Centrifuges, Electrostatic Oil Purifiers and Vacuum Separators.
- Replacing Shell and Tube Heat Exchanger with Plate Type Heat Exchanger, which are more efficient, reliable and relatively maintenance free

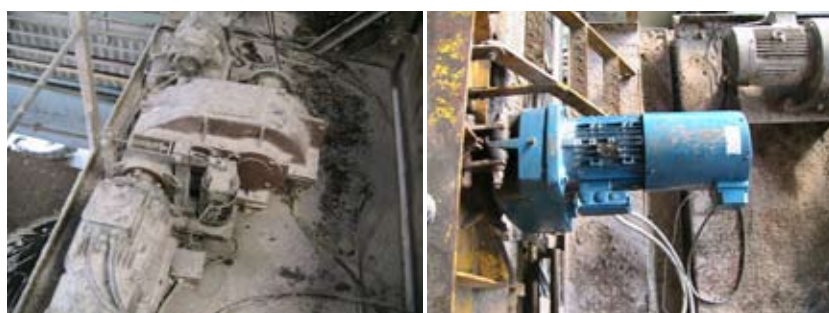
Fig. 7: EOT Crane - Old Arrangement & New Arrangement

- Upgrading roll grinding machine during 2007 with CNC control for achieving better roll surface finish and thereby a longer regrind interval. Since then the regrind interval has been around 180 days on an average (ref Fig.6)
- Identification of suitable grease for critical applications
- Alignment checks for EOT crane gantry rails
- Balancing Paper Machine rolls as per grade G1 to ensure smoother runs in elevated speeds
- Replacing Rotating syphons with Stationary syphons in all dryers in PM1
- Replacing wire rope slings with Nylon slings for ease of handling and maintenance
- Replacing conventional gearboxes in EOT crane LT drive mechanism with shaft mounted

gearunits, thereby saving power and reducing downtime (Fig.7)

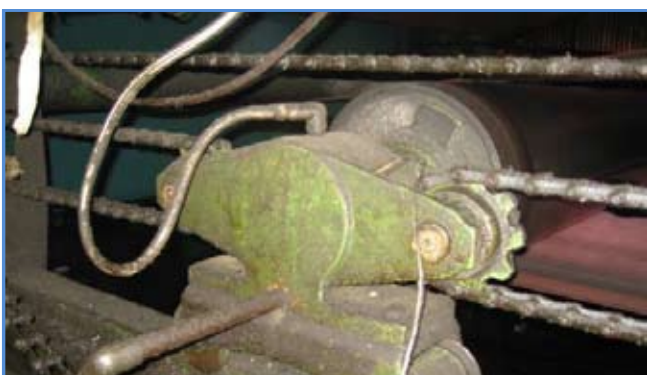
Fig.9 : Modified arrangement for Oil lubrication

oil lubricated ones and this was executed, taking advantage of the Paper Machine rebuild, during 2002. In this period all the 14 grease lubricated bearings were re-engineered to make them suitable for oil lubrication.

The housings were provided with suitable oil inlet and outlet provisions and oil tubings were laid. The benefits were evident from the number of bearing changes in these locations. Table 2 below describes the benefits of this re-engineering.

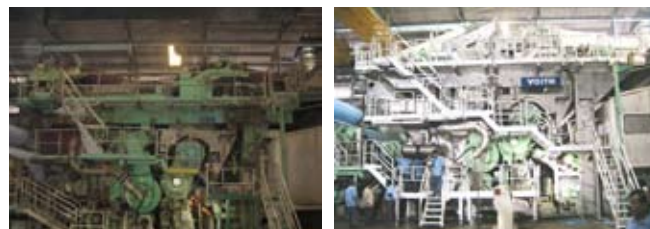
Fig.10 : Press part - Before and After LCE

Under this project, the entire press section MS frames were replaced with SS / SS clad frames. This also gave an opportunity to redesign the frames for easier fabric changing. Now TNPL enjoys the benefits, like stable machine structurals and easier fabric changing

process leading to higher operating speeds and hence lower shut down times (Fig.10).

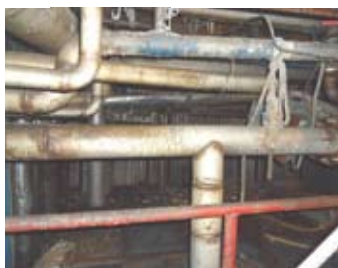
Fig. 13: Old location and New location of Vibrating Screens

TNPL decided to re-engineer the entire system and accordingly relocated the vibrating screens to a new place, which was very convenient to work in (Fig.13). Also the pipe line routing and valve location were modified to ensure quicker pumping of starch to the rolls and hence avoid dry run damages. The results were in line with the expectations
