# Seshasayee Paper and Boards Limited Erode

## Maintenance Strategies For Cost Reduction and Quality Improvement

**AT SPB**

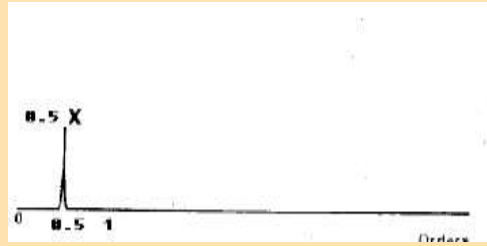
SYMPTOM	MOST LIKELY	OTHER POSSIBLE CAUSES	SPECTRUM
0.5x Half Running speed	Rub	Rotor rub (Sleeve bearing) Severe looseness (0.5x, 1x, 1.5x...) Drive belt resonance (could be >1x)

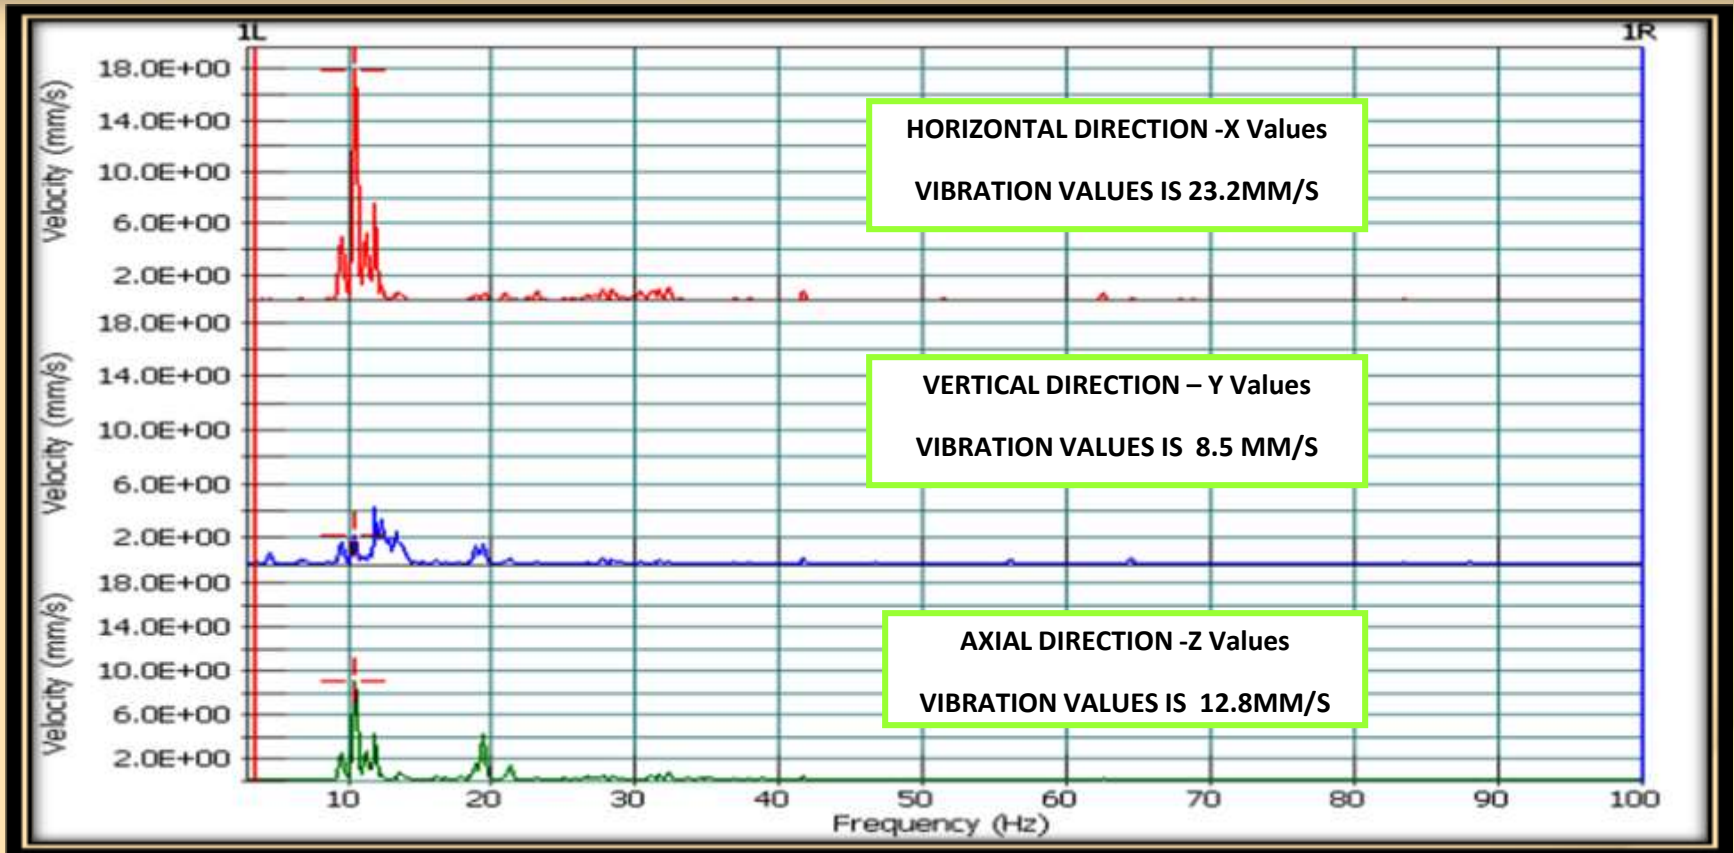
# SPECTRUM OF ROLLS IN 3<sup>RD</sup> PRESS IN X Y AND Z DIRECTION

- Major values are at the frequency of 10.5 hz in x direction in the above spectral data.
- **Threshold limit for vibration is 4.8 mm/sec**

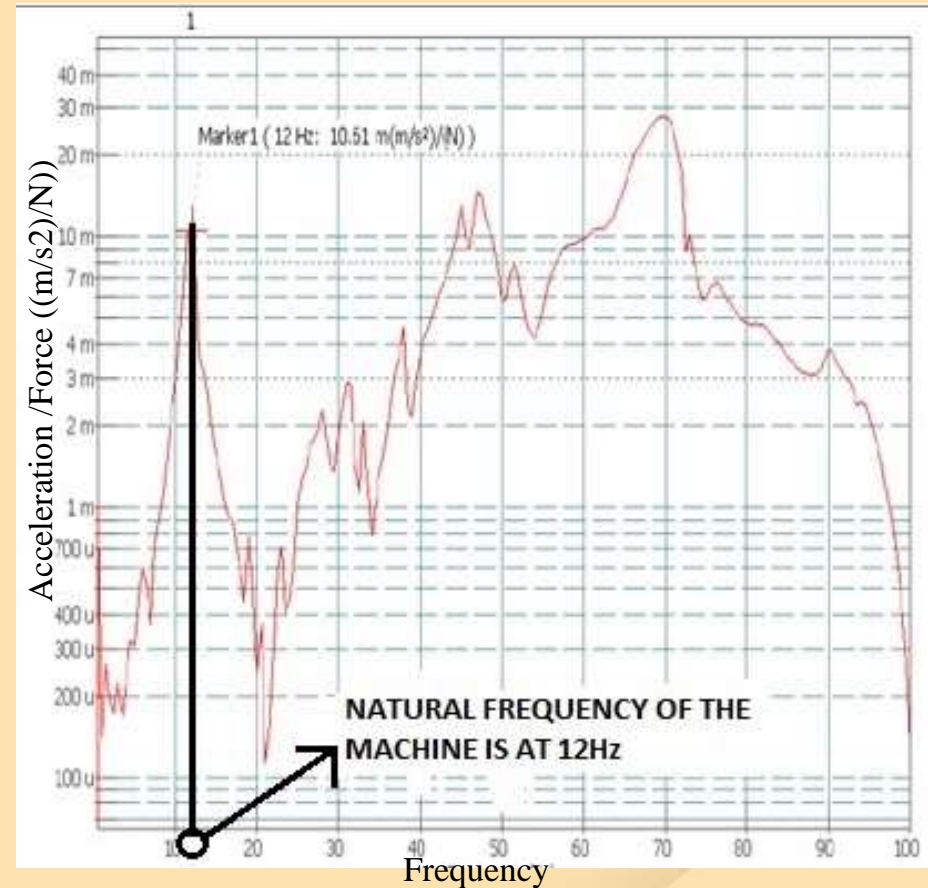
# FREQUENCY RESPONSE FUNCTION (FRF) BUMP TEST FINDINGS

- Since vibrations are predominant at one frequency (10.5 Hz), structural resonance was suspected to be one of the reasons.
- Frequency Response Function (FRF) for each structure was measured with an instrumental hammer at various structural locations, including the location of high vibrations.

- **Roll vibration frequency is 10.5 Hz**
- **Structural resonance is also 12 Hz**
- **Since they are close M/c vibrations are seen.**

- **Decision taken to improve the structural strength and accordingly action plans were worked out,**

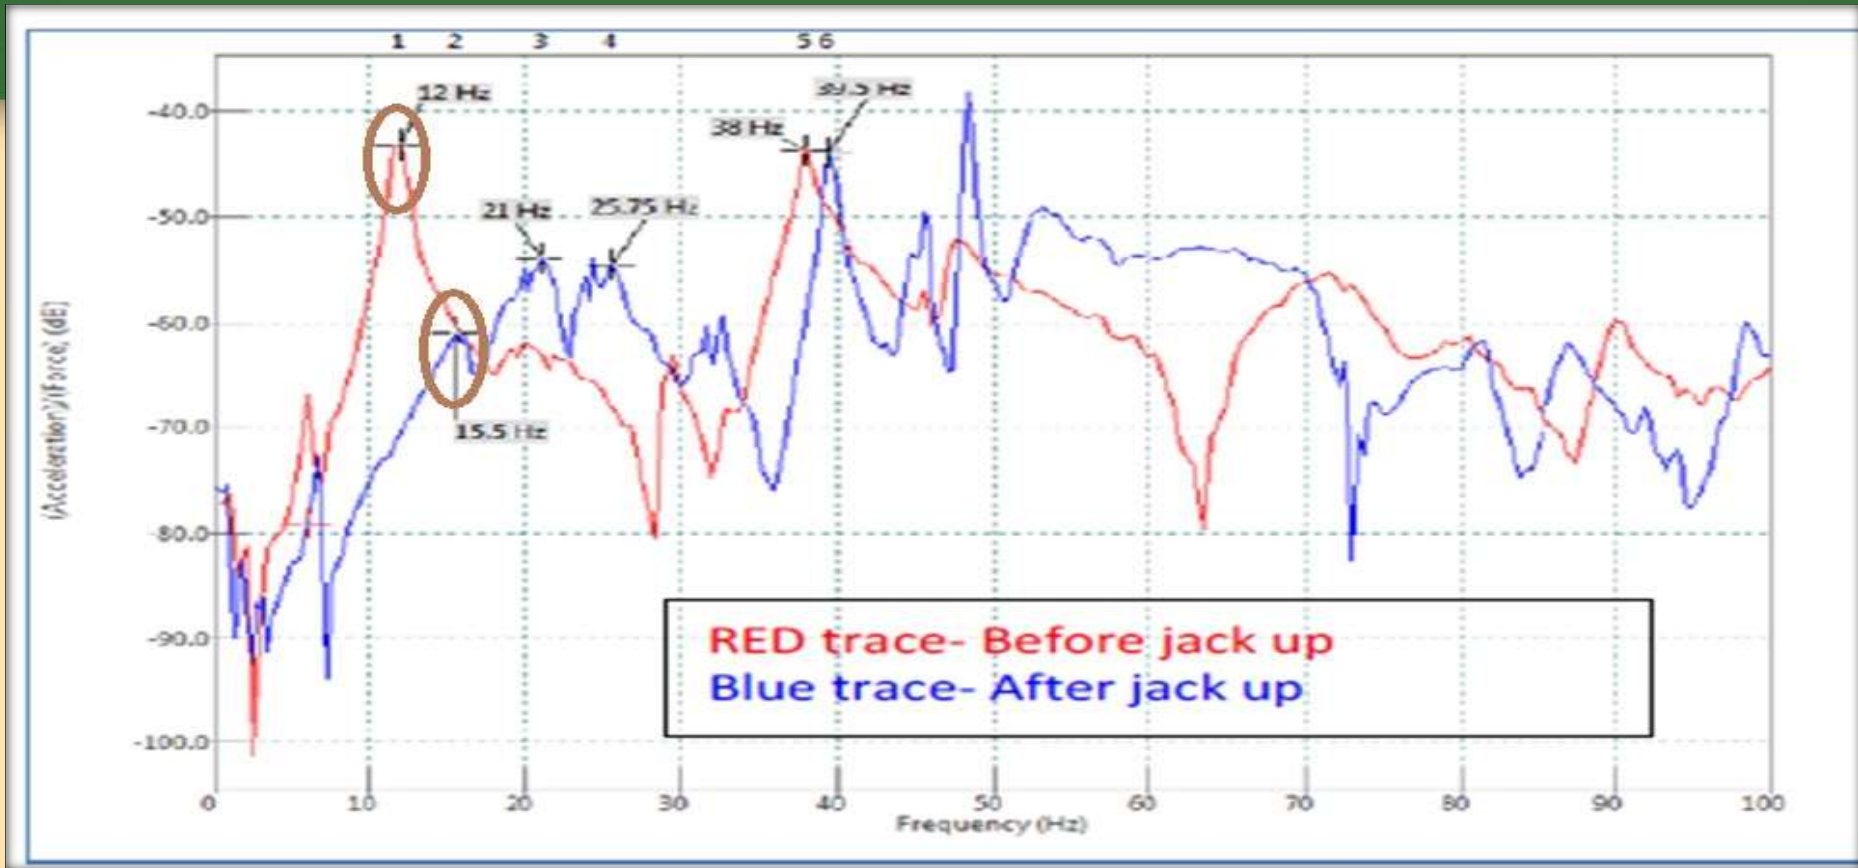
# FRF SPECTRUM OF STRUCTURE B BEFORE AND AFTER JACKING UP

- Bump test at the jacked condition was taken to find the structural behaviour.
- It was observed that the 12 Hz resonance frequency got shifted to 15 Hz .
- Permanent supports were made ready and fitted.
- Typical FRF spectrum for structure B are shown in fig.,

From frequency response test on structure ,12hz is observed equals to **720Rpm** .At **680 mpm** of machine speed ,Most rolls run at 635 rpm which is close to 720 rpm and if the machine speed is increased beyond this ,all roll speed will reach 720 rpm which is natural frequency of structure. After jacking the frequency got shifted to **15.5 Hz** that is **930 rpm**. So the press section is safe to run till **993 mpm**

- From vibration severity point of view, with permanent support provided for structure B,
- From the spectrum (15Hz) machine is safe to run at 850mpm
- The machine speed increased to 730 mpm from 680 mpm.

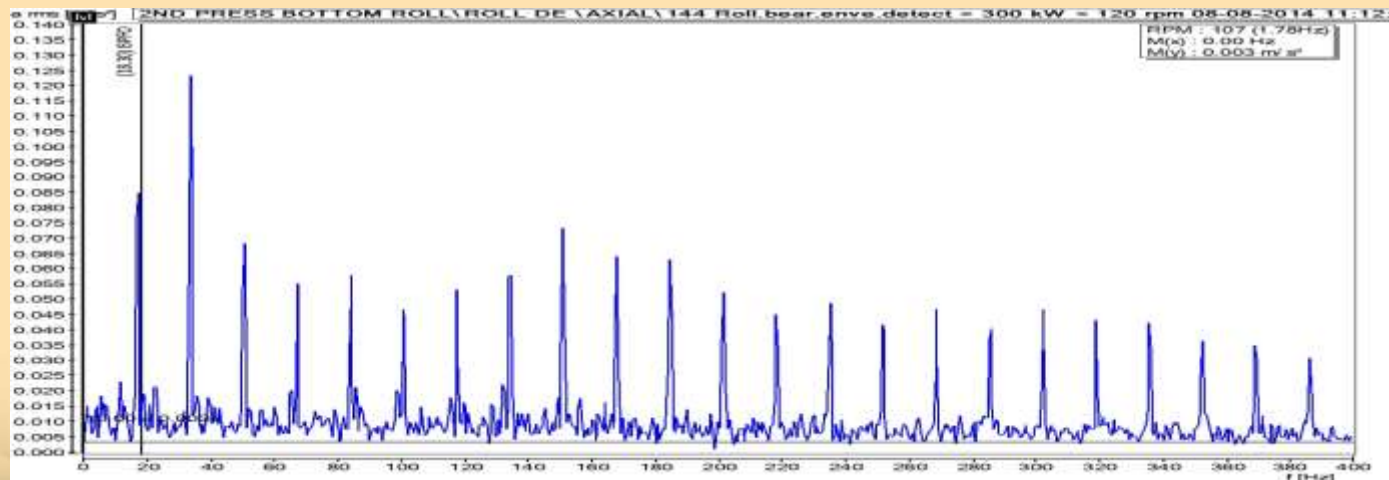
Vibration level and spectrum at abnormal condition:

LOCATION	VIBRATION VELOCITY IN MM/SEC.		
	HORIZONTAL	VERTICAL	AXIAL
ROLL DE	3.05	2.19	8.26
ROLL NDE	3.36	2.31	9.33

- Heavy vibration observed.
- Bearing outer race coincides in the spectrum.

(Removed bearing after dismantling seems to have a crack in the outer race)

- To change the bearing.

- Roll Changed with the new bearings.
