# CONTINUOUS IMPROVEMENTS IN PAPER MANUFACTURING AUTOMATION AT TNPL

**ABSTRACT:**

This Paper talks about the continuous measures taken to improve the safety for Men and Machine, Enhance the productivity, Improve the Quality, Reduce the cost of Production, Improve the overall Efficiency of the System, Ease the Process Operation and addressing the Technological Obsolescence in a Smart way.

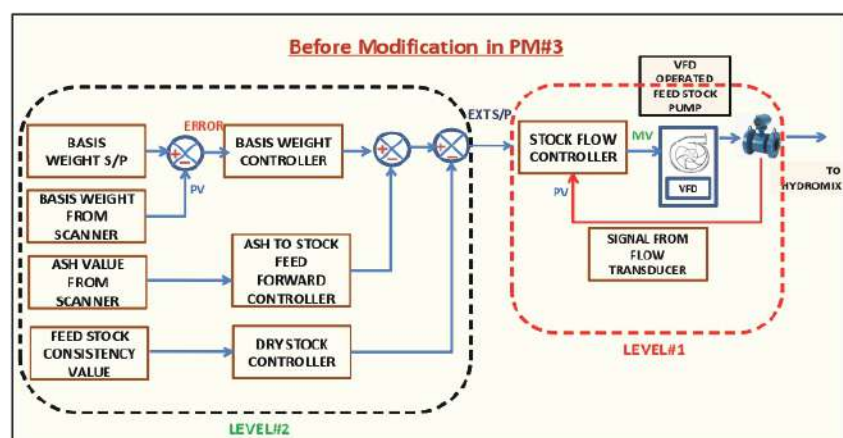
Figure 1: PM#3 Basis Weight Control Loop before Modification

Level#1 is Stock Flow Control Loop and Level#2 is Basis Weight Control Loop. Level#1 Process Variable (PV) is collected from the Stock Flow Meter and Level#2 PV is collected from the Reel Scanner Basis Weight Sensor (Figure 1).

- MD Basis Weight 2 sigma variation was on higher side and it was around  $\pm 2.5\%$ .
- Frequent Machine stoppage due to Stock Flow hunting which was beyond permissible limits.

- Reliable measurement was a requirement for such critical Control Loop for achieving better performance.
- The Variation in Stock Flow Measurement was on higher side and it was malfunctioning often (>14000 LPM) due to air entrapment which lead to unstable measurement.
- Electromagnetic Flow Meter performance is limited by certain factors such as presence of air entrapment from the process line, Electromagnetic Interference, Pulsating Flow, Fluid conductivity etc.
- Hence for getting reliable PV measurement, it was decided to use Stock feed pump actual Speed instead of Stock Flow measurement as the pump speed measurement was not influenced by the above mentioned factors.

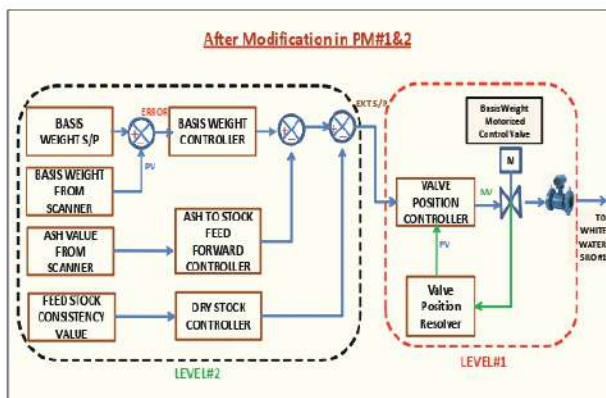
Figure 3: PM#1&2 Basis Weight Control Loop After Modification

- Similarly for PM#1 & PM#2, Level#1 Stock Flow controller was replaced with Basis Weight Valve Position Controller. The PV of Stock Flow was replaced with Basis weight Valve Position (Figure 3).

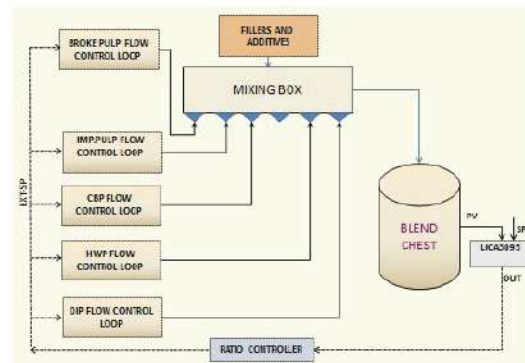
Figure 4: Stock Blending

- Blend Chest Level Control is a critical loop which plays an important role in Stock Blending.
- Variety of Pulps as per furnish demand are mixed in a pre-defined ratio along with fillers and additives in Mixing Box and the mixed Stock is fed to the Blend Chest.
- Blend Chest Level Control Loop is cascaded with associated Pulp Flow Control Loops in the desired Stock proportioning ratio (Figure 4).
- According to the remote set point given from Blend Chest Level Control Loop, Pulp Flows are maintained.

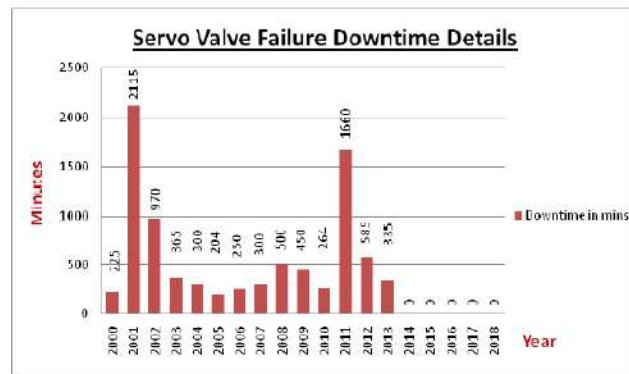
Figure 10: PM#2 Servo Valve Failure Downtime details

- Eliminated Machine Stoppage on account of Servo Valve failure (Figure 10).
- Zero R&M Cost on Servo Valve.
- Improved Productivity.

- Frequent failure of Servo Valves resulted in Machine stoppage (Figure 8).
- 5 Micron oil filter was inbuilt in the valve supply port which got clogged frequently.
- Around 144 Hrs. of downtime on account of Servo Valves failure and the Production loss was around 2200 MT between 2000 and 2013.
- Defective Servo Valves had to be sent to OEM works for servicing as it was not field serviceable.

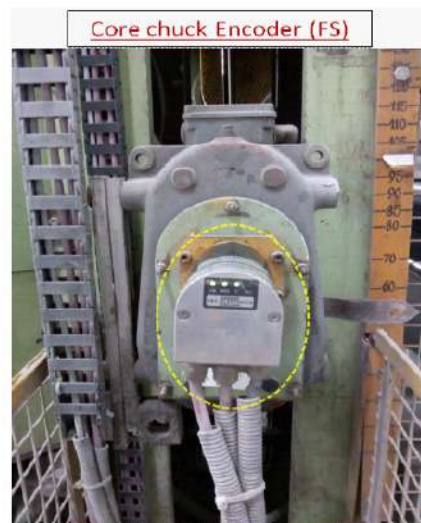
Figure 12: Core Chuck Encoder

- In Winder#2, Core Chuck / Unchuck operation is carried out by an Electric Motor and its position is captured by an Incremental Encoder.
- Encoder sends Core Chuck position feedback to PLC through Profibus-DP communication (Figure 12).

- Possible reasons for Core Chuck Motor continuous operation towards Unchuck position during problem was analysed and found Encoder value disturbance was the root cause;
- Encoder values might get disturbed due to Profibus Slave failure / PLC Bus fault / Cable & Connector issues.
- No control logic was programmed to identify and locate the Profibus device/Network fault so as to eliminate the above problem.
- Hence, it was decided to program new Safety logics to address this failure.

- Complete program logic for Core-Chuck operation was studied.
- It was searched and identified that Profibus diagnostic block was available which could be incorporated in our control system application software to detect failure of Profibus devices which identifies and generates "Slave fault error bit".
- Logic functioning was tested in offline with Profibus device installed in a test kit.
- The same was programmed in Winder PLC. The "Slave fault error bit" was used as an interlock for the operation of Core Chuck Motor Chuck / Unchuck permissive.

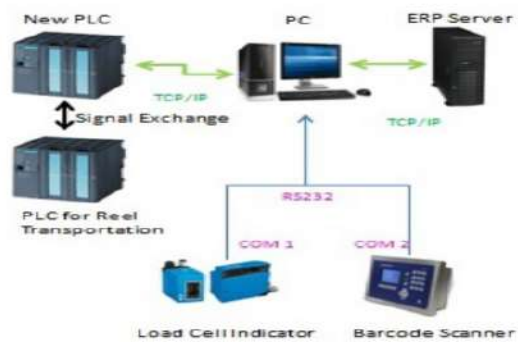
Figure 14: PLC Architecture.

- Existing Siemens S7 PLC was used to transport Reels from Winder 7 Meter Floor to Reel Wrapping. This CPU was not compatible to communicate over TCP/IP with PC Station. Hence, a separate PLC was installed (Figure 14).
- Hardwired Signals were exchanged between old and new PLC in such a way to position the Reel on the slat conveyor to
  - Collect Reel ID from the Barcode
  - Collect Reel weight data from the Weigh Scale and
  - Attach the collected data with respect to its Reel ID
- Application software was developed to fetch & validate the reel data from mill ERP system for the scanned barcode;
  - Reel weight data available in ERP system is arrived via calculation based on the Caliper data, GSM, Reel length and width.
  - Actual Reel weight is compared with the calculated weight available in the ERP data base and is checked for a given tolerance.

- Upon successful verification PC station commands the PLC over TCP/IP protocol.
- The Command received in the new PLC is transferred to the existing PLC in Reel Wrapping through hardwired signals to allow the reel for further transportation.
- Similar Weigh Scales, Barcode Scanners and PC Station with ERP connectivity have also been installed and commissioned in Rewinder#2, Rewinder#3, Rewinder#4, Rewinder#5, Cutter#1, Cutter#2 & Cutter#3 and Cutter#4 to account Finishing Loss at each stage.
- Right measures are being taken to reduce the Finishing Loss by (Ref: Figure 15 & Figure 16).
- Trim Optimisation
- Deckle Optimisation
- Reducing spool end wastages.

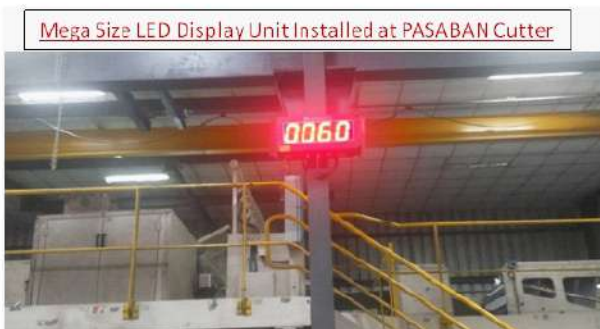
Figure 18: Large Size LED display.

- Machine Rated Speed data was collected with respect to the Chopping size.
- Speed Efficiency calculation was programmed in Standalone PLCs for all the Cutters / Sheeters by obtaining machine speed in real-time using the formula:
  - Speed Efficiency % = (Actual Machine running speed/Design speed for the respective chopping Size)\*100
- Calculated Speed Efficiency value in % was displayed in Mega sized LED display unit (Figure 18) at Sheeters / Cut Pack Lines.

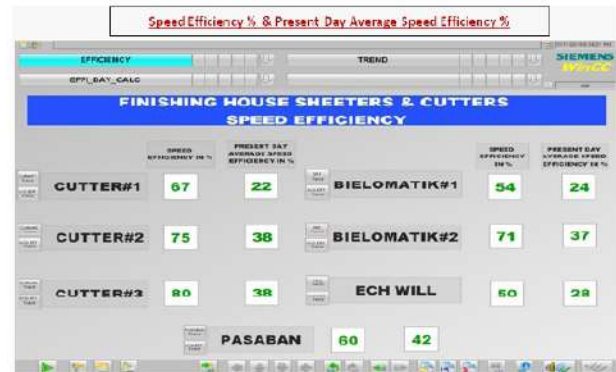
Figure 19: Sheeters & Cutters Speed Efficiency display page.

Calculated Speed Efficiency values in % and the day Average Efficiency values were displayed in a Operator Station installed at the Shift In charge's office (Figure 19 & Figure 20).

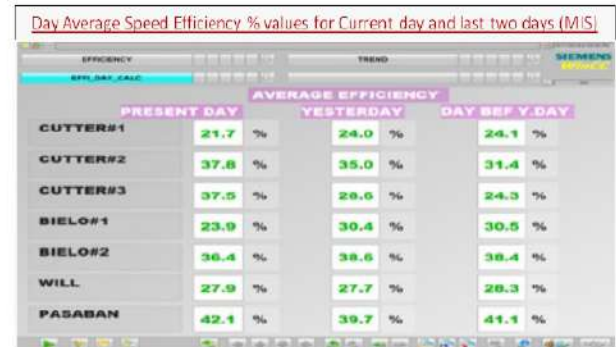
Figure 20: Sheeters & Cutters Speed Efficiency Day Average.

- Hardwired Speed Efficiency signals from the Sheeters / Cut Pack Lines Control Systems are connected with Master PLC.
- Day Average Overall Speed Efficiency of Cutters / Sheeters are programmed in Master PLC using the following formula,
  - Day Average Speed Efficiency =  $\int_0^T \text{Speed Efficiency (\%)} / \int_0^T \text{lapsed time (T)}$

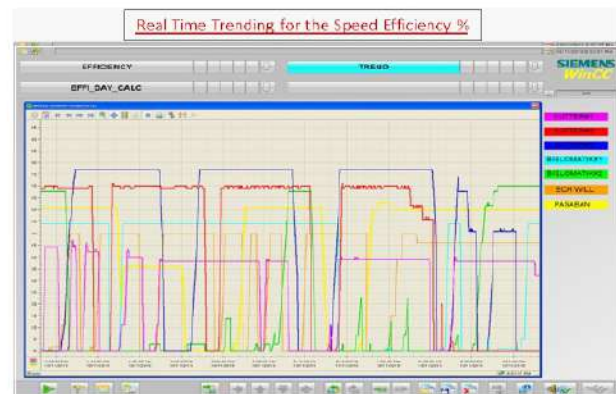
Figure 21: Sheeters & Cutters Speed Efficiency Real-time Trend Display.

Trend collection was also made available to analyze past machine performance (Figure 21).

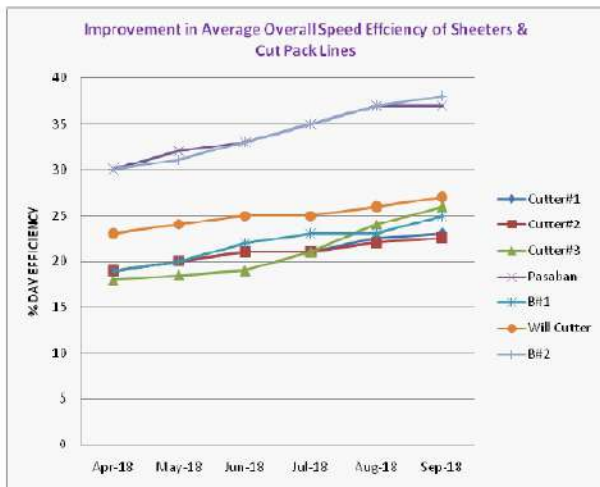
Figure 23: Overall Average Speed Efficiency improvements in Sheeters & Cut Pack Lines

- Improved Productivity.
- Continuous Speed Efficiency monitoring led to identification and elimination of unnoticed issues such as;
  - Wrapper feeding problem at Bielomatik#2
  - Cutter#3 cross cutter knife rough cutting issues at high speed.
  - Bielomatik#2 slitter knife reduced life.
- Speed Efficiency of Sheeter and Cut Pack Line are increased as follows (Figure 23);
  - Cutter#1 by 9 %,
  - Cutter#2 by 9%,
  - Cutter#3 by 15%,
  - Pasaban Cutter by 12%
  - Bielomatik#1 by 14%,
  - Will Cutter by 7% &
  - Bielomatik#2 by 11%
- Reduced Finishing Loss by eliminating Core end wastages.
- 75% reduction in Contract Sheeters dependency.
- Reduced Cost of Production.
