Maintenance Improvements in Continuous Digester for Bagasse Pulping

V. Nagarajan, R. Balasubramaniam, S. Govind and K.S. Kasi Viswanathan

Seshasayee Paper & Boards Ltd., Pallipalayam, Erode-638007 (T.N.)

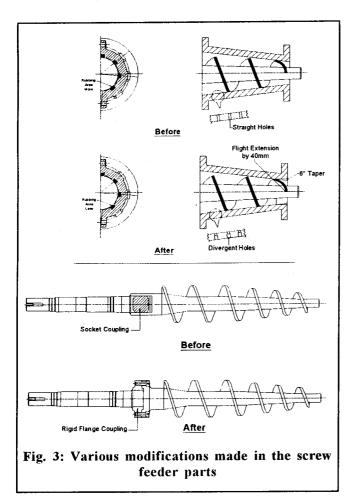
- With the socket driven arrangement, the weight of the screw rested on the wear bar necessitating the frequent renewal of wearing parts. Mean time between screw changes was less than 400 hours. Rebuilding cost was also very high.
- Pandia digester had to be stopped for changing the screw feeder and throat involving a down time of 12 hrs.
- Grease lubrication of the screw feeder bearing housing

was not effective and bearings were getting heated up very frequently.

• The screw could not be operated more than 55 rpm because of its weight and robust construction.

- The screw was now coupled with main drive shaft by means of rigid flange type coupling which avoided the screw resting on the wear bar. The screw no longer rested on wear bars and hence reduced the need for frequent renewal of wear parts.
- The size of the screw feeder was changed to 17" screw feeder to reduce the weight.
- The screw flight length was increased by about 40 mm at the convergent end for free discharge of bagasse to the inlet chamber.
- For reconditioning of the screw, chromium carbide welding electrode was used.
- All the bearings were converted to oil lubrication bearings.
- The holes in the throat were modified to provide for divergent holes for better dewatering.
- The throat was converted from a purely convergent

- The wear bars were located in such a manner so as to have a relief angle to ensure that the surface area of contact was reduced to a line contact on the traction side.
- The length of the plug pipe was reduced from 12" to 9".
